**Technical Service Bulletin (TSB)**  
**Steering Wheel Push Button Breakage**

<b>REFERENCE:</b>	<b>TSB:</b> 08-015-25 <b>GROUP:</b> 08 - Electrical	<b>Date:</b>	January 21, 2025	<b>REVISION:</b>	08-148-24
<b>VEHICLES AFFECTED:</b>	<b>2023 - 2025 (H1) Jeep Commander</b> <b>2023 - 2025 (M1) Jeep Compass</b> This bulletin applies to vehicles built on and after August 01, 2023 (MDH 0801XX) and on and before <b>**December 05, 2024 (MDH 1205XX)**</b> .			<b>MARKET APPLICABILITY:</b>	
				<input checked="" type="checkbox"/> NA <input type="checkbox"/> MEA <input checked="" type="checkbox"/> SA <input type="checkbox"/> IAP <input type="checkbox"/> EE <input type="checkbox"/> CH	
<b>CUSTOMER SYMPTOM:</b>	<b>Customers may comment on the following:</b> <ul style="list-style-type: none"> <li>One or more of the frontward steering wheel switch buttons are broken, or are inoperable.</li> </ul>				
<b>CAUSE:</b>	Manufacturing issue

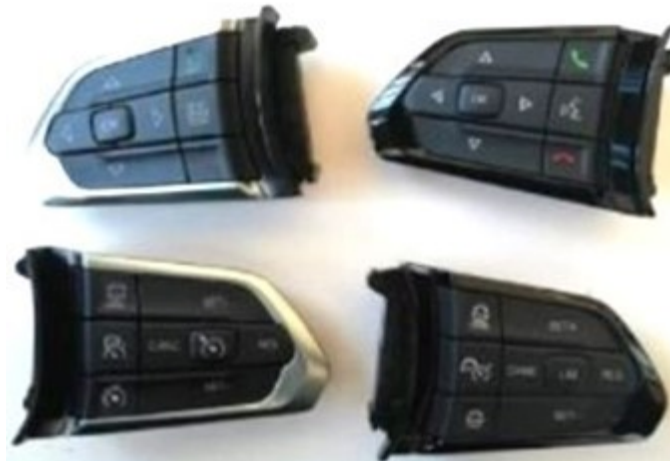
**Fig. 1**

- NOTE: This Repair Procedure covers the frontward steering wheel switch buttons. The rearward steering wheel switch buttons are not involved and should not be inspected or replaced under this TSB.**
- Press all of the frontward steering wheel switch buttons on both the left side and right side [Fig. 1](#), 10 times each.

Frontward Steering Wheel Switch Buttons

- Did any of the switch buttons [Fig. 1](#) break, or are inoperable?
  - YES >>> Proceed to [Step 4](#).
  - NO >>> This bulletin has been completed. Use Inspect LOP (08-80-93-90) to close the active RSU.
- Replace the switch bank(s) as required.** Refer to the detailed service procedures available in DealerCONNECT/Service Library under: "Service Info > Operações de Reparo > 55 – Sistemas Elétricos/ 5570T03 - Grupo de Comandos do Telefone/Computador de Bordo no Volante - Remoção/Recolocação".  
**Or,** refer to the detailed service procedures available in DealerCONNECT/Service Library under: "Service Info > Operações de Reparo > 55 – Sistemas Elétricos/ 5580A11 - Comando Cruise Control no Volante - Remoção/Recolocação".
