Subject: REVISION: N242485780-01 - Service Update
Power Steering Pump – Service Procedure
Revised Parts, Warranty Information, and Service Procedure

Models: 2024 - 2025 Chevrolet Express
2025 Chevrolet Silverado 2500 HD/3500 HD
2024 - 2025 GMC Savana
2025 GMC Sierra 2500 HD/3500 HD

N242485780 Power Steering Pump

Condition	Some of these vehicles may contain a power steering pump that may prematurely fail.
Correction	Dealers will inspect and replace the power steering pump as necessary.

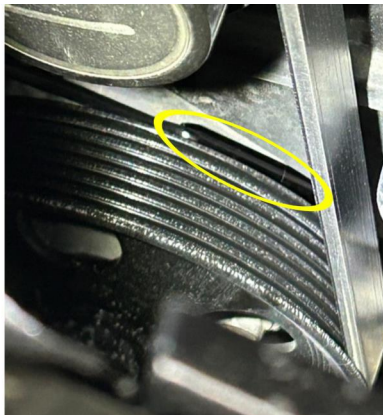
6815800

1. Locate the Power Steering Pump. Refer to *Power Steering Pump Replacement* in SI for component location.

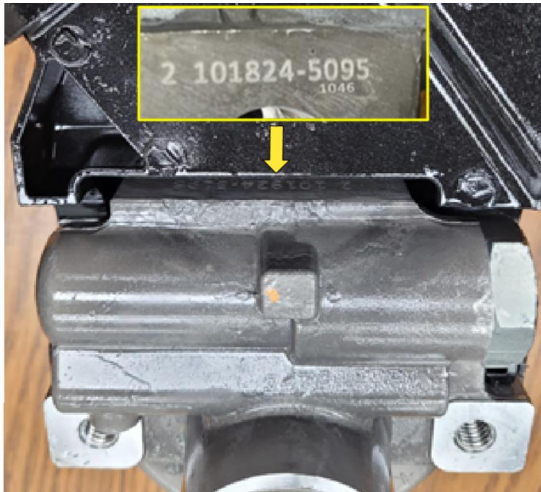
6817376

2. Insert a right-angle borescope behind the power steering pump pulley, from the most accessible side horizontally along the top edge of the Power Steering Pump. The date code and lot code are located on a flat between the reservoir and pump body as pictured below. Angle the camera towards the engine, as the codes are inside of the gap beneath the reservoir.

NOTE: Pulley removed to show location, it is NOT required to remove the pulley for borescope inspection. As pictured above, Date Code: 101824 Lot Code: 5095

3. Verify the Date Code Range (6 digit) does not fall between 100424 and 102624.
 - If the code **IS NOT** between 100424 and 102624, the power steering pump is within specification and no further action is required.

- If the code **IS** between 100424 and 102624, proceed to step 4.
4. Verify the Lot Code Range (4 digit) is not within the 5xxx series, seen as 5xxx.
 - If the code **IS** within the 5xxx Lot Code Range, the Power Steering Pump **MUST** be replaced. Refer to *Power Steering Pump Replacement* in SI for instruction.
