### Problem Details:

# 13-007 Air Compressor Discharge Line Blocked by Ice in Cold Weather

## TSB-13-007-FTL

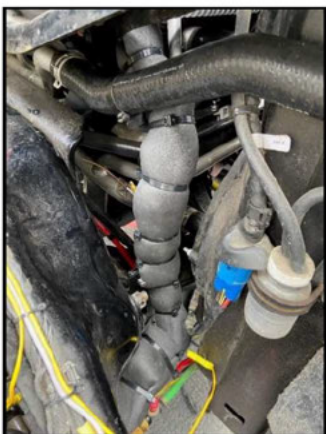
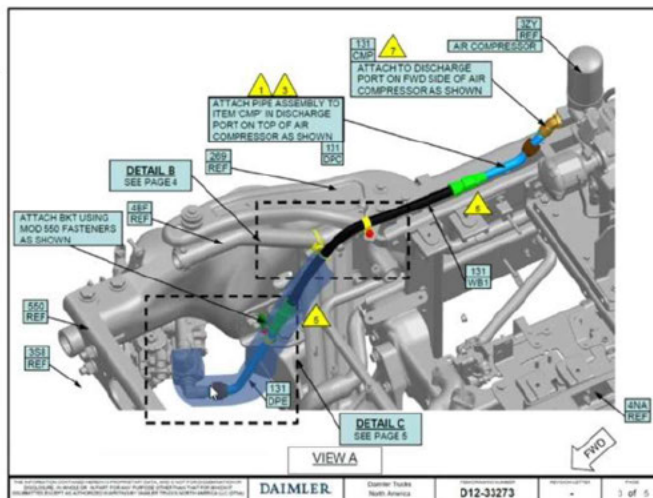
- Air compressor stops building air due to ice blockage at discharge line overflow valve.
- When discharge line becomes blocked, air compressor relieves pressure through relief valve on housing and sprays compressor oil
- Occurs in high-humidity near (+/-) freezing environmental conditions

- Moisture accumulates in spring chamber of overflow valve, then freezes, disabling valve
- Original theory was ice blockage in the air stream but this has been proven untrue

- Splash cover will be added in production mid-2025

- Service Bulletin TSB-13-007-FTL with instructions for thawing valve and installing insulation
- Service Bulletin will be revised when splash cover becomes available.
