Gen 5 DD13 Turbo Oil Drain Tubes Cracking

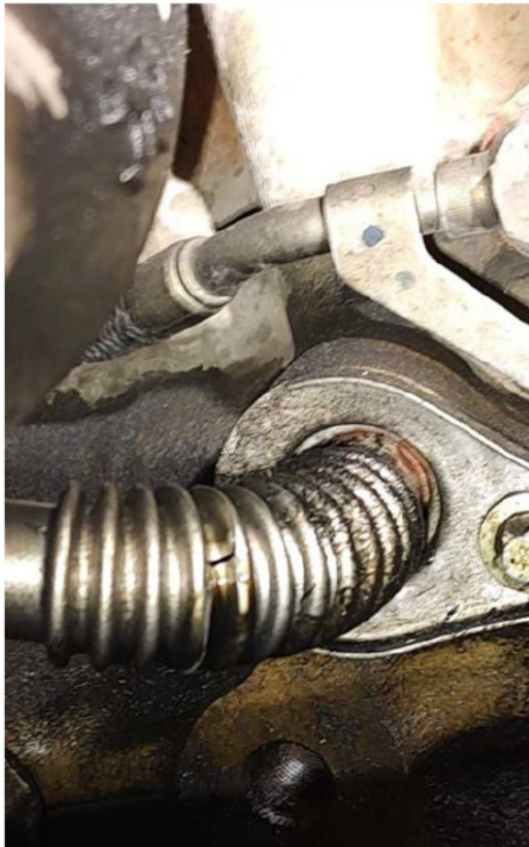
- Gen 5 DD13 turbo oil drain tubes are cracking and causing oil leaks. Based on returned material, missing turbo support bracket bolts appear to be a large contributing factor.

- Replace the turbo oil drain tube. Check the turbo mounting brackets for cracks or loose/missing bolts. Follow 24CSA-17.
