SS 3161-FTL Cascadia intermittent no-start and CPC not configured message

New Cascadia vehicles with Detroit powertrain

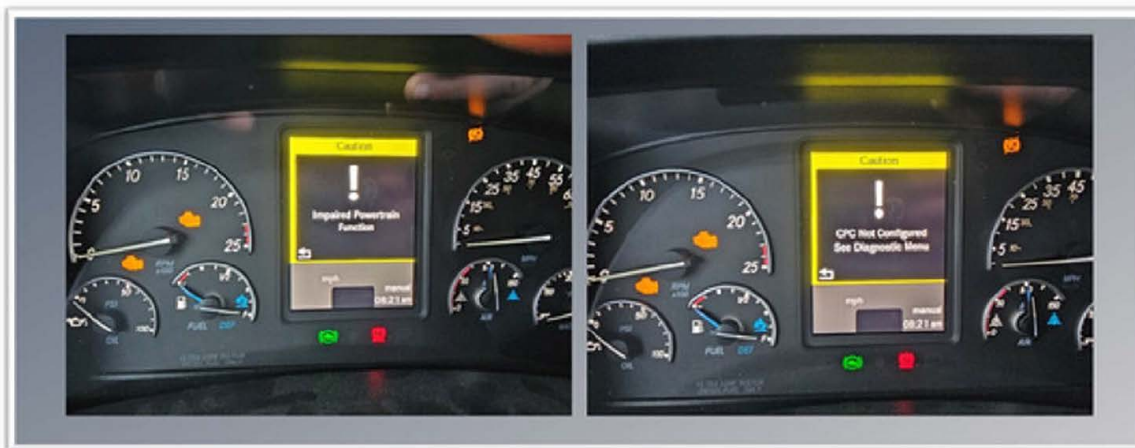
Intermittent No-start with "CPC not configured" or "Impaired powertrain" message in ICUC

2024 Freightliner New Cascadia 126 Day Cab 4 x 4 Tractor				
VIN: 3AK8LUDV485V19813 Transmission: DT12-DT12-DC				
EIN: 47195251100543 Engine: ODEEC20-DO13				
All faults Fault History Test Results Virtual Technician Data				
Description	Number	Mode	Status	Troubleshooting
Impaired Powertrain - Common Powertrain Controller 5				
DT12 TEM CAN signal faulty	520193	14	previously active	Traditional
DT12 MCM CAN signal faulty	520194	14	previously active	Traditional
ACM data not plausible	520222	12	previously active	Traditional
WPC data - CAN timeout	520330	12	previously active	Traditional
Ignition Circuit Voltage Erratic	168	2	previously active	Traditional
TCM data not plausible	1482	12	previously active	Traditional
MCM data - CAN timeout	1483	12	previously active	Refer to TechLit

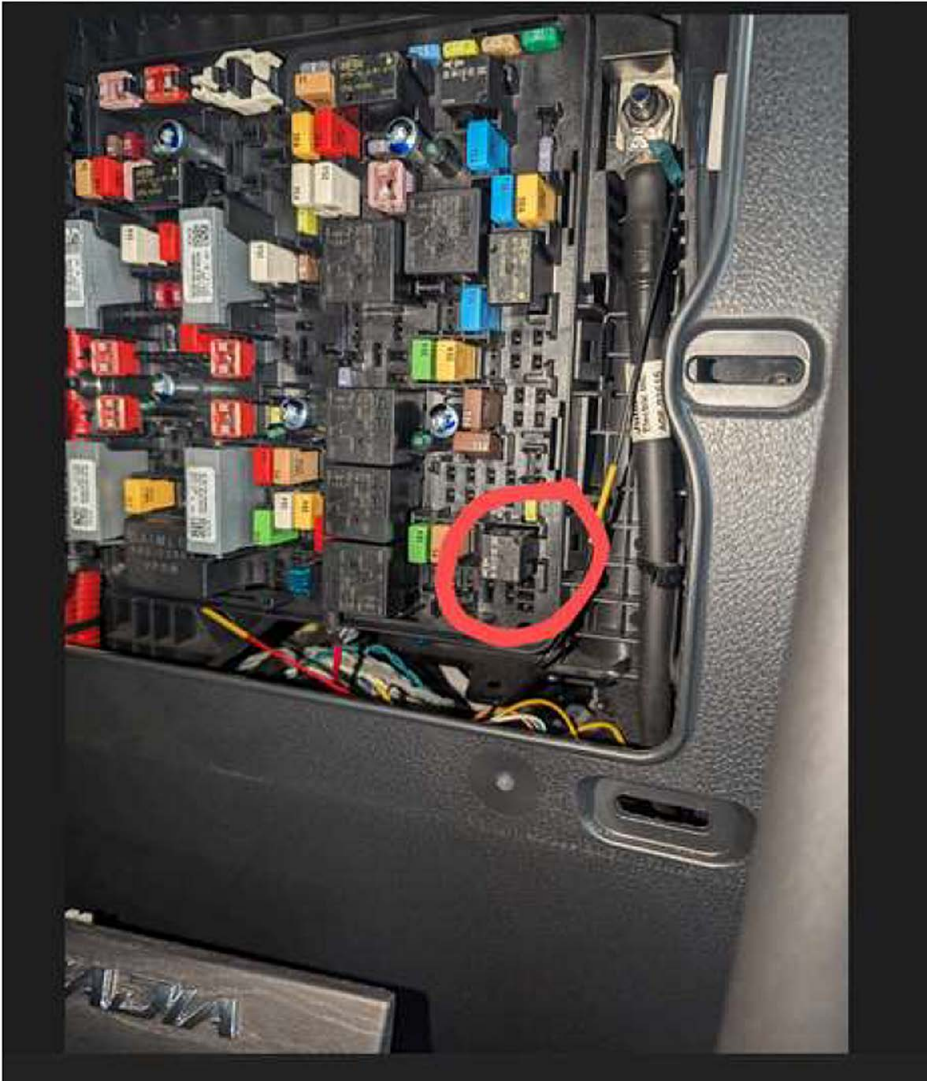
In the majority of cases with this complaint, we have verified this to be an intermittent concern with the PT Wake up/IGN relay within the VPDM. This will be either relay R22 or R24 in the VPDM depending on the layout.

The relay location will be shown on the back of the VPDM cover.

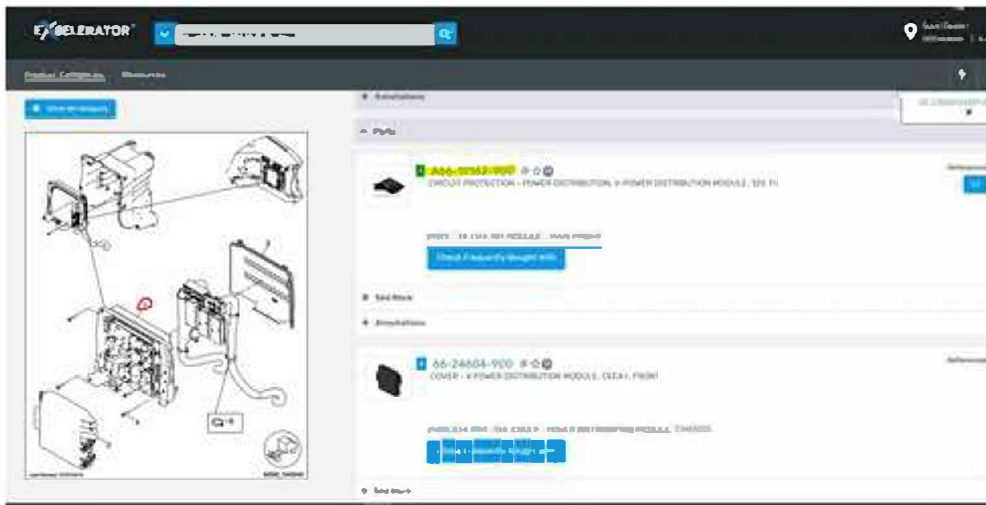
See section 3.3.2 Wall Charts for the VPDM Layout

Use the VPDM part number to locate the correct Wall Chart

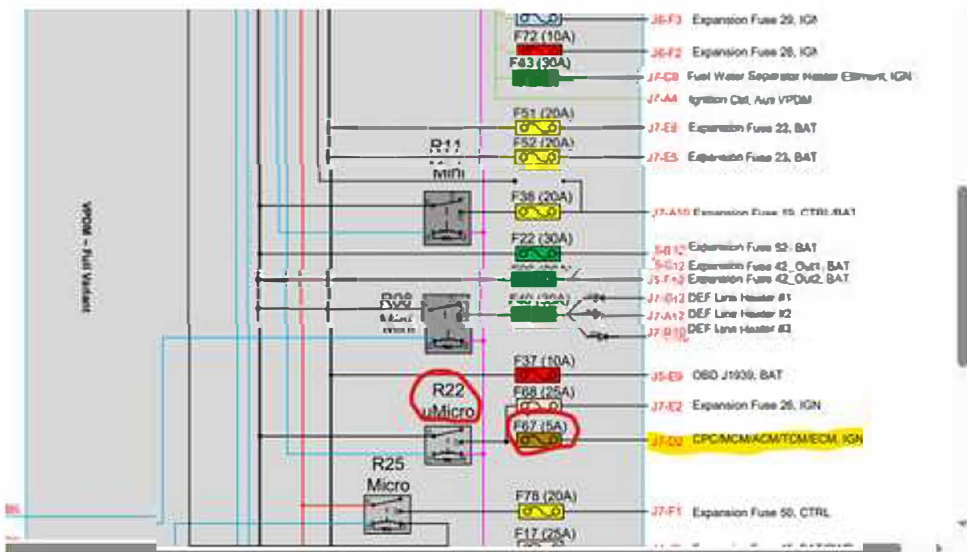
Once the correct wall chart is located search for either fuse F49 or F67 as this is the ignition power for all Powertrain modules, this will show us the correct relay that powers the ignition circuit for all Powertrain modules (Typically either R22 or R24 in the VPDM).
