# SS 3163 FTL Power Steering Reservoir Fill Cap Venting

Freightliner vehicles equipped with 2 and 4 quart capacity polymer power steering reservoirs.

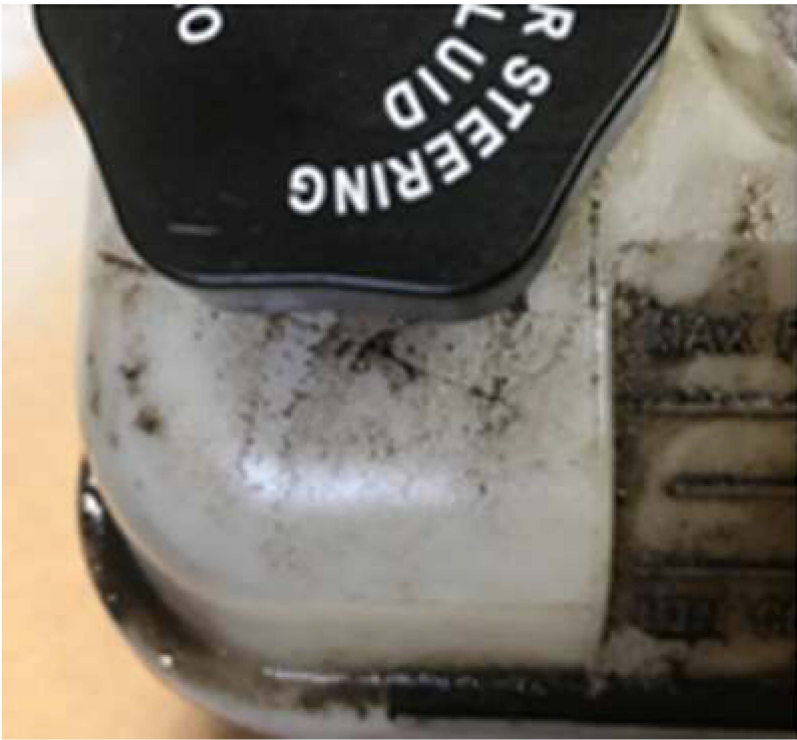
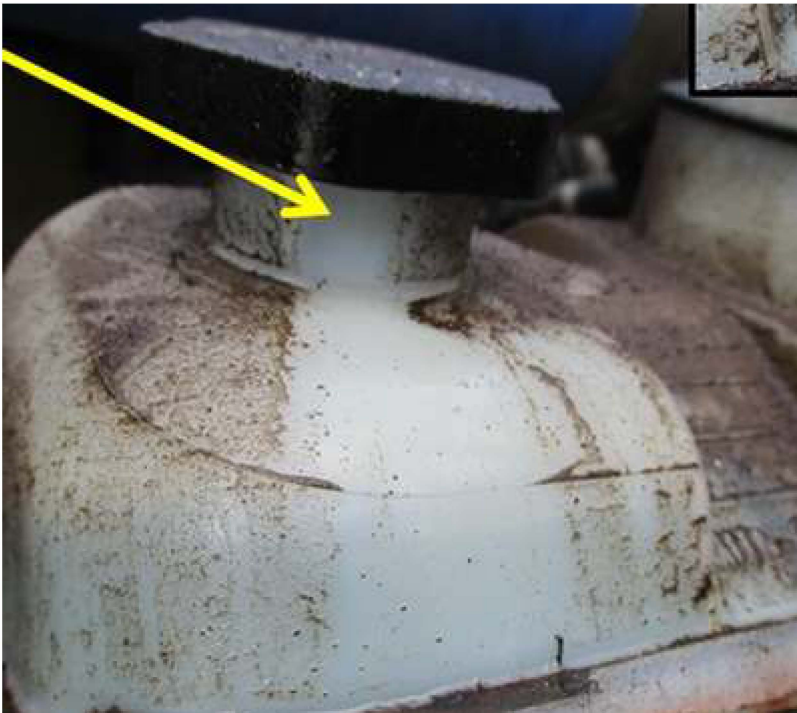
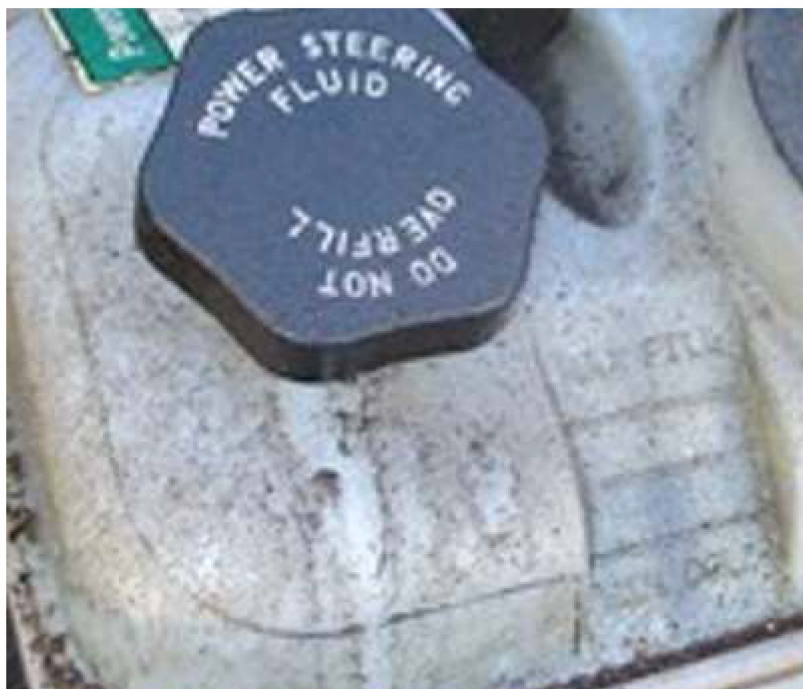
- Normal venting operation can lead to a film of misted/vented power steering fluid on the exterior surface of the reservoir body.
- Depending on application, environmental conditions and maintenance practices, the amount of vented fluid film can vary.
- There are instances where fluid film buildup can pool along the reservoir body seam line.
- Certain applications/operating environments can lead to an excessive amount of debris accumulating on the vented fluid film.

The below figures show examples of normal fill cap venting.

The symptoms detailed above for normal fill cap venting can lead to an incorrect diagnosis of a failed reservoir fill cap or failed reservoir body. This can lead to unnecessary replacement of the fill cap or reservoir assembly.

If damaged fill cap symptoms are not observed, the following procedure is recommended:

- Thoroughly wash and wipe clean the reservoir body.
- Ensure power steering fluid level is within limits.
- Maintaining reservoir fluid at "mid-level" can potentially reduce misted/vented fluid film buildup.
- If the vented fluid film path is shown to come from the lower surface of the fill neck, the fill cap can be rotated 180° and reinstalled. This will orient the cap vent path to pointing up.

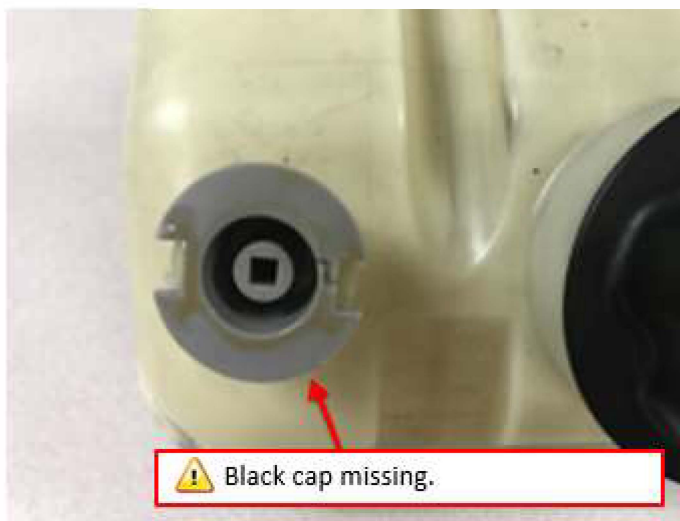
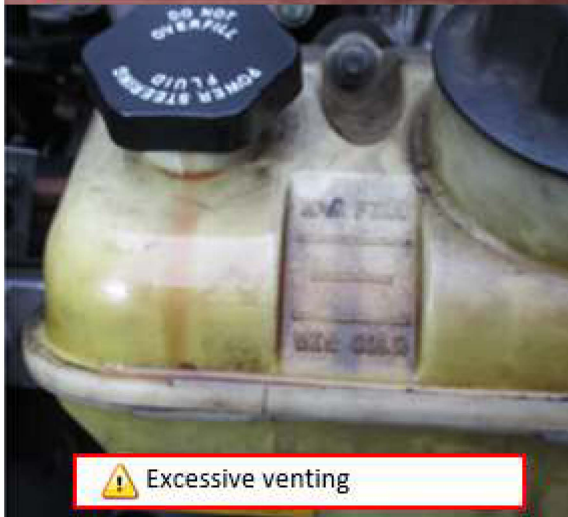
There are instances where the fill cap is damaged and the venting feature is not functioning as designed. Symptoms associated with damaged fill caps are:

- The outer cap is missing and the inner seal cap remains in the fill neck.
- The outer cap unsnaps from the inner seal cap when being removed from the fill neck.
- There is evidence of a steady stream of fluid flowing down from the fill cap

The images below show examples of damaged fill caps.

If a fill cap is damaged and not venting correctly, this can lead to a drop in power steering fluid level. Depending on operating conditions and maintenance schedules, there can also be an excessive amount of debris build up on the reservoir body.

The recommended service solution for a damaged fill cap is:

- Thoroughly wash and wipe clean the reservoir body.
- Ensure power steering fluid level is within limits
- Replace the fill cap with a new part.
