# SS 776-WST X-Series intermittent no-start and CPC not configured message

X-Series vehicles with Detroit powertrain

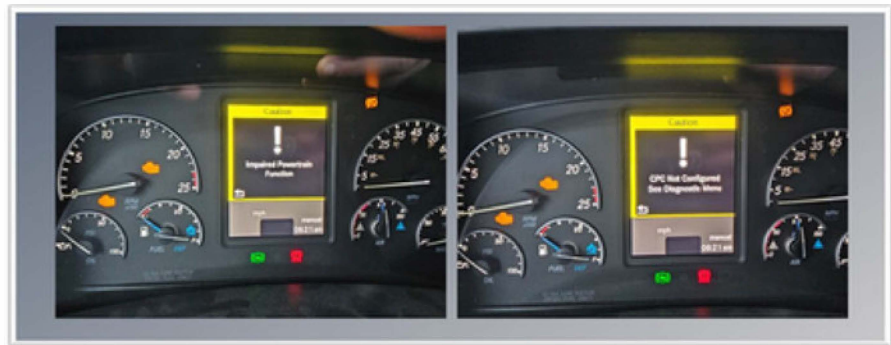
Intermittent No-start with "CPC not configured" or "Impaired powertrain" message in ICUC

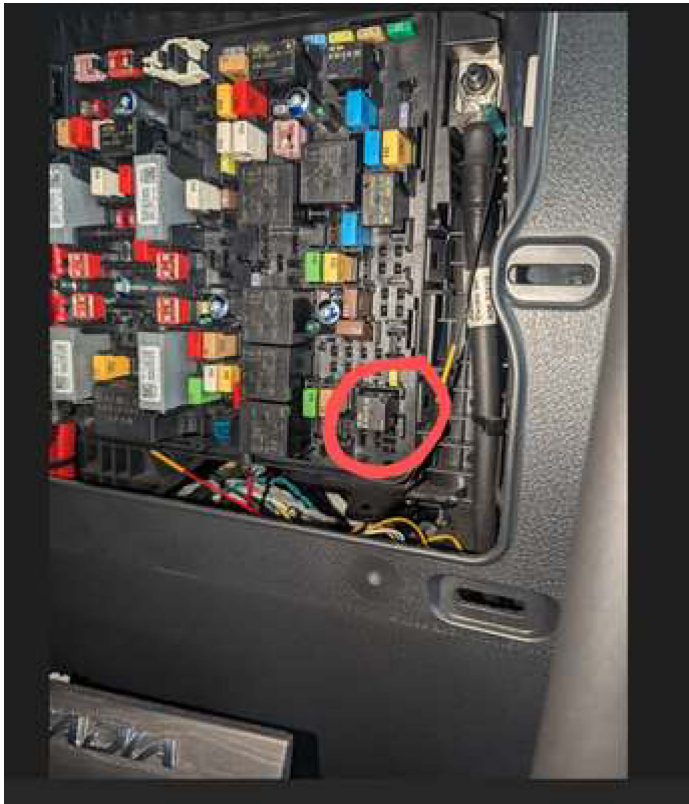
In the majority of cases with this complaint, we have verified this to be an intermittent concern with the PT Wake up/IGN relay within the VPDM. This will be either relay R22 or R24 in the VPDM depending on the layout.

The relay location will be shown on the back of the VPDM cover.

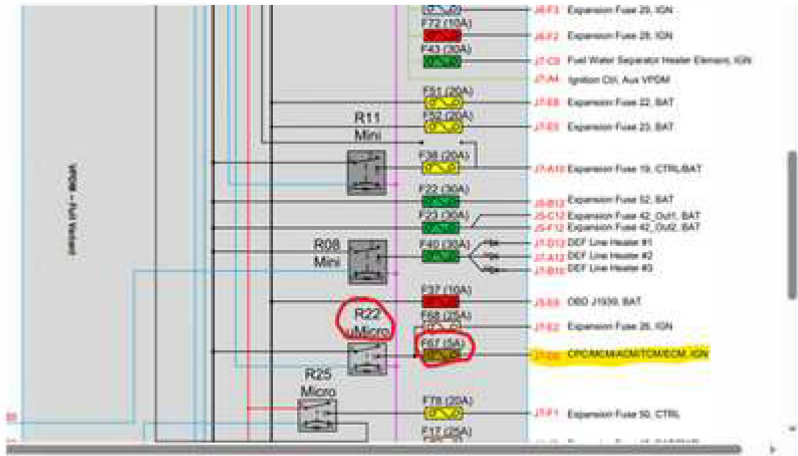
Once the correct wall chart is located search for either fuse F49 or F67 as this is the ignition power for all Powertrain modules, this will show us the correct relay that powers the ignition circuit for all Powertrain modules (Typically either R22 or R24 in the VPDM).
