SS 778 WST Power Steering Reservoir Fill Cap Venting

Western Star 47X/49X/57X/4700/5700 vehicles equipped with 2 and 4 quart capacity polymer power steering reservoirs.

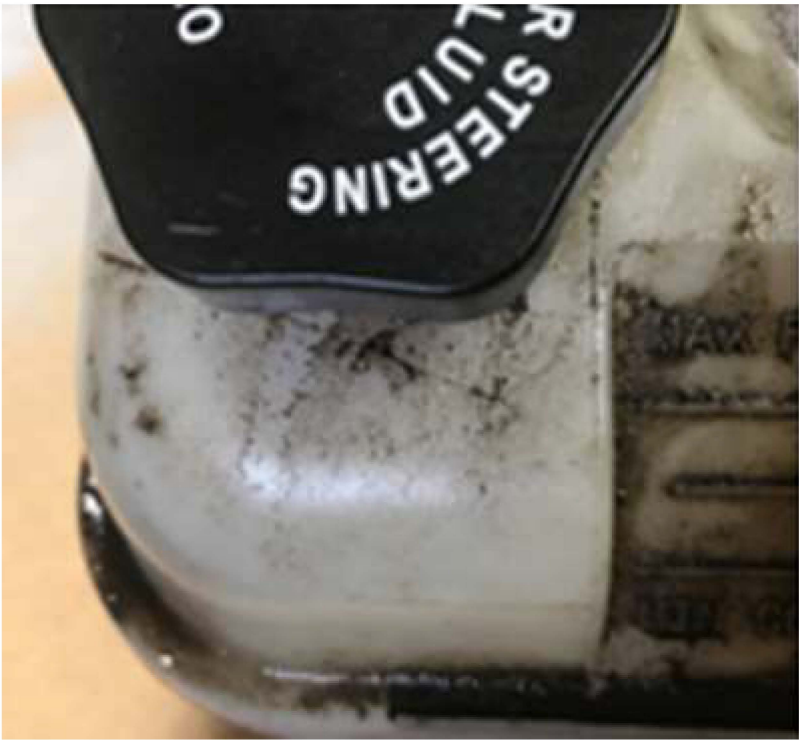
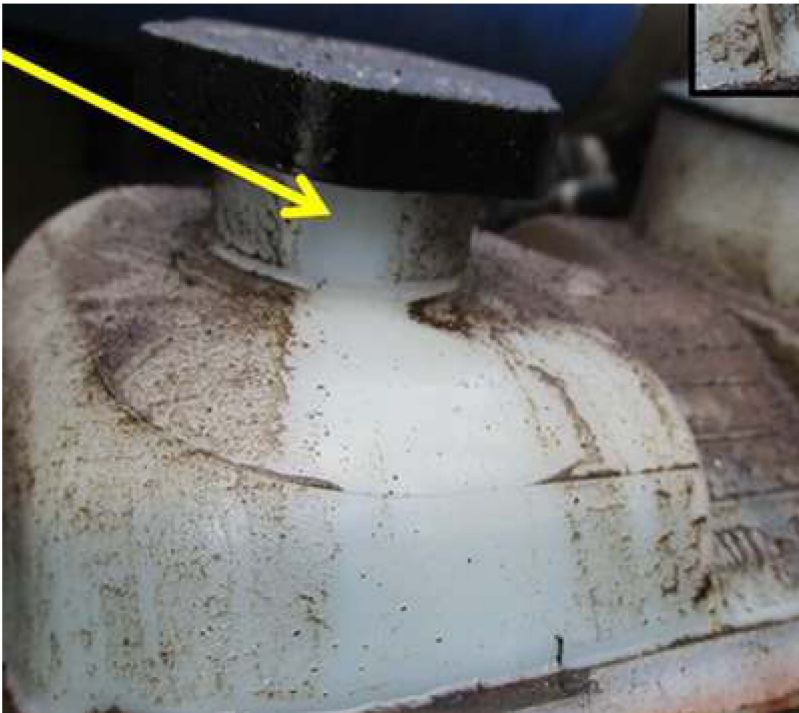
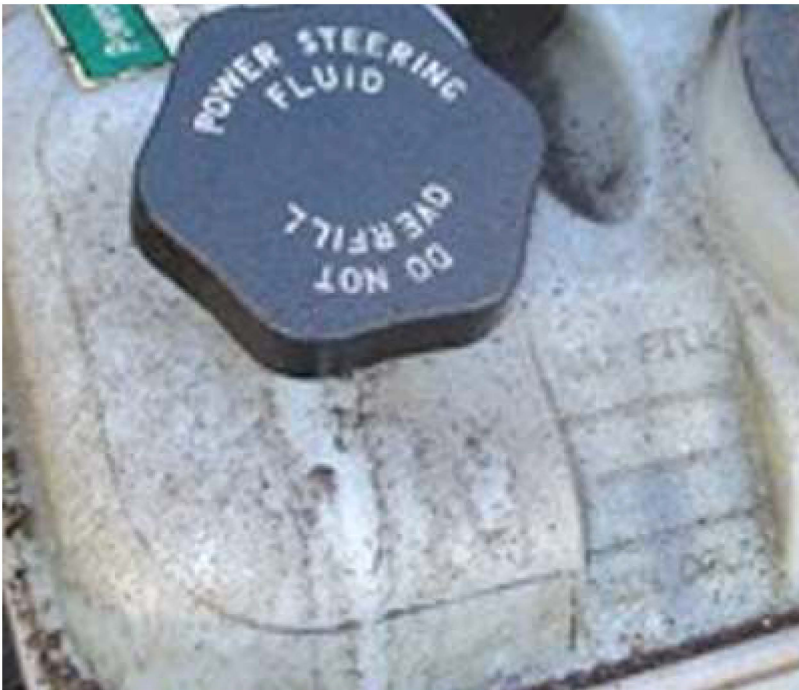
- Normal venting operation can lead to a film of misted/vented power steering fluid on the exterior surface of the reservoir body.
- Depending on application, environmental conditions and maintenance practices, the amount of vented fluid film can vary.
- There are instances where fluid film buildup can pool along the reservoir body seam line.
- Certain applications/operating environments can lead to an excessive amount of debris accumulating on the vented fluid film.

The below figures show examples of normal fill cap venting.

- Thoroughly wash and wipe clean the reservoir body.
- Ensure power steering fluid level is within limits.
- Maintaining reservoir fluid at "mid-level" can potentially reduce misted/vented fluid film buildup.
- If the vented fluid film path is shown to come from the lower surface of the fill neck, the fill cap can be rotated 180° and reinstalled. This will orient the cap vent path to pointing up.

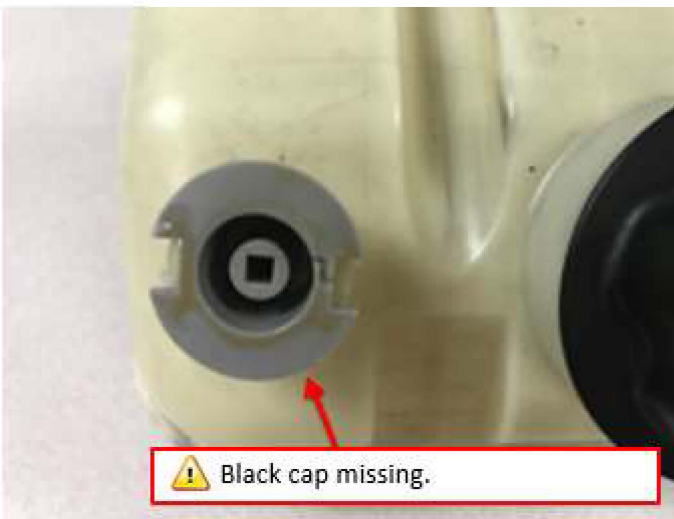
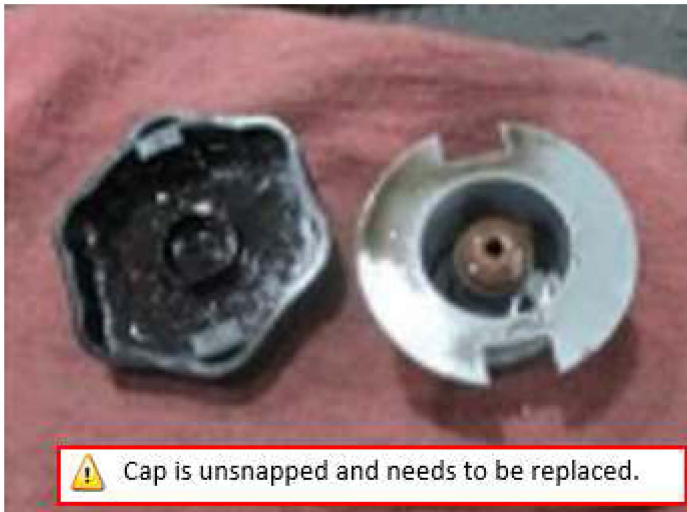
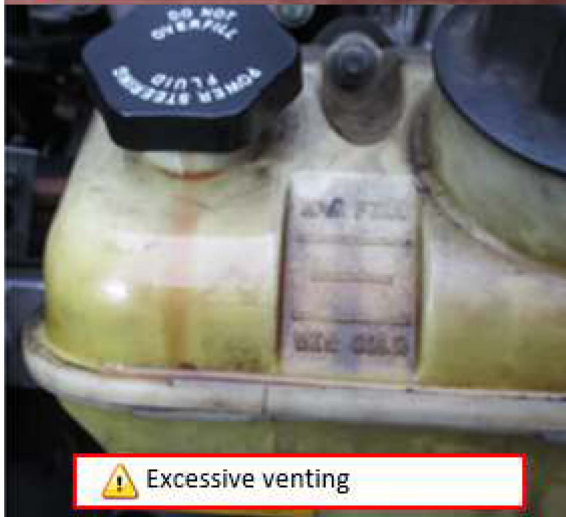
- The outer cap is missing and the inner seal cap remains in the fill neck.
- The outer cap unsnaps from the inner seal cap when being removed from the fill neck.
- There is evidence of a steady stream of fluid flowing down from the fill cap

The images below show examples of damaged fill caps.

If a fill cap is damaged and not venting correctly, this can lead to a drop in power steering fluid level. Depending on operating conditions and maintenance schedules, there can also be an excessive amount of debris build up on the reservoir body.

- Thoroughly wash and wipe clean the reservoir body.
- Ensure power steering fluid level is within limits
- Replace the fill cap with a new part.
