Adjusting the Coolant Pipe Position

TSB-20-089 FTL

► eCascadia

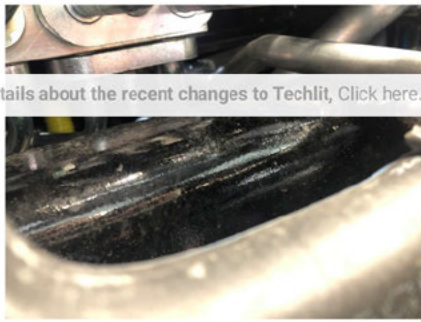
Fig. 1, Checking the Clearance between the Frame Rail and Coolant Pipe

4. Check the clearance between the coolant pipe and the frame rail. See Fig. 1.
Is the clearance 3/4-inch (19 mm) or more?

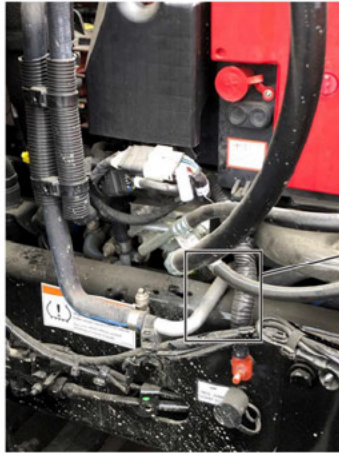
Fig. 2, Before Adjustment

Insufficient coolant pipe to frame rail clearance on eCascadia vehicles can rub the coolant pipe, which may result in excessive chaffing. Use the following directions to adjust the coolant pipe position.

NO → Go to step 5. See Fig. 2.

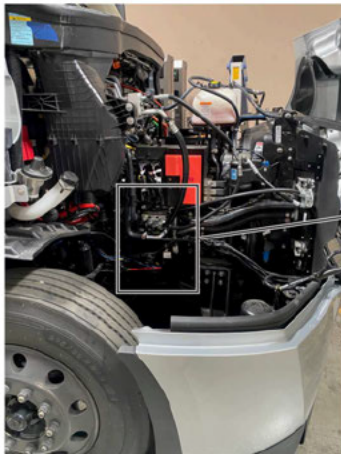
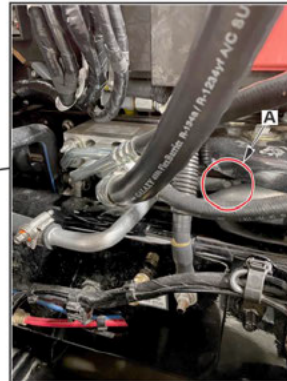
Fig. 3, Location of the Bolt to Adjust the Coolant Pipe Position

A. Bolt Location

5. Loosen the bolt and lift up the coolant pipe. See Fig. 3.

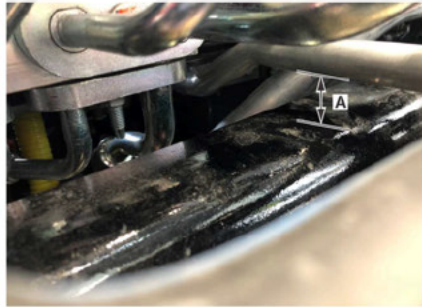
Fig. 5, Verifying the Clearance

A. Clearance measurement should be at least 3/4-inch (19 mm) between the frame rail and coolant pipe.

7. Verify that the clearance to the rail is at least 3/4-inch (19 mm). See Fig. 5.
