# Service Bulletin

Bulletin No.: 21-NA-049

**Subject: Diagnostic Aid – PicoScope Information and Setup for Transmission Related Concerns**

Brand:	Model:	Model Year:		VIN:		Engine:	Transmission :
		from	to	from	to		
Chevrolet	Corvette	2020	2025	—	—	All	All

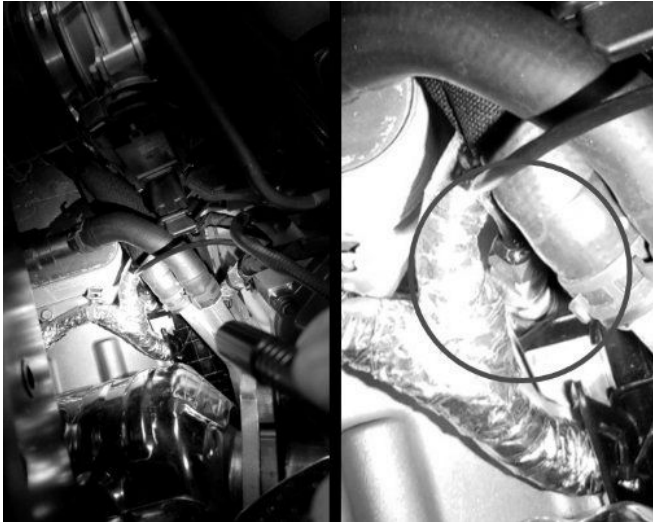
5751814

1. Place the PicoScope sensor on the bolt head shown in the image above. This is located on the right side of the transmission, near the transmission cooler. This bolt is used to secure a bracket for the wire harness. The sensor cable can be run into the passenger compartment with the engine compartment closed.
