Service Bulletin

Bulletin No.: 21-NA-155

Subject: Information on Check Trailer Wiring Message and/or Service Trailer Brake Displayed on Driver Information Center (DIC) - DTC C1114 Set

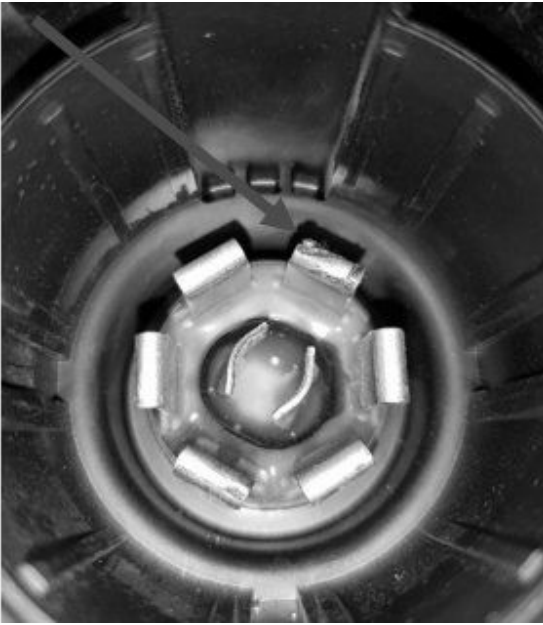
5867917

1. Short on trailer side damaged the terminal – Trailer side connector is loose/worn – **Non-Warranty Issue.**

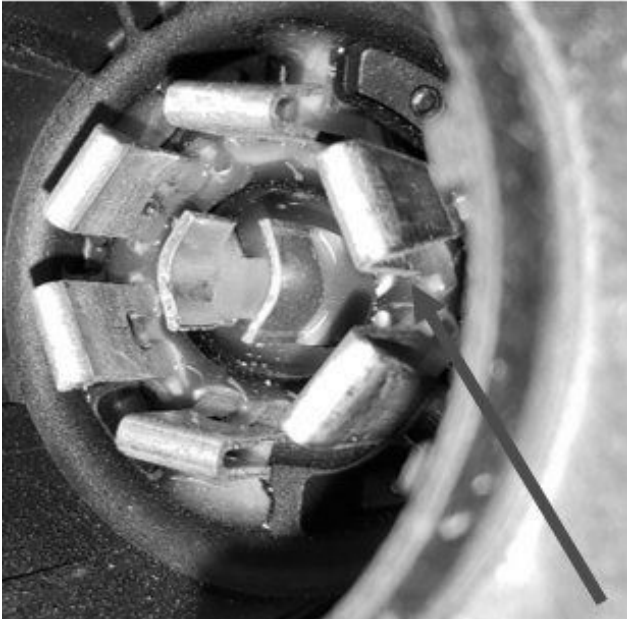
5867994

2. The blue/green is expected, and this small amount of corrosion does not impact function of connector – **Non-Warranty Issue.**

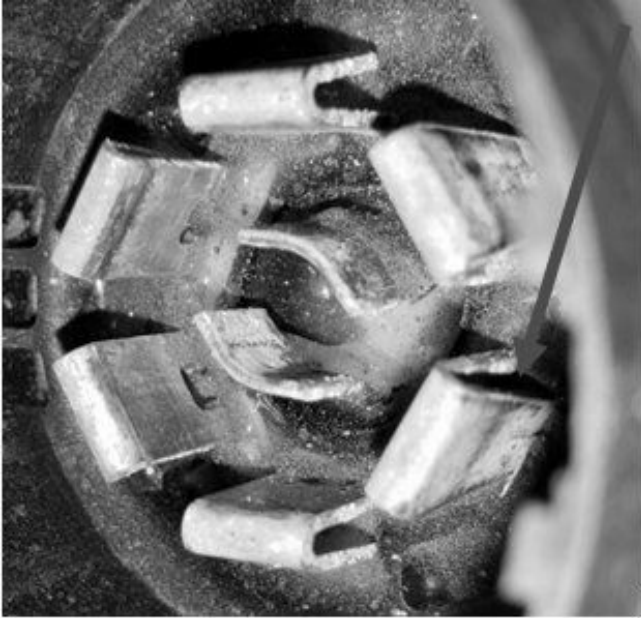
5867995

3. Trailer side connector is damaged/deformed causing removal of protective plating. This is the result of the trailer side connector is moving or bouncing when connected (excessively worn connector) – **Non-Warranty Issue.**

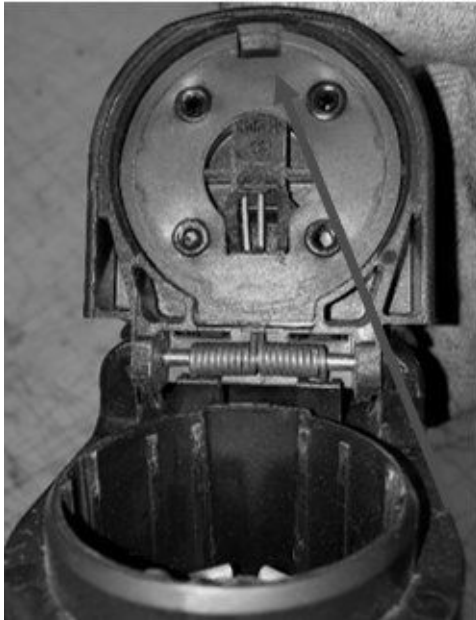
5867997

4. Trailer side harness retention tab has been broken off cover which is the result of customer pulling away from trailer without releasing the trailer harness – **Non-Warranty Issue.**

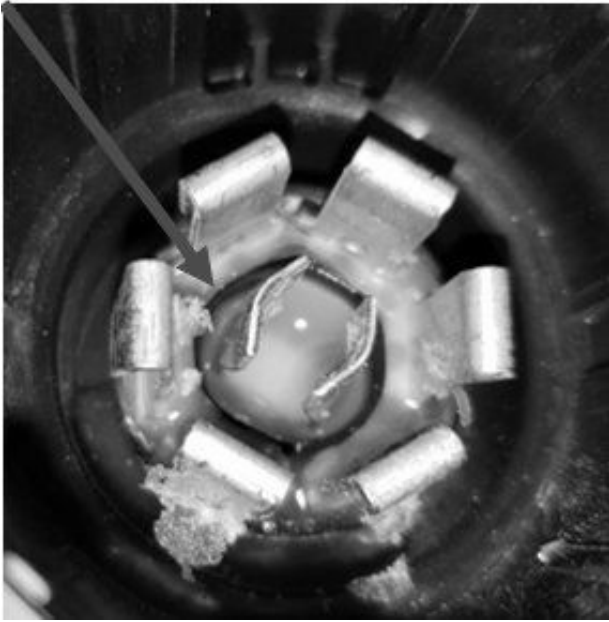
5867998

1. Sealant from part on terminals, would cause intermittent connection issues connecting to trailer – **Subject to terms of warranty.**

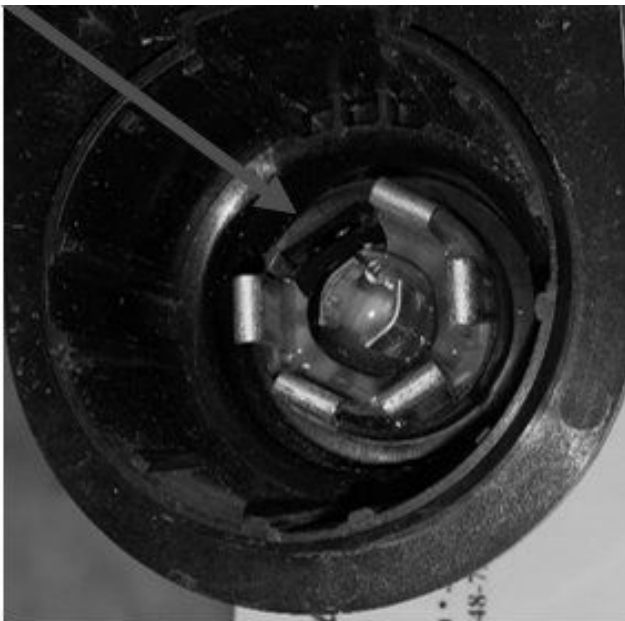
5868000

2. Terminal is pushed out – **Subject to terms of warranty.**
