Service Bulletin

Bulletin No.: 21-NA-240

Subject: Information on LSY Engine Oil Leaks

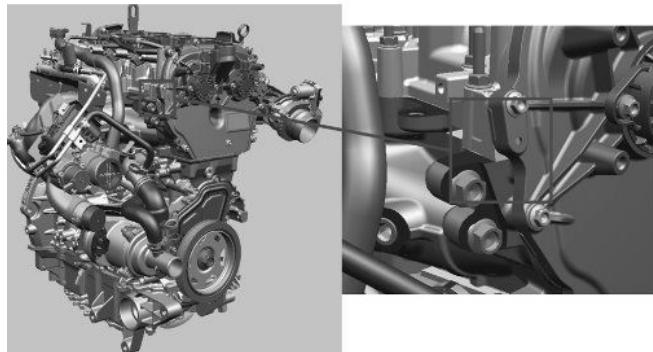
The graphic above shows the cam carrier T-joint location and where the leak may be potentially coming from. 6816616

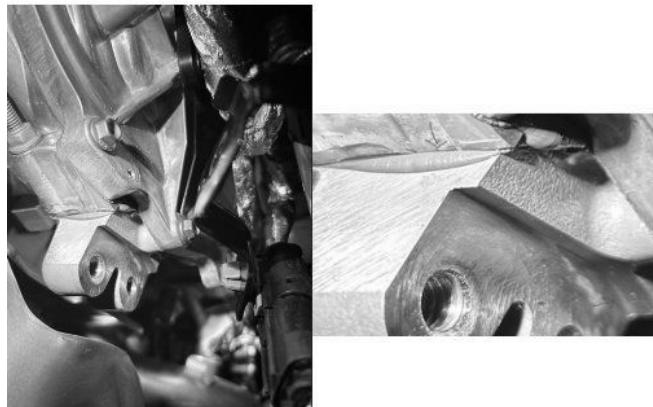
The graphic above shows the cam carrier T-joint slowly leaking from the adhesive joint. 6816617

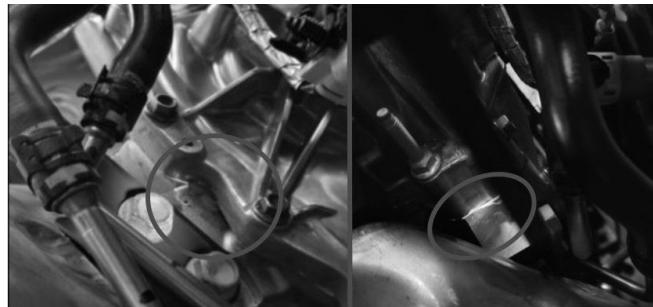
5911107
The graphic above shows the cam carrier T-joint area using a black light to highlight the oil dye.
