Service Bulletin

Bulletin No.: 22-NA-150

Subject: Malfunction Indicator Lamp (MIL) Illuminated, Service Emission System and/or DEF Level Low Message on Driver Information Center (DIC), DEF Level Sensor Reading Incorrectly, DEF Level Sensor Being Erratic, DEF Level Sensor Stuck

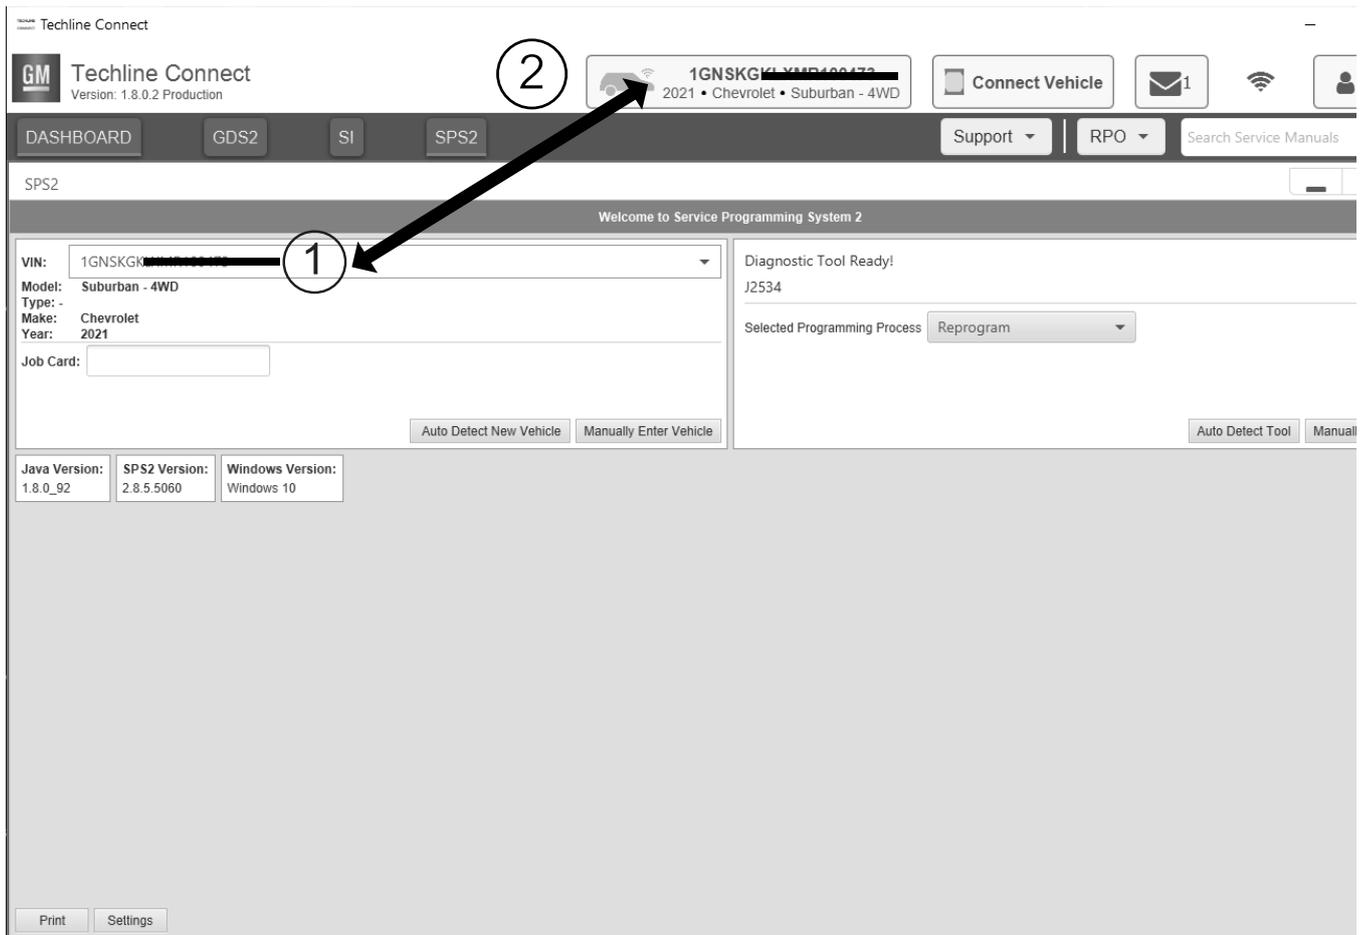
5743643

Caution: Be sure the VIN selected in the drop down menu (1) is the same as the vehicle connected (2) before beginning programming.

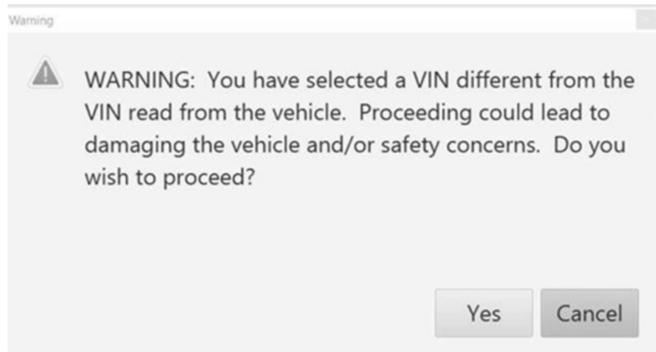
5877000

Important: If the vehicle VIN DOES NOT match, the message below will be shown

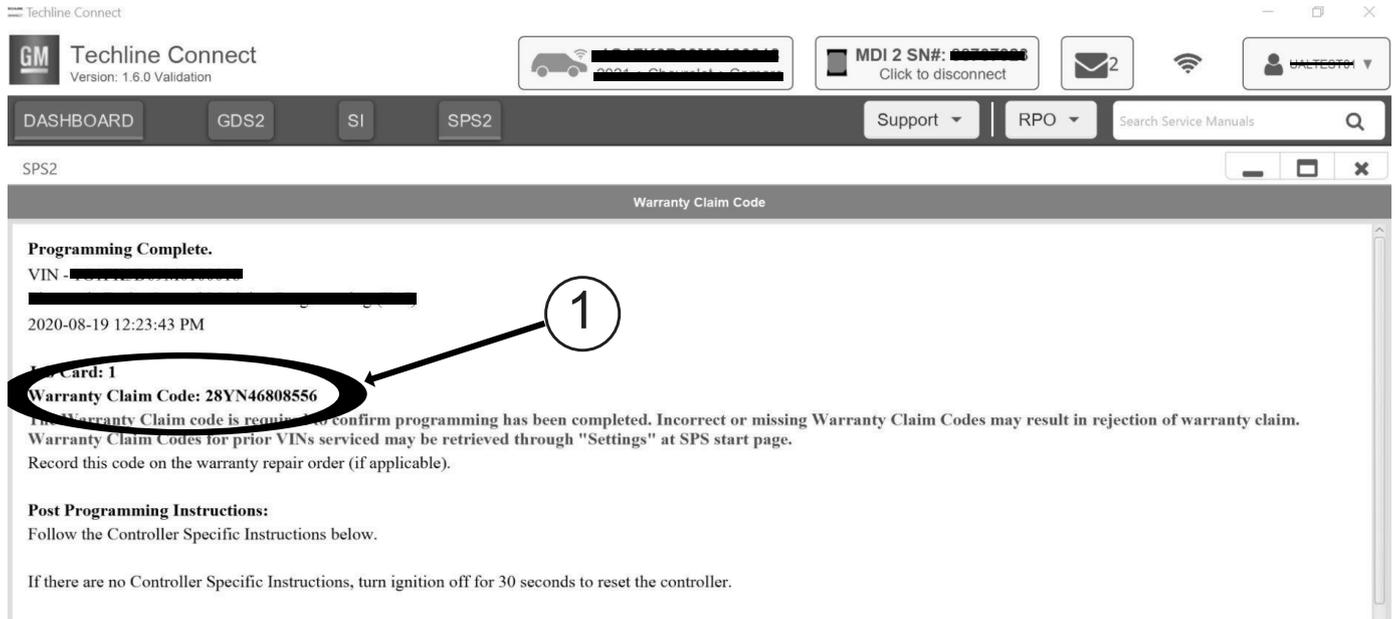
5644478

Note: The screenshot above is an example of module programming and may not be indicative of the specific module that is being programmed. Module selection and VIN information have been blacked out.

Important: To avoid warranty transaction rejections, you MUST record the warranty claim code provided on the Warranty Claim Code (WCC) screen shown above on the job card. Refer to callout 1 above for the location of the WCC on the screen.
