Service Bulletin

Bulletin No.: 24-NA-082

Subject: Clicking Noise at Slow Speeds

Brand:	Model:	Model Year:		VIN:		Engine:	Transmission:
		from	to	from	to		
Cadillac	LYRIQ	2023	2025	-	-	-	-

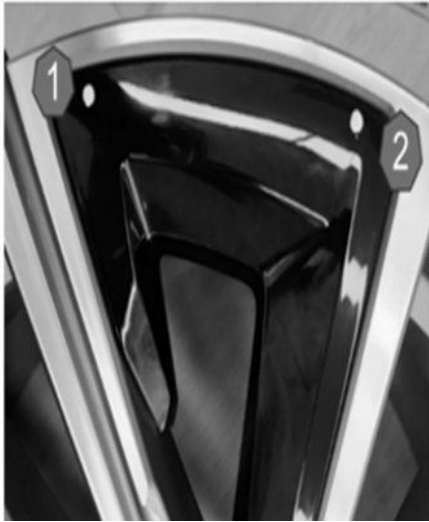
6465406

1. Place the wheel horizontally on work bench. Need to check 2 points (shown with white dots in above illustration) for each of the 6 inserts on the wheels.

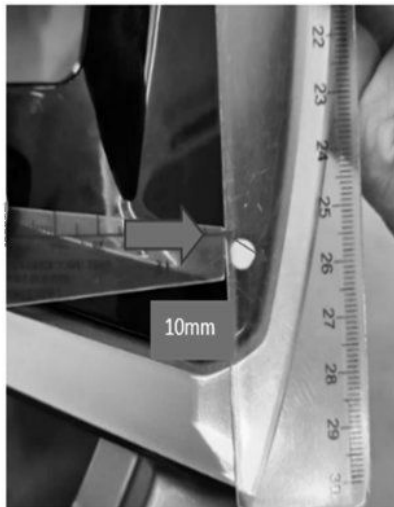
6465407

2. Place the flat bar on the front of the wheel from point 1, covering 10mm of the insert in the width.
3. Insert the 1.7mm feeler gauge between the flat bar and the insert.

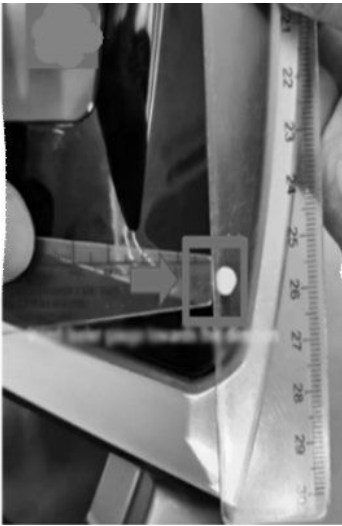
6465411

4. If the feeler gauge cannot go through the gap between the ruler and the gauge, the part is OK as shown above.

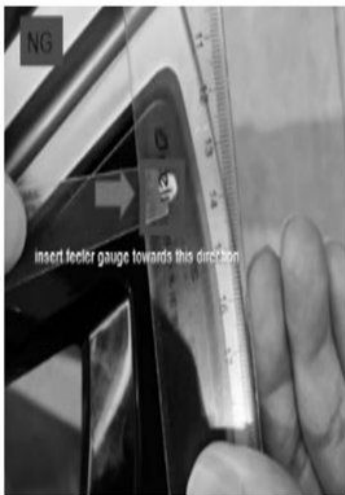
6465412

5. If the feeler gauge can go through the gap between the ruler and the gauge, it means the insert is sitting too deep.
6. Measure the two points (Point 1 and Point 2 as shown in Step 1).
7. Inspect the remaining five inserts following the same method.

For NOK wheels with Inserts sitting too deep, use below steps to rework the wheels:
