Service Bulletin

Bulletin No.: 24-NA-166

Subject: DTC C1171 C1172 C1173 C1174 Tire Pressure Monitor Sensor Unable to Relearn Ethernet Cable Overlay for TCP OnStar Module

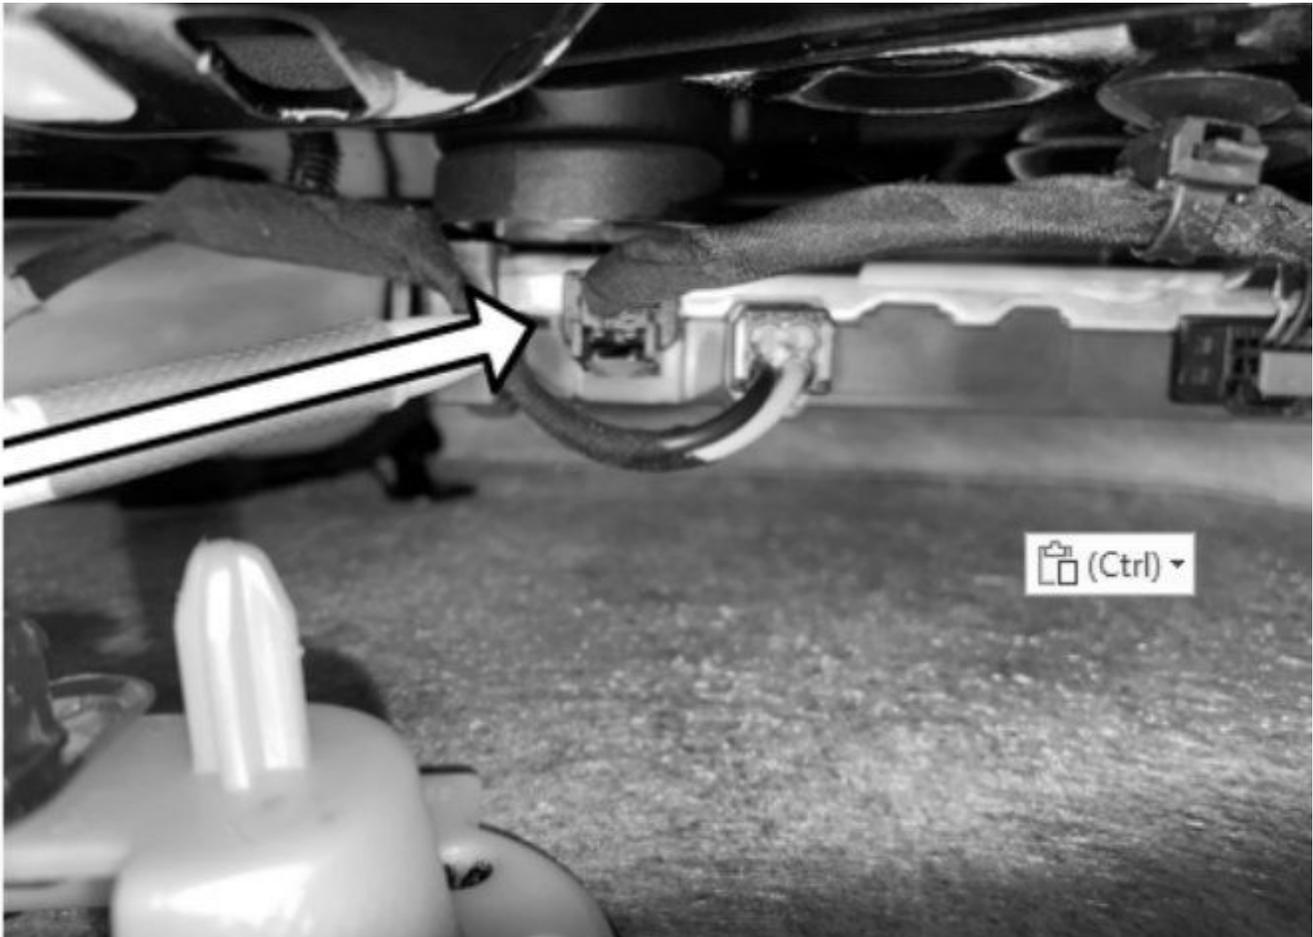
6720400

- Once confirmed the TPM sensors cannot be learned, gain access to the rear headlining trim panel. DO NOT remove the headlining trim panel, only lower it to gain access Refer to Headlining Trim Panel Replacement in SI. Disconnect the X7 connector and attempt to learn the TPM sensors.

If the TPM sensors are able to learn, continue with Ethernet Cable replacement. Otherwise follow SI.

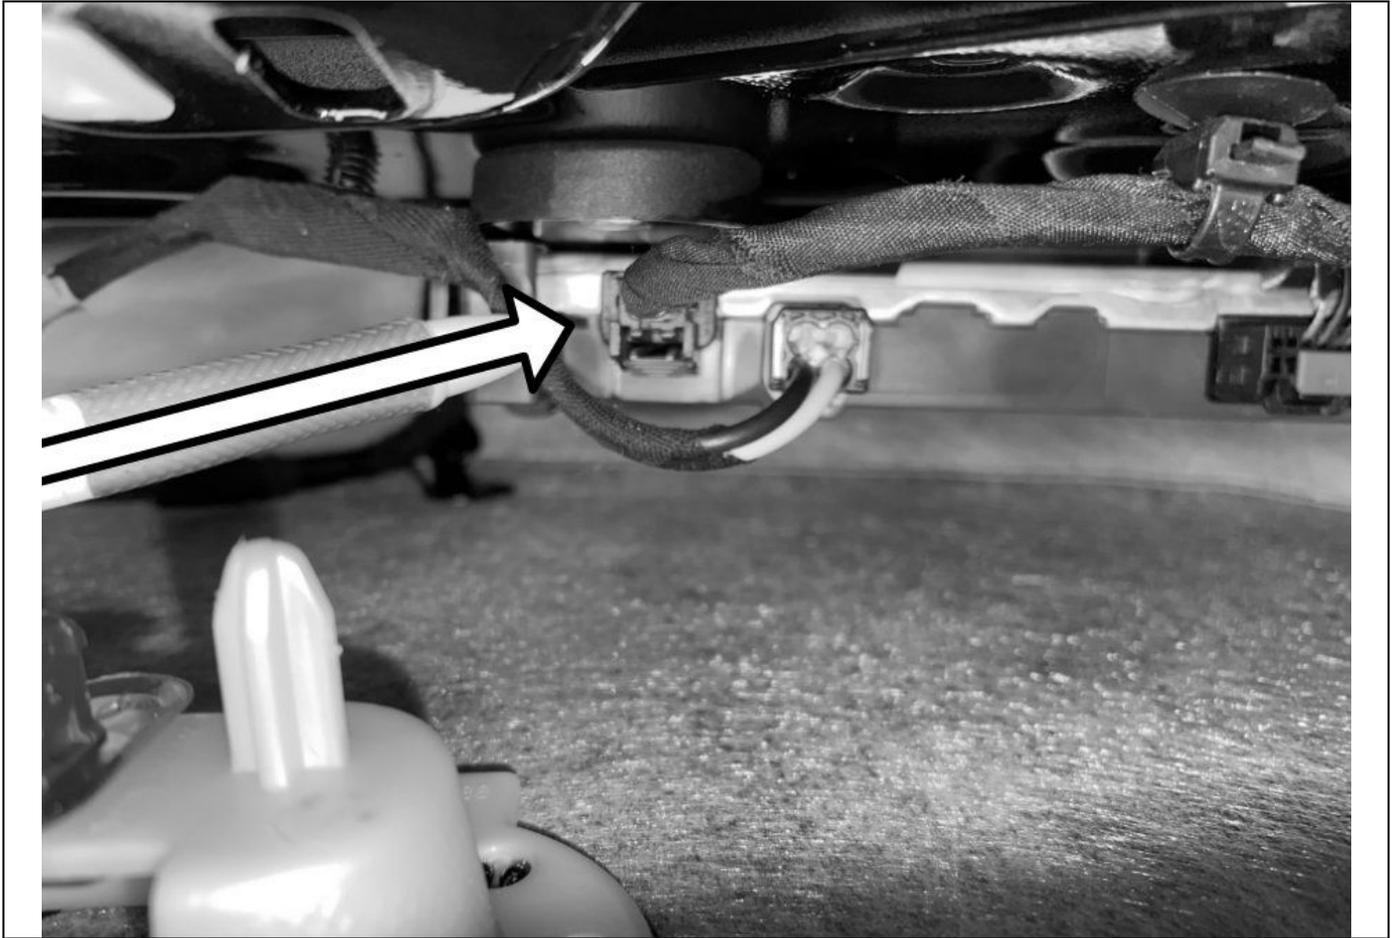
6699010

11. Locate the X205 Ethernet Cable in the Right-Hand Front Passenger Compartment and disconnect.

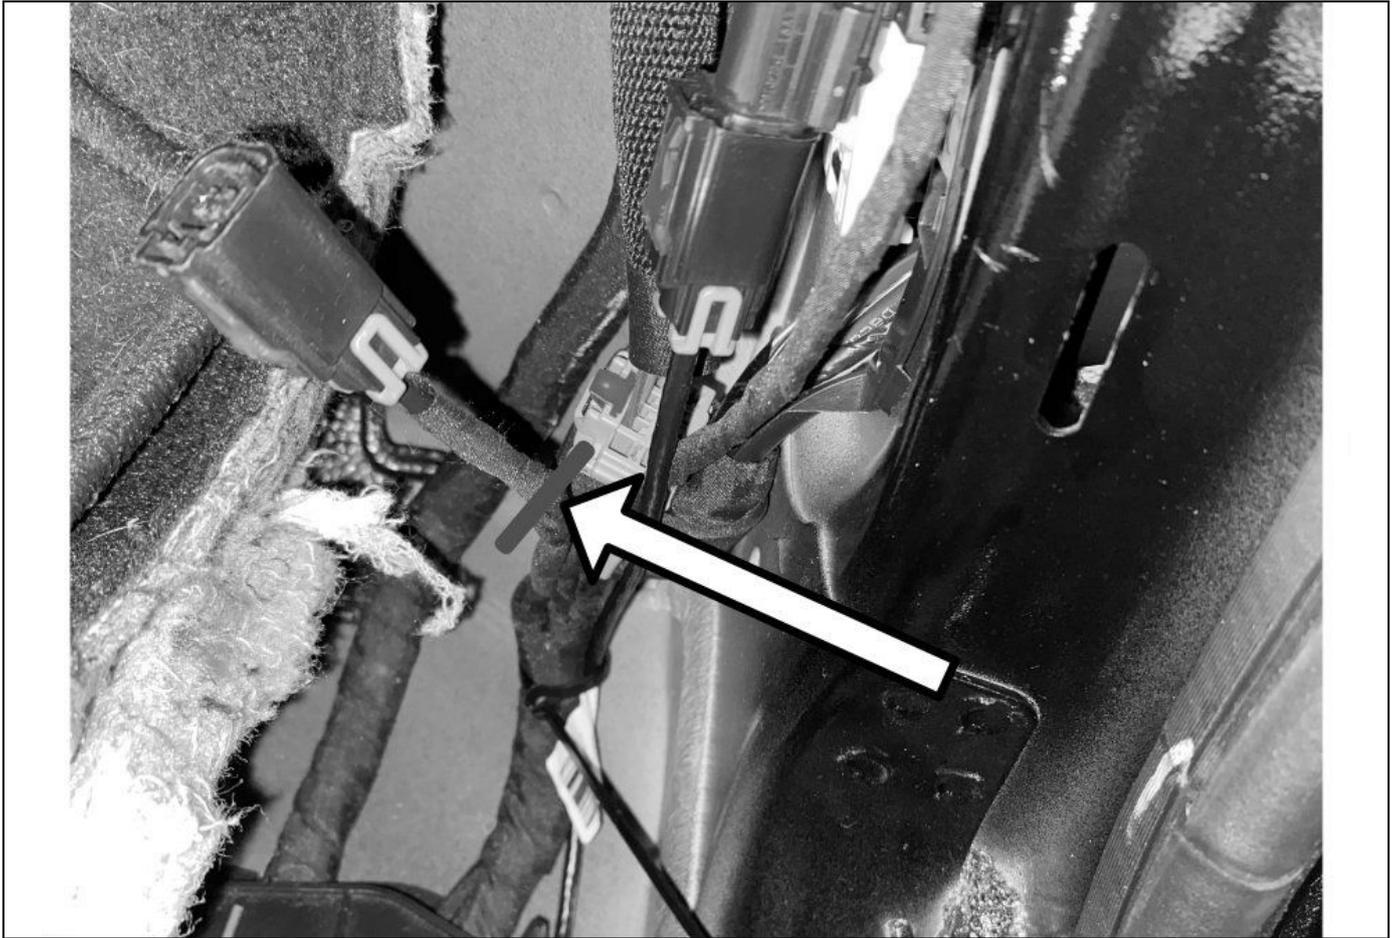
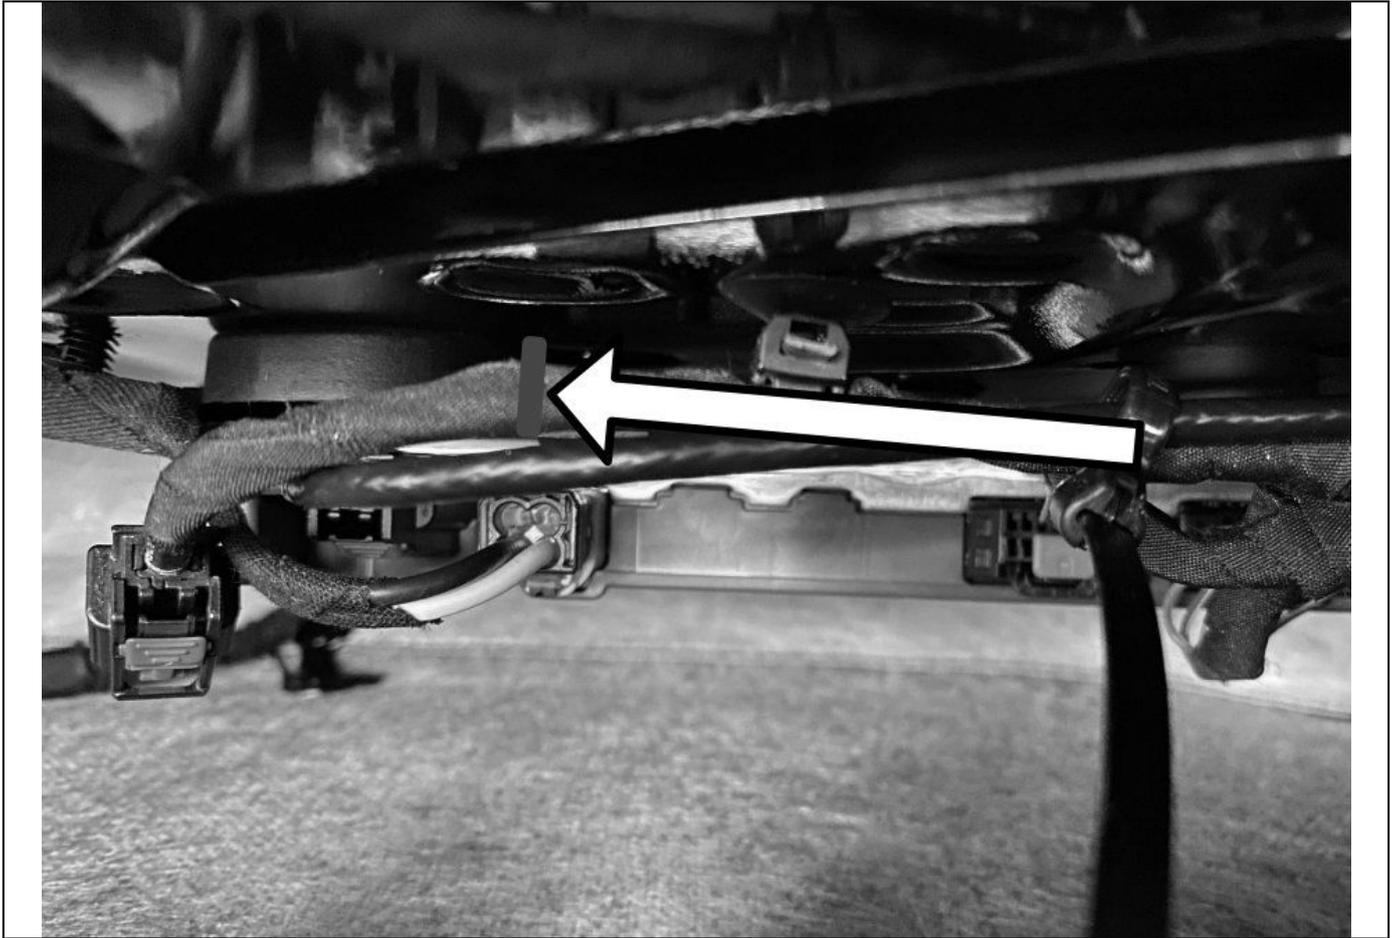
6699015

12. Locate the X7 Ethernet Cable at the Telematic Control Module and disconnect.

13. Cut BOTH ends off the existing Ethernet Cable at X205 and X7 of the Telematic Control Module and wrap PVC Electrical tape around both ends of the cable to prevent future use. The unused cable can remain bundled with the body harness.

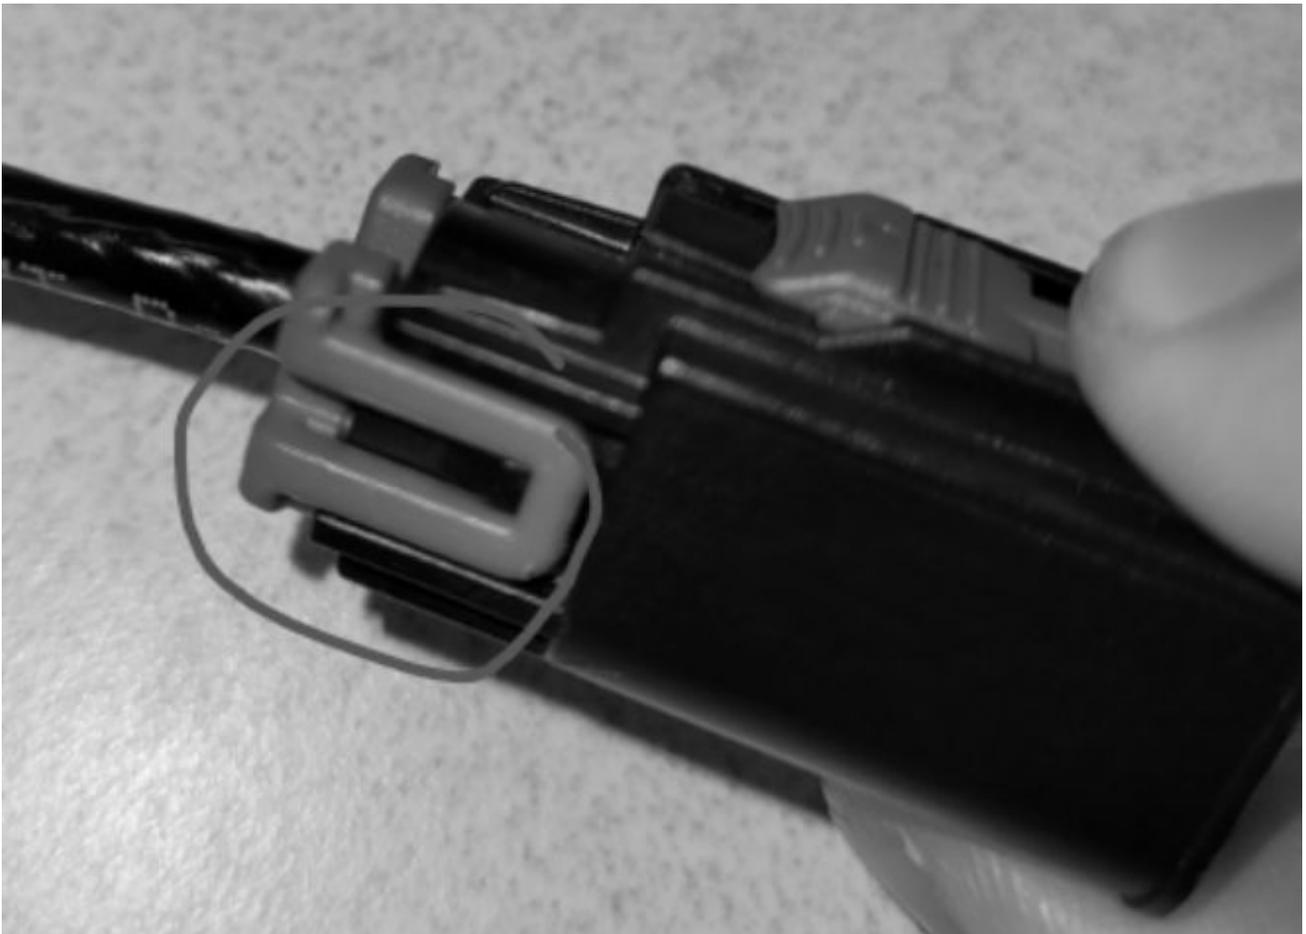
6720403

Empty housing shell. Circle in red is the 1 release tab. Arrow is showing the direction the tab needs to be pressed to release the cable, moving it away from the middle.

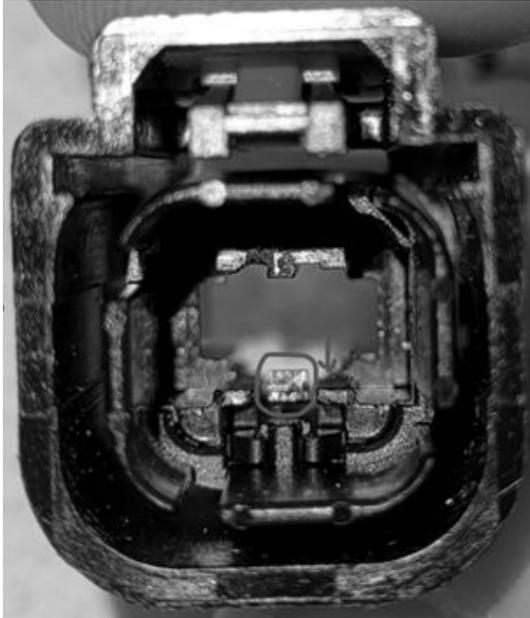
6720429

The X205 housing tab is very difficult to see with the cable installed.

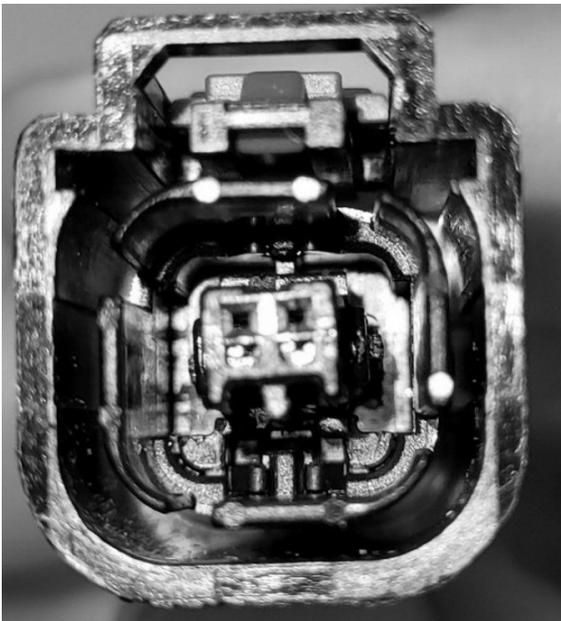
6720432

Following the middle ridge to the back, this is where the housing locks onto the cable.

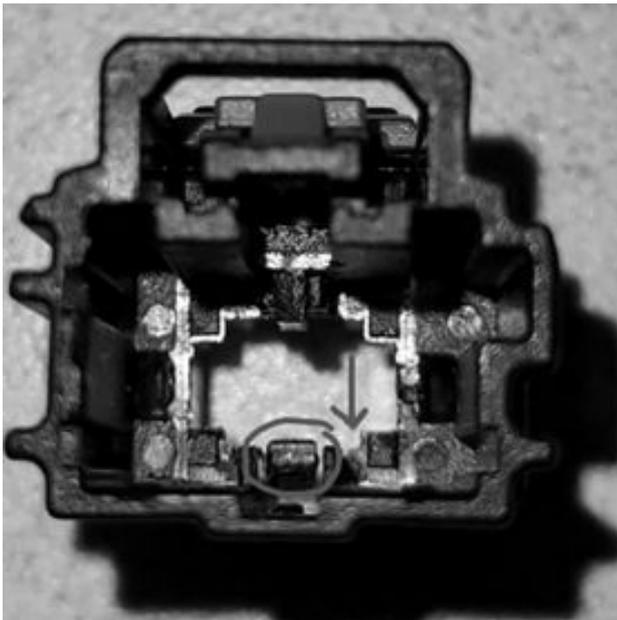
6720422

The X7 housing tab is very difficult to see with the cable installed.

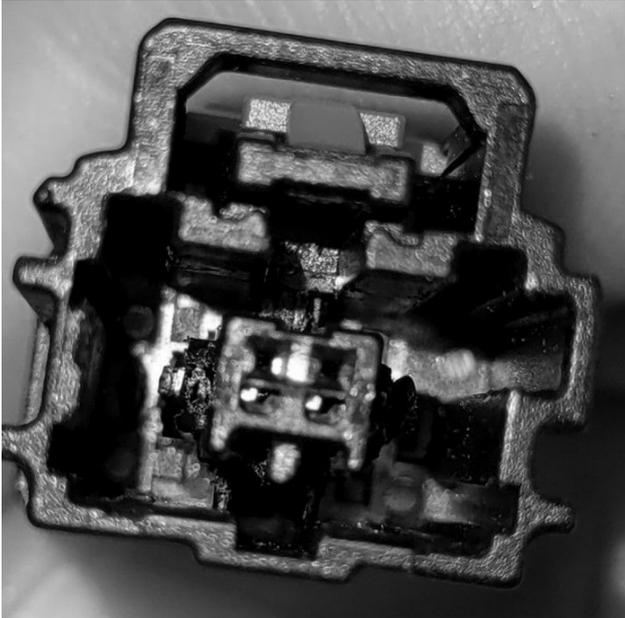
6720426

Following the middle ridge to the back, this is where the housing locks onto the cable.

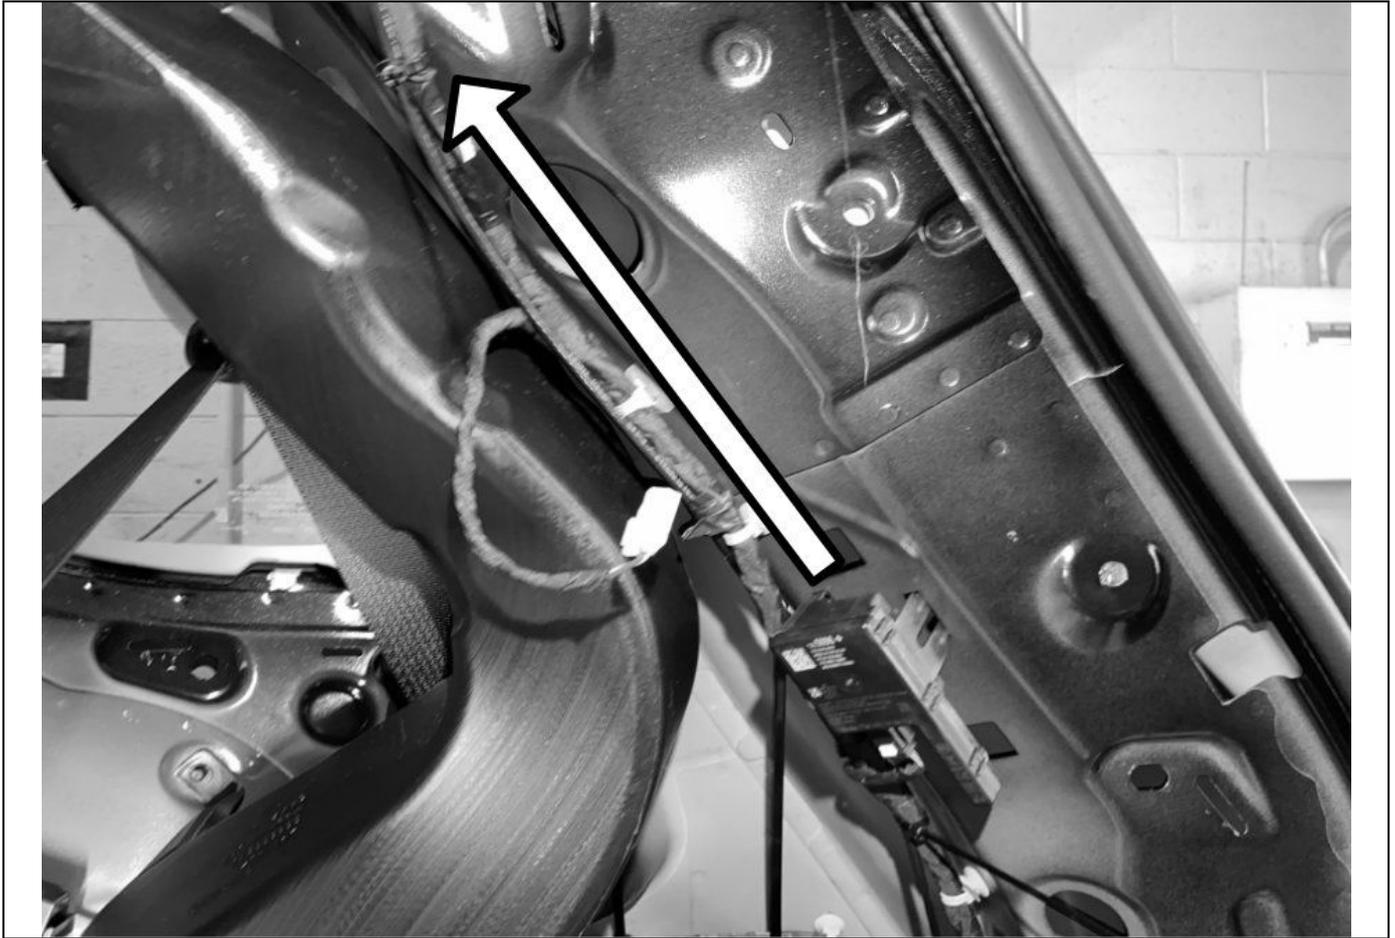
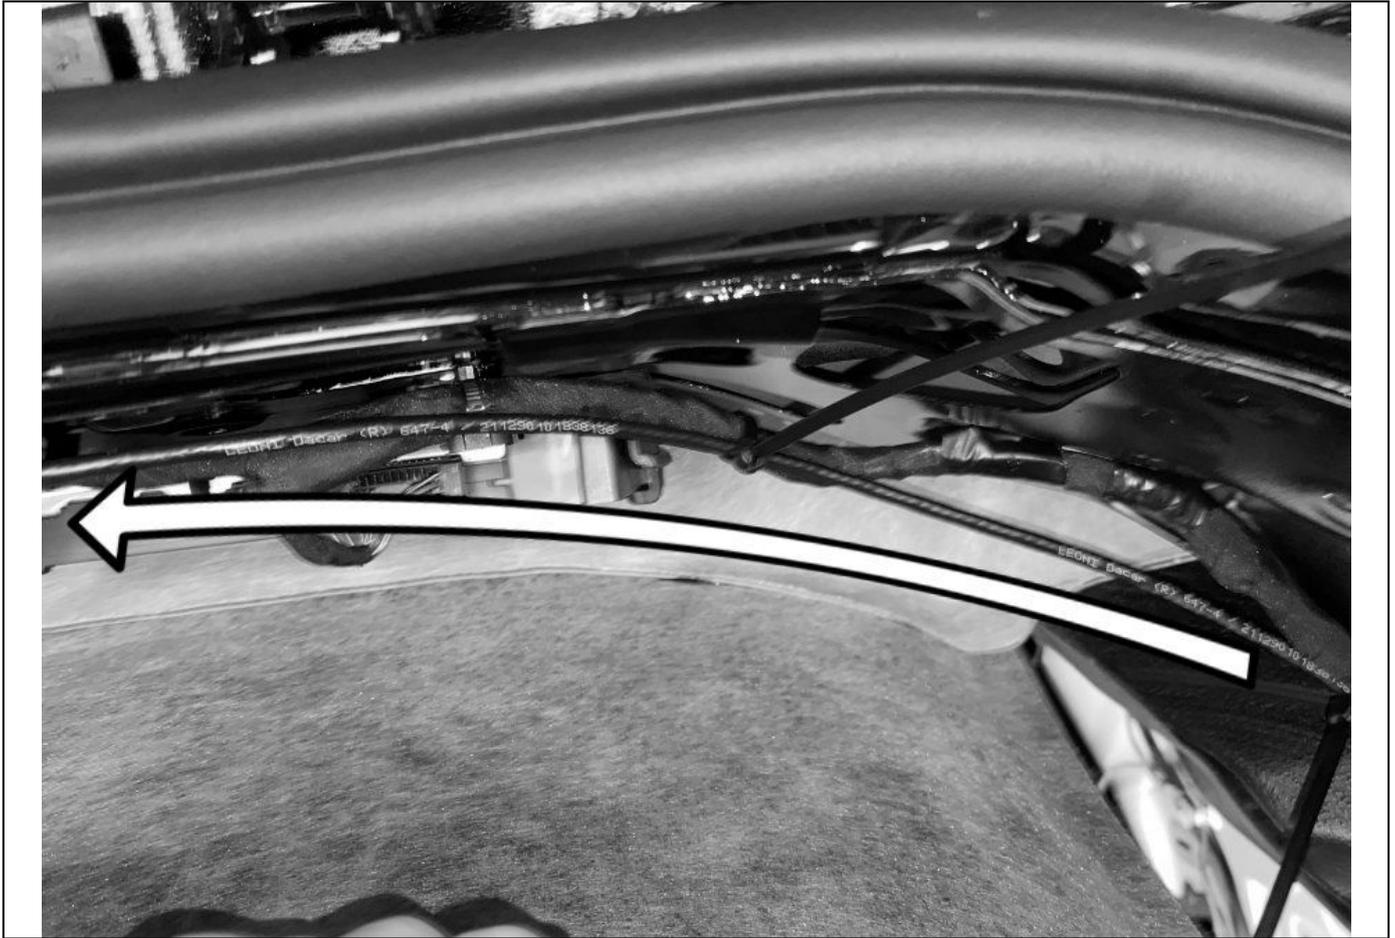
6706155

Important: Ensure the replacement Ethernet Cable will have enough slack so that it is not pulling on the connector at X7 of the Telematic Control Module. Failure to do so could damage the connector at the module.

22. Make a small loop to remove some of the excess cable and secure with a wire tie. Ensure to leave plenty of slack so that the cable will not pull on the connector at X7 of the Telematic Control Module.

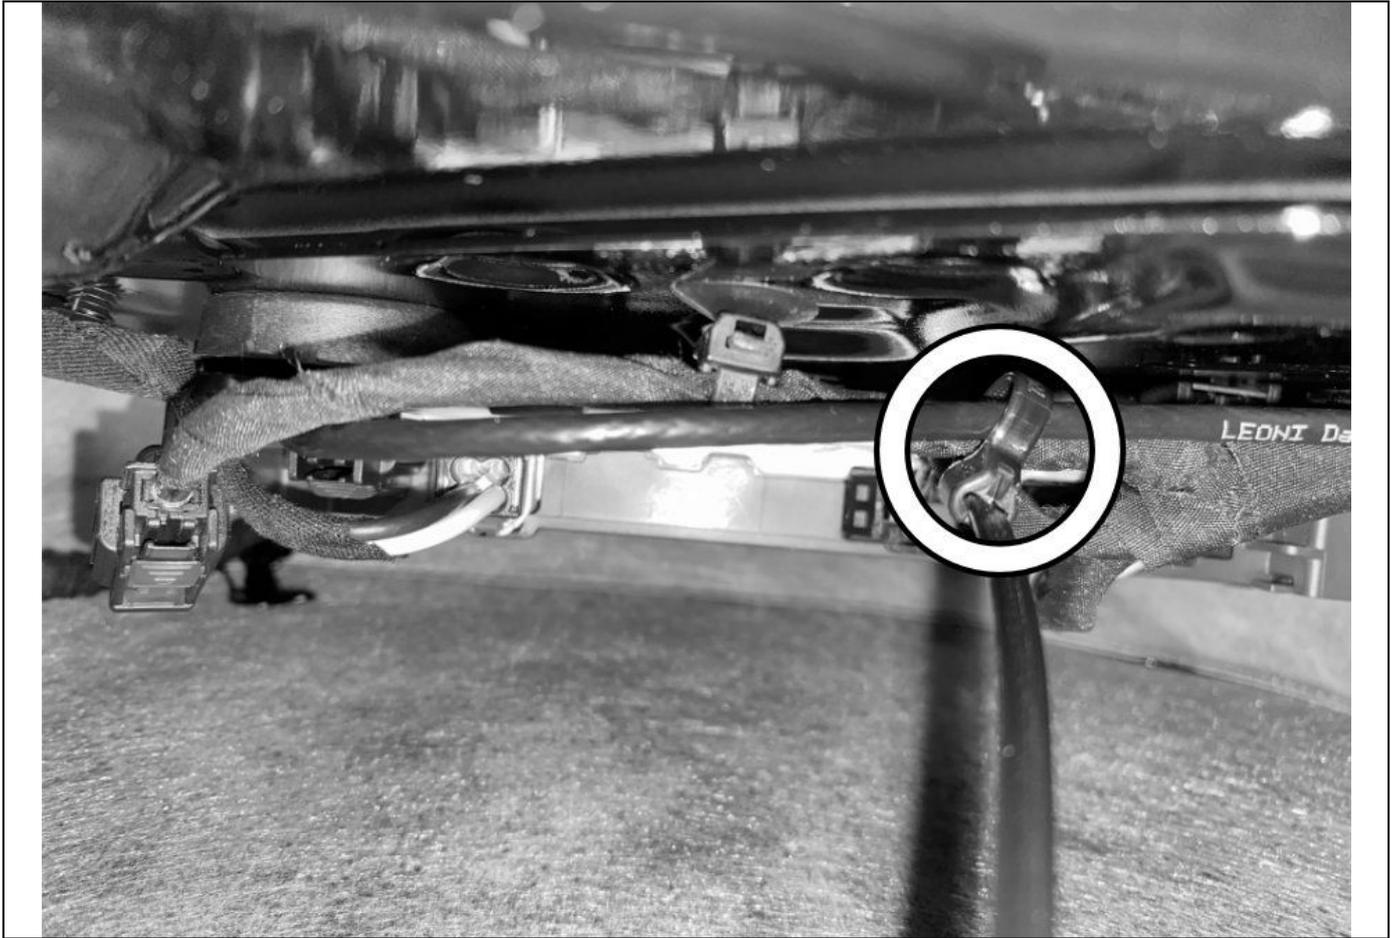
6706169

Important: Ensure the replacement cable has plenty of slack and is not pulling on the cable connector plug. Failure to do so could damage the connector at the module.

24. Connect the replacement cable into X7 of the Telematic Control Module. Ensure that the cable has enough slack left to not pull on the X7 connector.
