Service Bulletin

Bulletin No.: 24-NA-227

Subject: Vibration Rattle or Boom at 1800 to 2000 RPM

Brand:	Model:	Model Year:		VIN:		Engine:	Transmission:
		from	to	from	to		
Chevrolet	Equinox	2025	2025

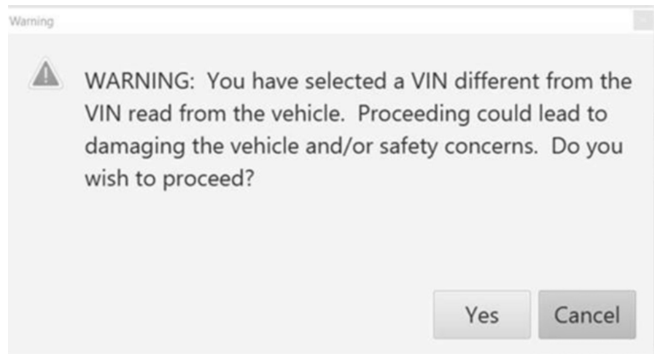
5877000

Important: If the vehicle VIN DOES NOT match, the message below will be shown
