TECHNICAL SERVICE BULLETIN

Classification: EC24-012A	Reference: ITB24-017A	Date: January 14, 2025
------------------------------	--------------------------	---------------------------

ENGINE ROOM SUB-HARNESS

APPLIED VEHICLES: 2016-2018 Q50 (V37)
2017-2018 Q60 (CV37)
APPLIED ENGINES: 2.0L Turbo Gasoline Engine

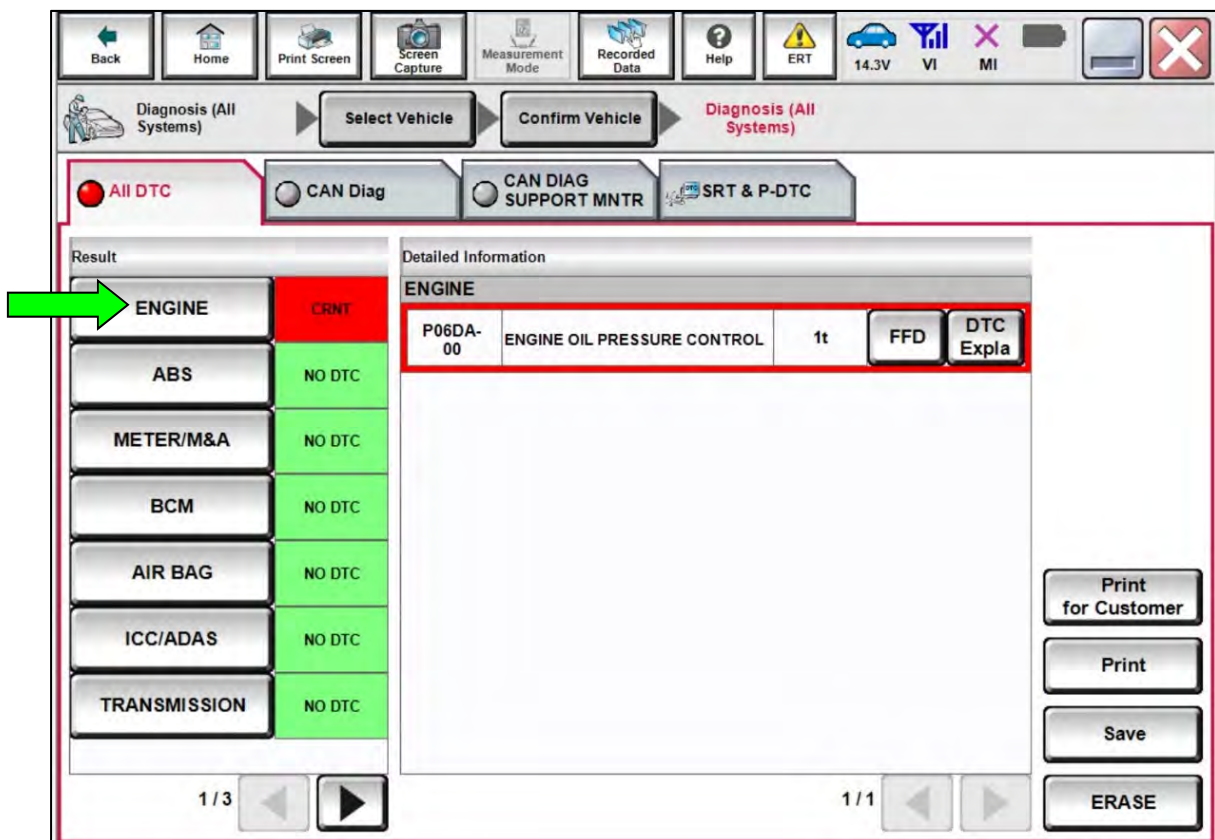
Figure 7

15. Check to see if DTC P06DA-00 for “ENGINE-OIL PRESSURE CONTROL” is “CRNT” in **ENGINE**.
 - If DTC P06DA-00 is current in the ENGINE:
 - a. Print the DTC and description and attach it to the repair order.
 - b. Replace the engine room sub-harness located in the engine oil pan.
 - On 2WD models, continue to step 16 on page 7.
 - On AWD models, skip to step 25 on page 10.
 - If DTC P06DA-00 is NOT current in the ENGINE, this bulletin does not apply. Refer to the ESM for further diagnostic information.
 - If additional DTCs, other than P06DA-00, are present in the ENGINE, refer to the ESM for further diagnostic information and repair first, then return to step 15.

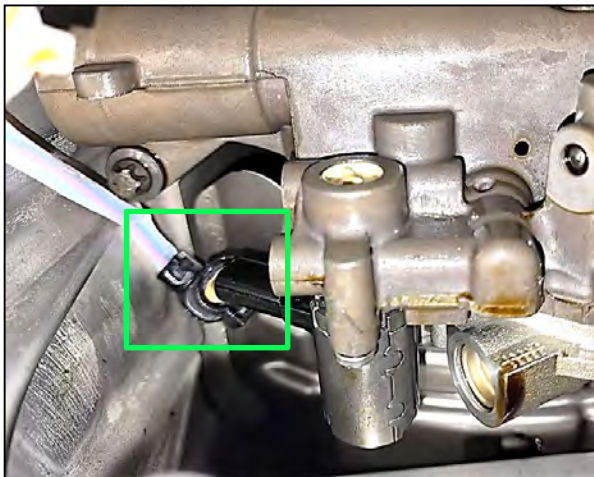
Figure 22

To avoid damage to the oil pump solenoid valve, closely follow step 31 to prevent the oil pump valve wiring harness connector from contacting the oil pan.

- a. Position the oil pump valve wiring harness connector of the NEW engine room sub-harness connector at an angle as shown in Figure 22.
- b. Connect and lock the wiring harness connector.
