# Service Bulletin

Bulletin No.: 24-NA-248

**Subject: Blank or Black Screen, Update A22 Radio Control**

Brand:	Model:	Model Year:		VIN:		Engine:	Transmission:
		from	to	from	to		
Chevrolet	Corvette	2021	2024	—	—	—	—

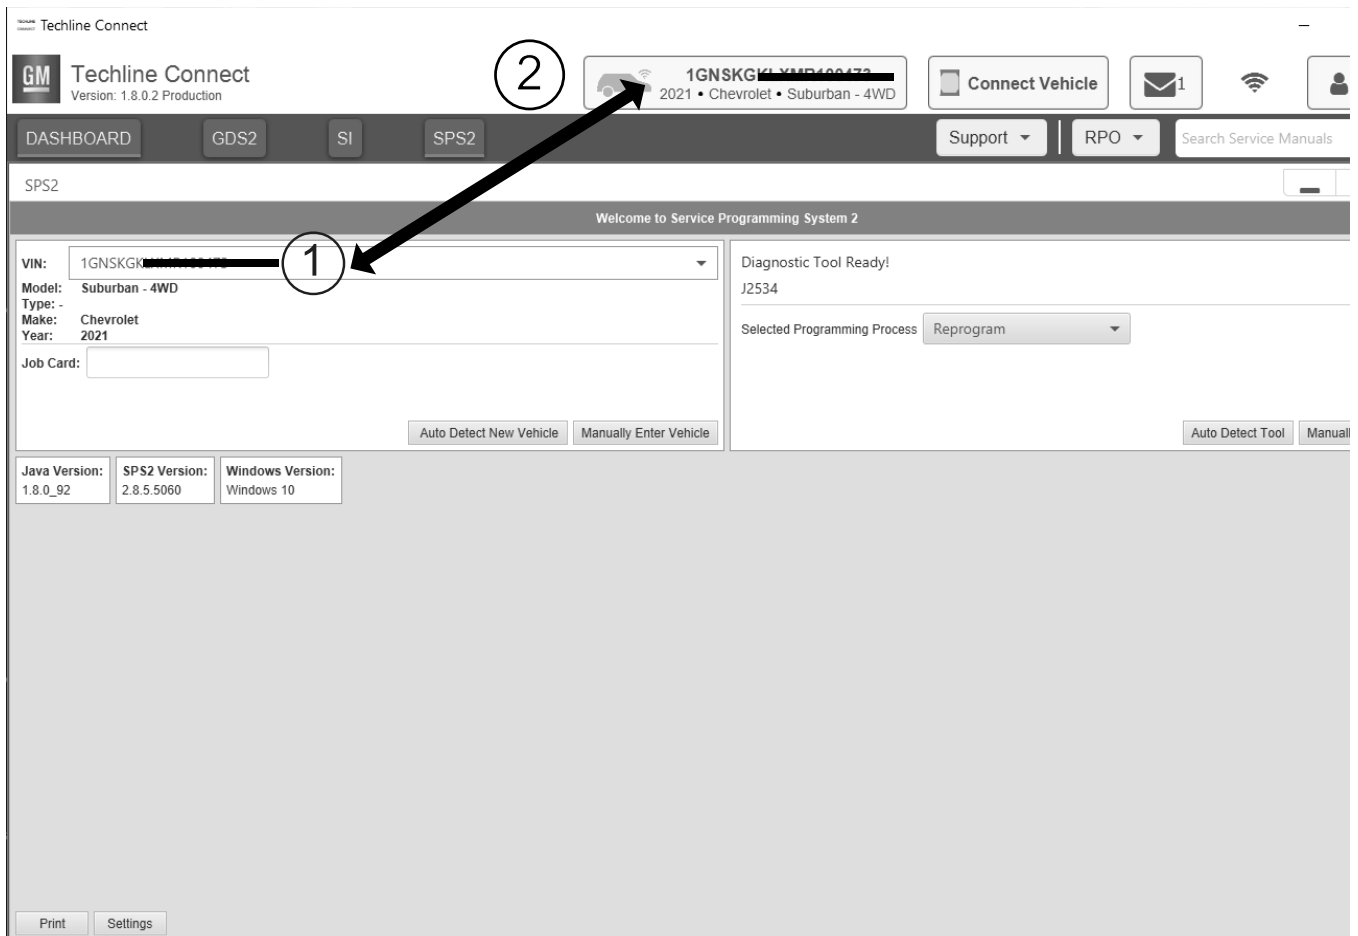
5743643

**Caution:** Be sure the VIN selected in the drop down menu (1) is the same as the vehicle connected (2) before beginning programming.
