# TECHNICAL SERVICE BULLETIN

BR24-002A

NTB24-050A

## FALSE ACTIVATION OF AEB OR FCW

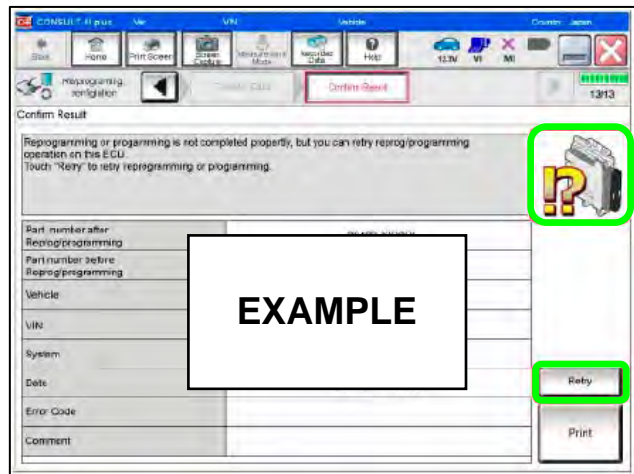
Figure 14

If reprogramming does not complete and the “!?” icon displays, as shown in Figure 14:

- Check battery voltage (12.0 - 13.5 V).
- Ignition is ON, engine OFF.
- External Bluetooth® devices are OFF.
- **All** electrical loads are OFF.
- Select **Retry** and follow the on screen instructions.
- Retry may not go through on first attempt and can be selected more than once.

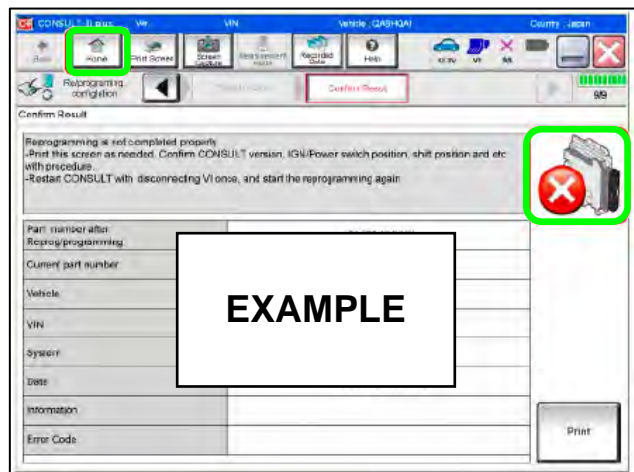
Figure 15

If reprogramming does not complete and the “X” icon displays, as shown in Figure 15:

- Check battery voltage (12.0 - 13.5 V).
- CONSULT A/C adapter is plugged in.
- Ignition is ON, engine OFF.
- Transmission is in Park.
- All CONSULT VI cables are securely connected.
- All C-III plus updates are installed.
- Select **Home**, and restart the reprogram procedure from the beginning.
