TECHNICAL SERVICE BULLETIN

Classification: DA24-009	Reference: NTB25-001	Date: January 7, 2025
-----------------------------	-------------------------	--------------------------

CRUISE CONTROL/PROPILOT STOPS WORKING

APPLIED VEHICLES: 2024-2025 Rogue (T33)

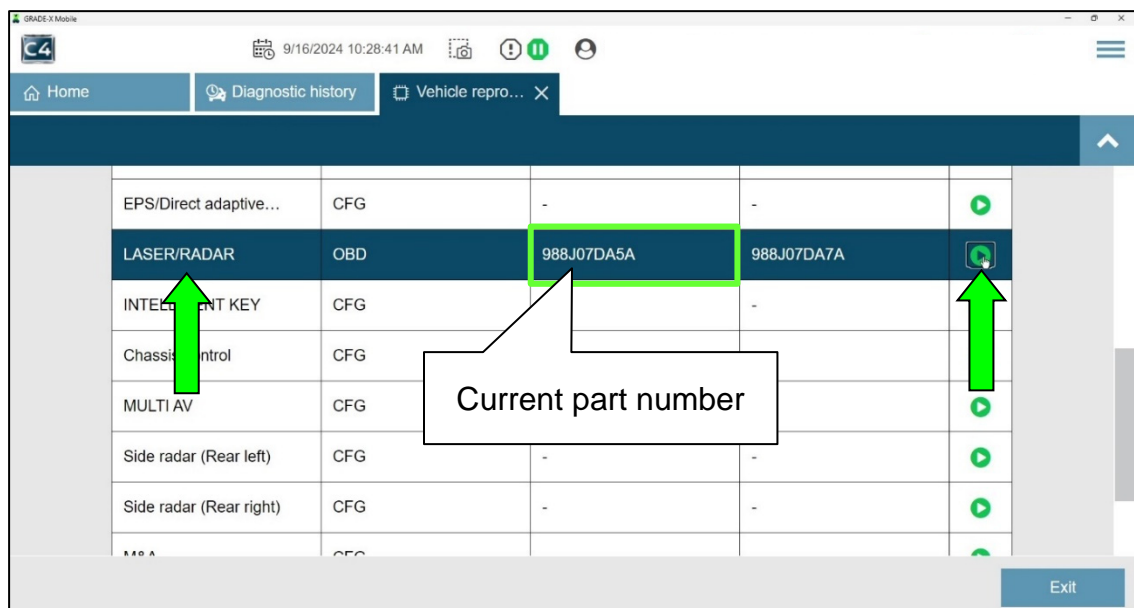
Figure 7

20. Select **LASER/RADAR** (Figure 7).

- Compare the **Current part number** to the numbers in the **CURRENT LASER/RADAR PART NUMBER** column in **Table A**.
 - If there is a match in **Table A**, select the “play” icon to continue with the reprogramming procedure.
 - If there is not a match in **Table A**, this bulletin does not apply. See the ESM (Electronic Service Manual) for further diagnostic information.

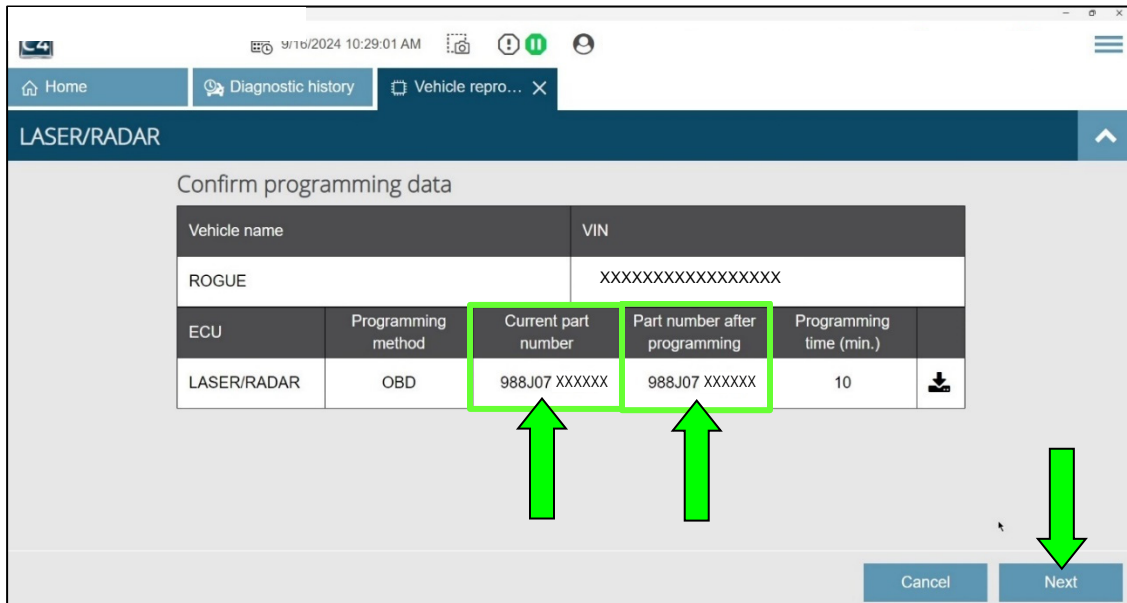
22. Confirm programming data in Figure 9 as follows:

- Find the **LASER/RADAR Current part number** and **Part number after programming** and write it on the repair order.

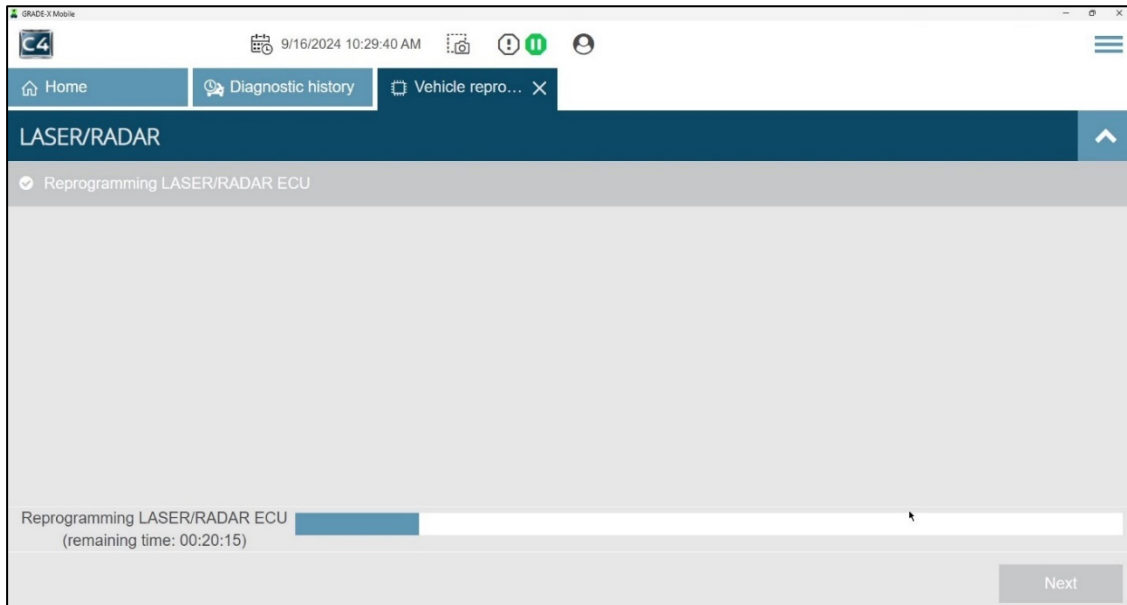
Figure 12

- Reprogramming **LASER/RADAR** ECU progress shown in Figure 12.

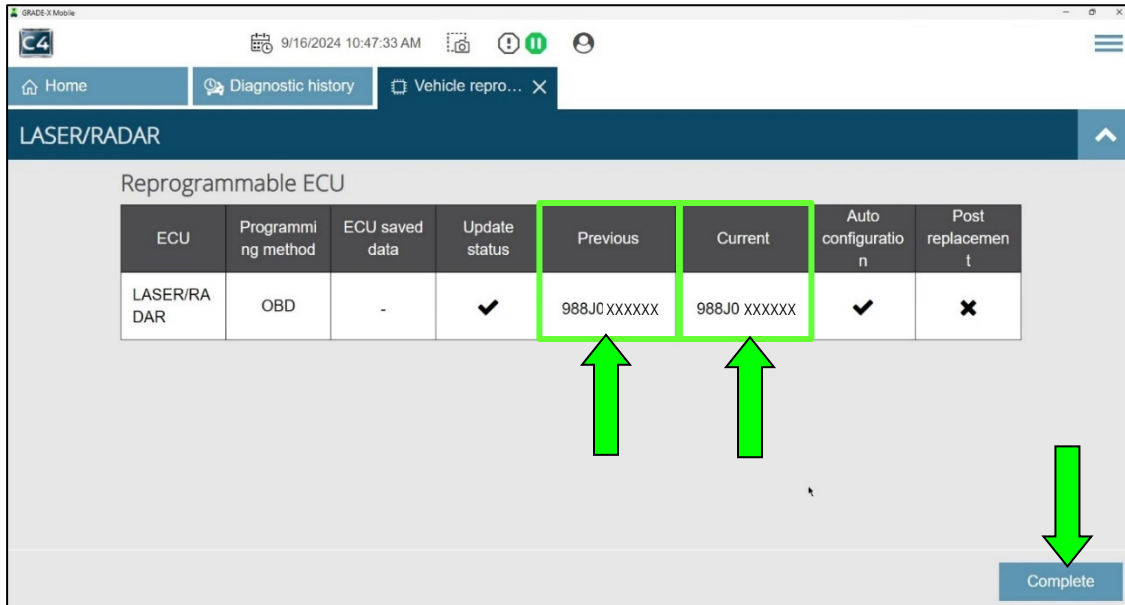
26. When programming finishes, confirm data in Figure 14 is updated.
- a. Compare LASER/RADAR “Previous” and “Current” entries match the entries from Step 22 on page 7.
 - b. Select **Next**, and then select **Complete**.
