Service Bulletin

Bulletin No.: 25-NA-007

Subject: Lower Closeout Panel Not Sitting Flush

Brand:	Model:	Model Year:		VIN:		Engine:	Transmission:
		from	to	from	to		
Cadillac	LYRIQ	2023	2024	-	-	All	All

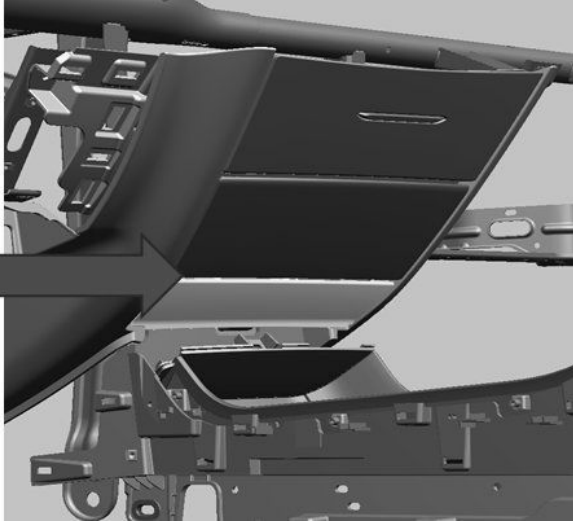
Involved Region or Country	North America, S. Korea, Europe
Condition	  <p>Some customers may comment that one side of the lower close-out panel is not sitting flush. 6814383</p>

<p style="text-align: right;">6814384</p> <p>This may be the result of the floor console alignment contacting the floor console carrier.</p>
Correction	Refer to the procedure below to correct this condition.
