## TECHNICAL SERVICE BULLETIN

<b>Subject</b>	ZX5.A01 BuSCoM 2.0 Software Release
<b>Issue Date</b>	5/8/2024
<b>Service Bulletin Number</b>	SC-24-013
<b>Models Affected</b>	Service Specified Vehicles
<b>Complete By</b>	Next Service Opportunity
<b>Labor Operation Code</b>	PP69Z
<b>Description</b>	Release to support bugs and enhancements for the ZX5.A01 fleet. The following ECUs will be updated throughout the procedure Dash (v5.3.0), Vehicle Controller (v3.13.08), Body Controller (v2.2.2), and Duo Power-

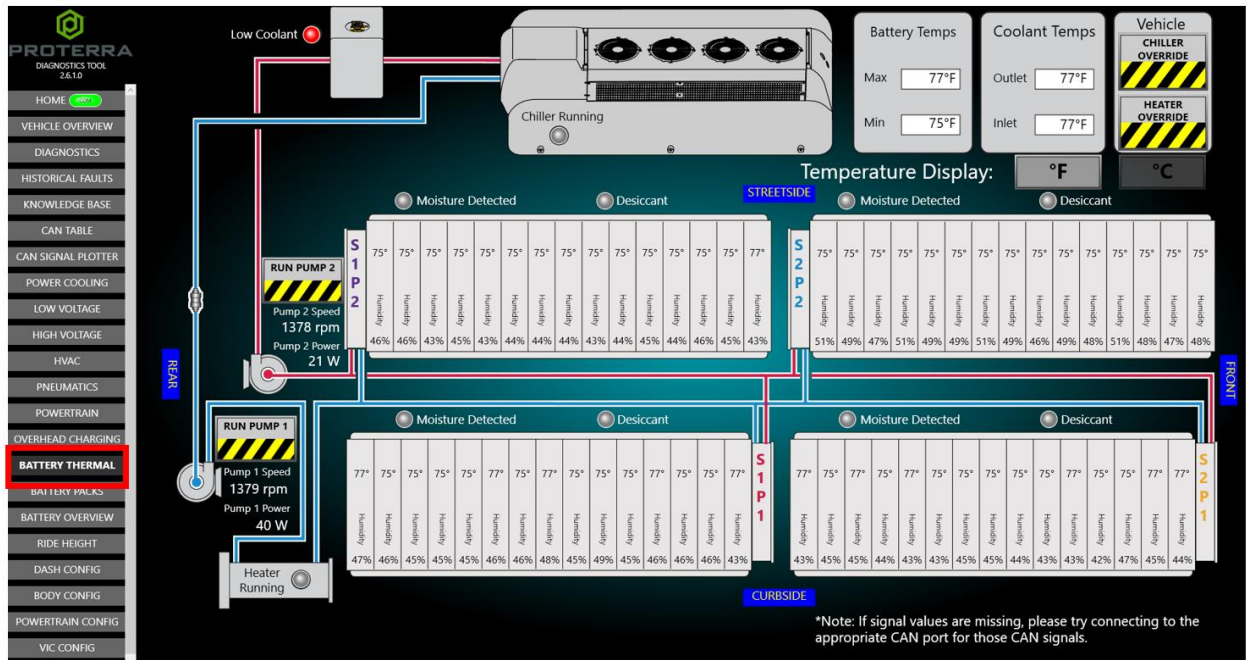
**Step 2:** View the “Battery Thermal” screen on the left-hand side. Example:

- a. Condition 1:
  - Humidity greater than 90%
- b. Condition 2:
  - Humidity greater than 70% AND
  - Internal Isolation less than 20,000 Kohms
