01/30/2025
CAL FTL 54-036

Subject: New Cascadia BCA Electrical Connection Inspection

Model: New Cascadia

Electrical Connection Inspection – Freightliner Cascadia

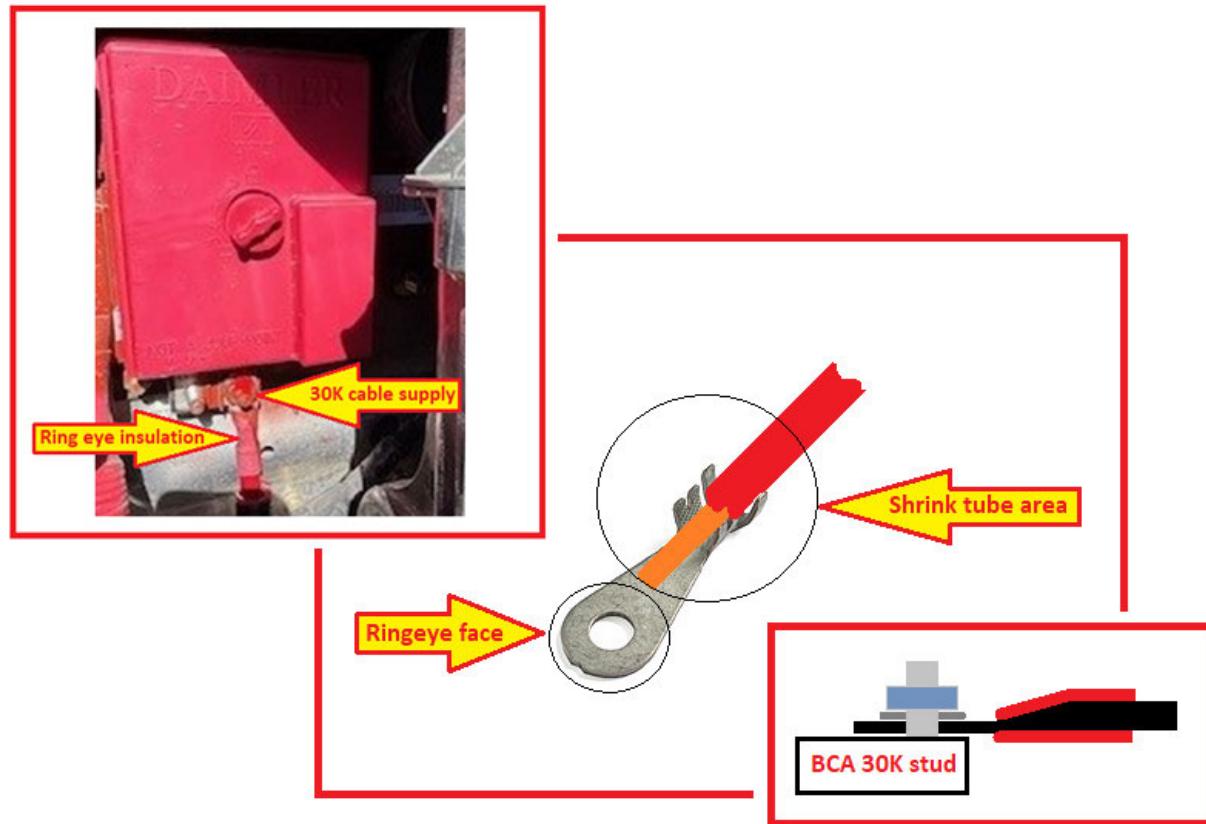
Battery Cable Access (BCA) Inspection	Comments
Identify and note in comments which stud the BCA 30K supply cable is attached to. Remove BCA 30K supply cable and inspect. Neither the heat shrink nor the sealant shall encroach upon the working surface of the terminal. Terminal Insulation spec 4.2.6.4. Trim ring eye heat shrink if interference exists between ring eye and mounting washer or bus bar. See Fig.1	
Inspect the bus bar for damage. See Fig. 2 .

Fig. 1, BCA 30K Cable Location. No Shrink Tube Between Ring Eye and Mounting Washer and Terminal Insulation (heat shrink) spec.

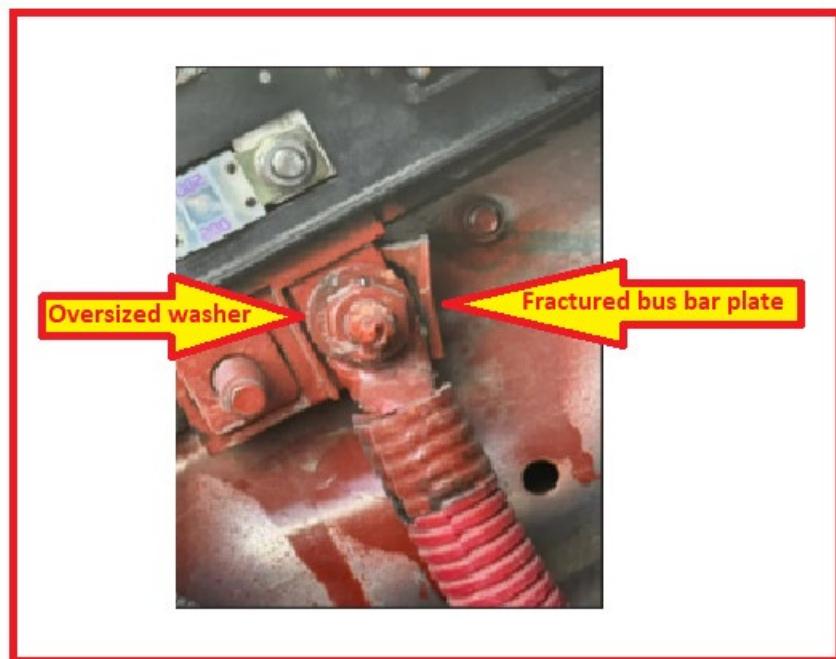
Fig. 2, 30K Cable Inspection At BCA

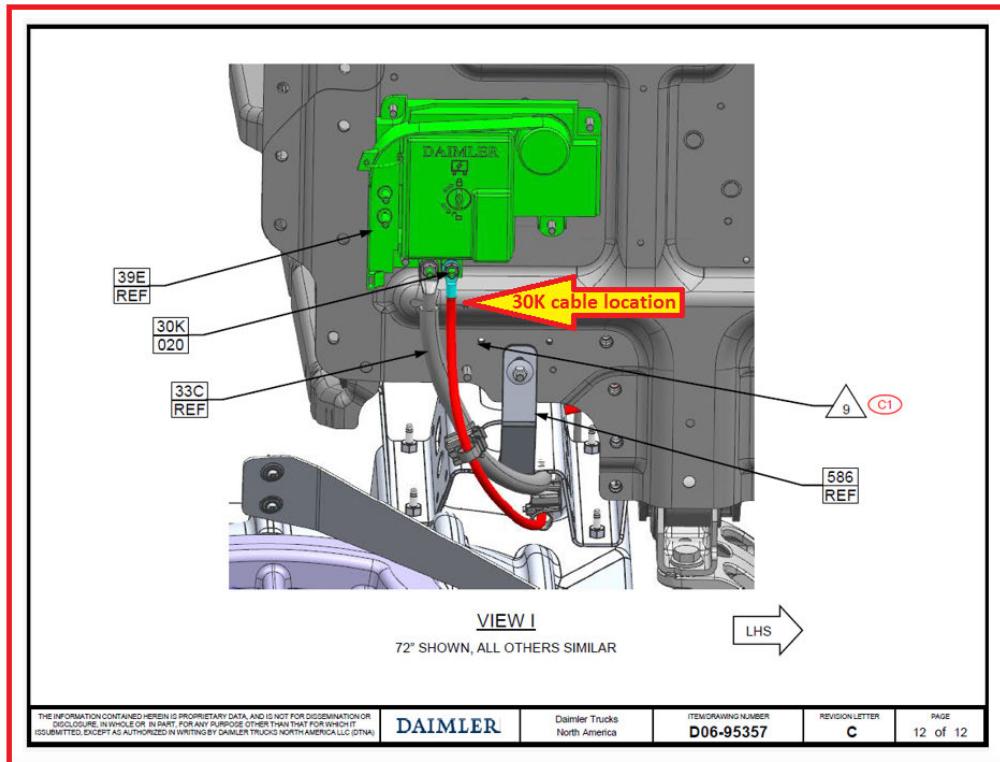
Fig. 3, 30K Cable Location At BCA

Install 30K supply cable to the lower right-side post of the BCA using new washer, part no 23-10900-031 (5/16" SST) and new nut part no. 23-14592-008 (SST, M8 patch lock) or reuse existing nut with 271 blue Loctite. Ensure joint is clean and free of interference from heat shrink or resin glue. Retrim or clean as needed. Torque to 15Nm. See Fig. 3 .	
Remove BCA cover and ensure that both circuit breaker (CB) nuts and Midi Fuses are torqued to spec.: 5.5Nm for circuit breaker, 4.5Nm for Midi Fuses. Reinstall cover. See Fig.4 .	
Visually inspect main power connection left side of BCA for corrosion, signs of arcing or loose connection. Repair or replace as needed. If repairs are made, torque both nuts to 15Nm. See Fig. 5 .	
Inspect full routing of 30K cables for any damage or chafing on both supply and ground cables. Refer to installation print D06-95357-000. See Fig. 6 , Fig. 7 , and Fig. 8 .	
Locate and identify the 30L cable that connects the tractor to the trailer. See Fig. 9 .

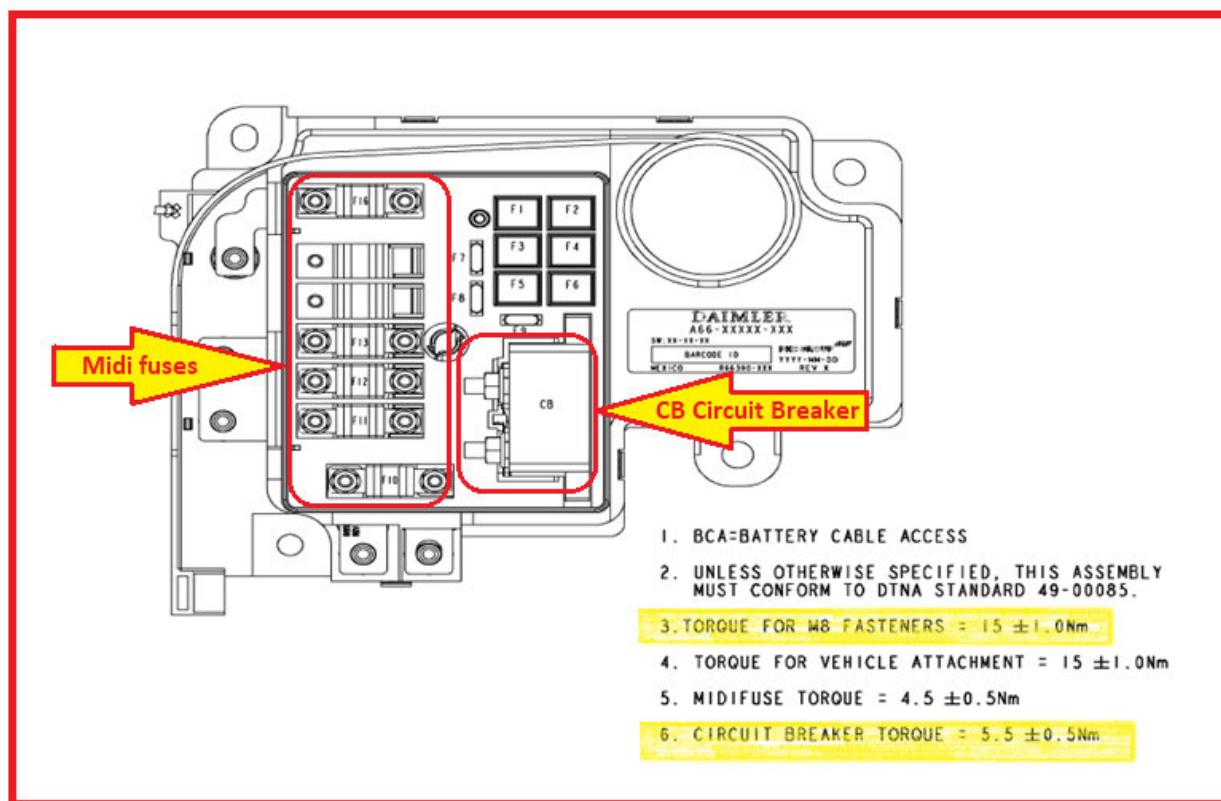
Fig. 4, CB Circuit Breaker and Midi Fuse Torque

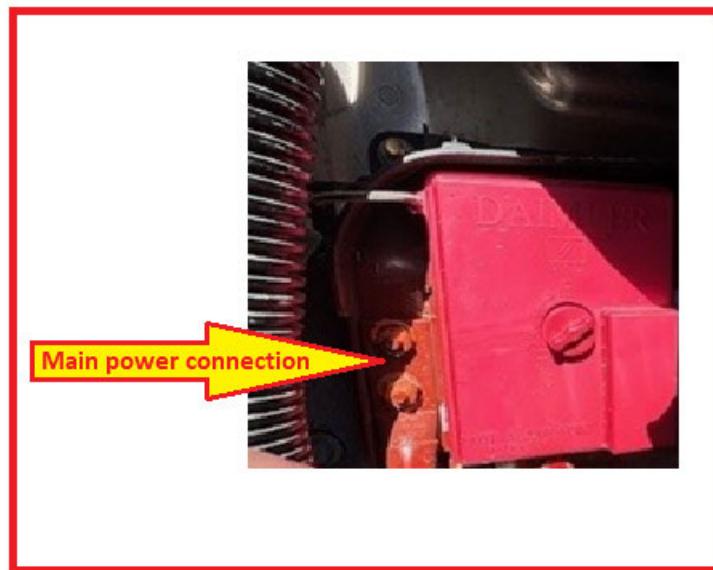
Fig. 5, Main Power Connection

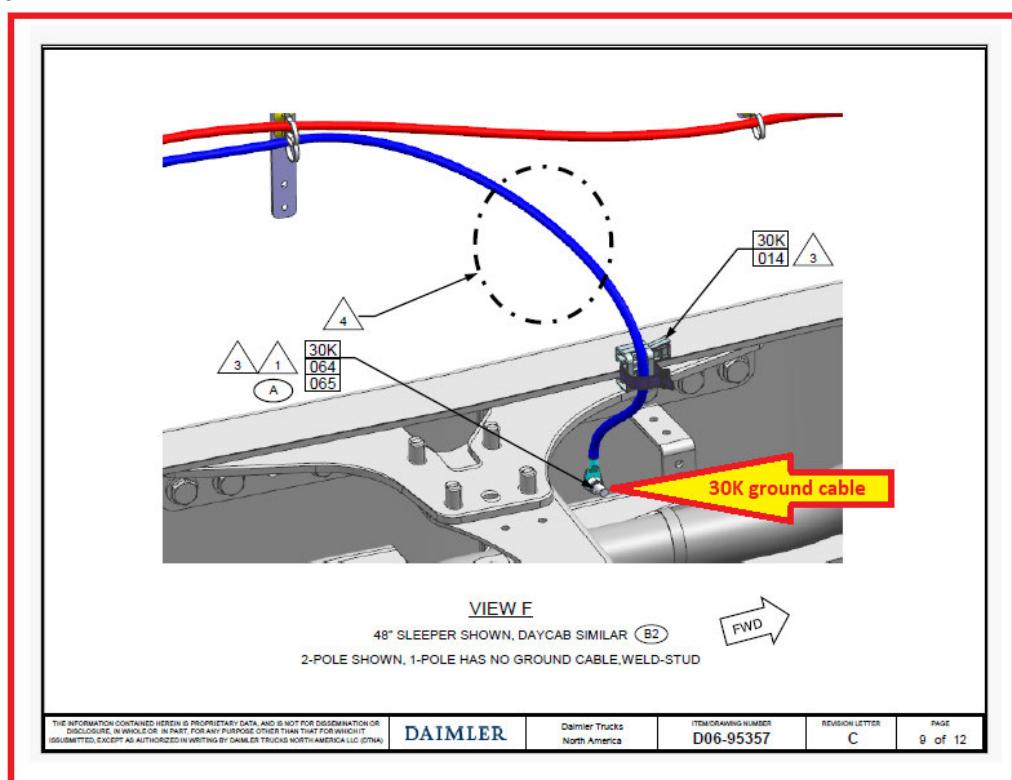
Fig. 6, 30K Ground Cable Location

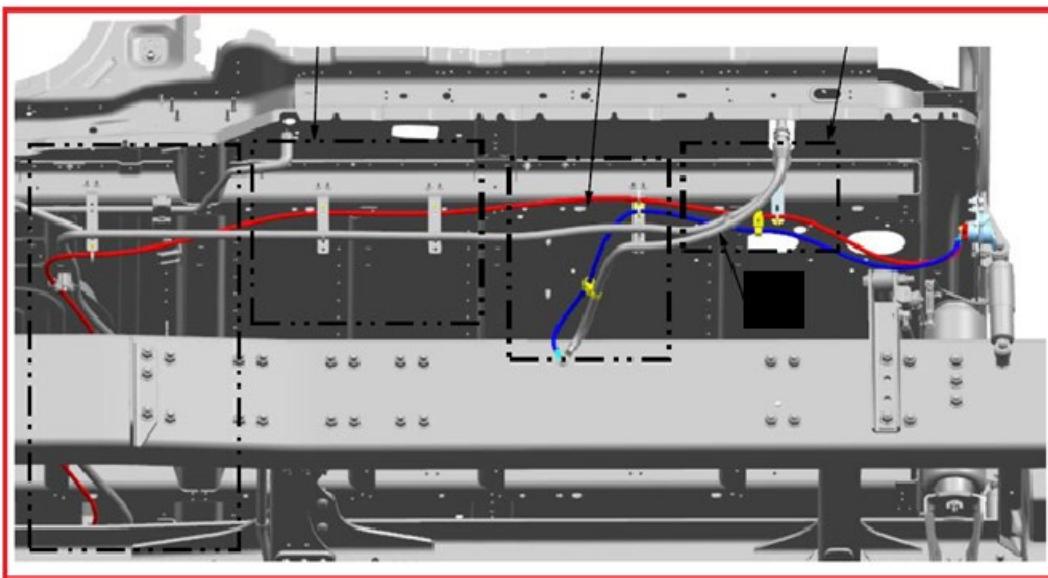
Fig.7, Under cab 30K Cable Routing

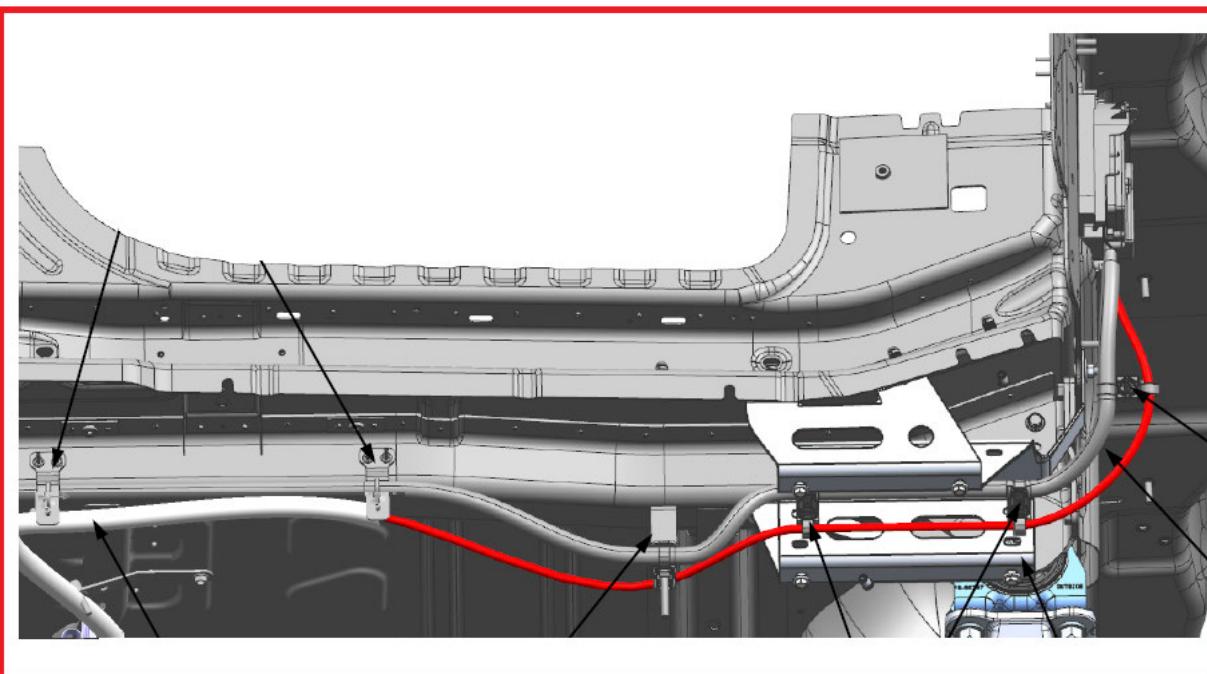
Fig. 8, BCA 30K Cable Routing

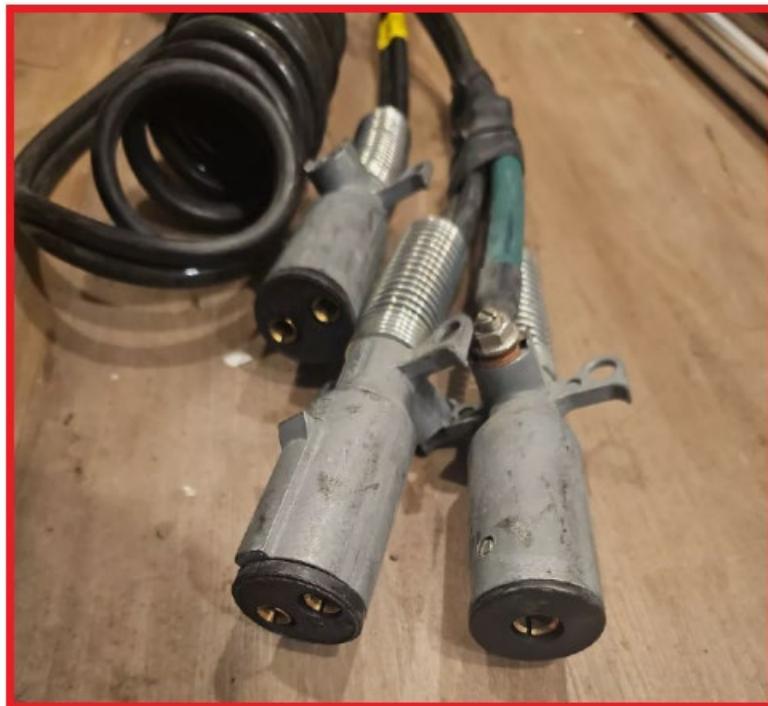
Fig. 9, PHM 23 2630 Cable Assembly

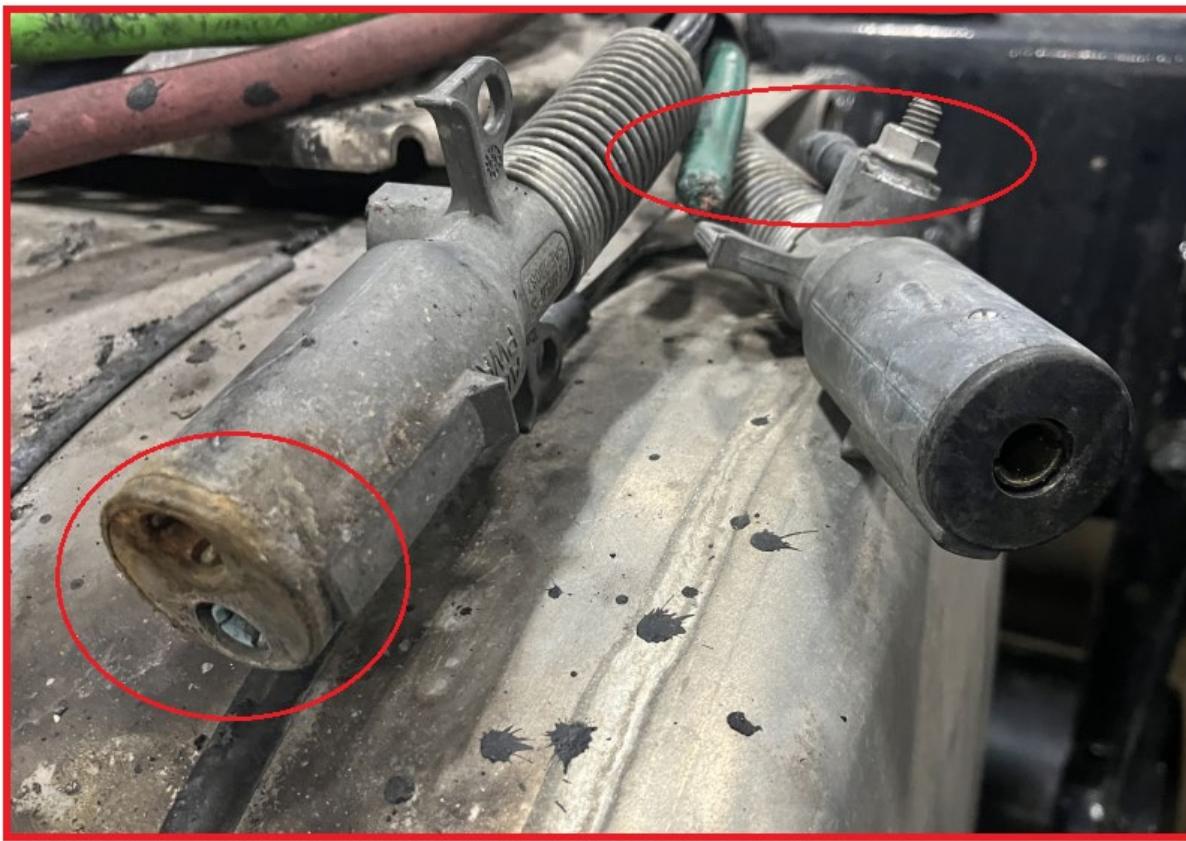
Inspect the 30L cable for any corrosion, chafing, or separation, at both the single and dual pin connector. Inspect the ground cable to ensure it is secure on the single pin connector and there is no corrosion, chafing or separation. Replace 30L cable if corrosion, chafing, or separation is present at either the connectors or the ground cable. See Fig. 10 .

Fig. 10, Inspecting The 30L Cable
