TECHNICAL SERVICE BULLETIN

Subject	ZX5.A02 BuSCoM 2.0 Software Release
Issue Date	7/15/2024
Service Bulletin Number	SC-24-014
Models Affected	Service Specified Vehicles
Complete By	Next Service Opportunity
Labor Operation Code	PD54Z
Description	Release to support bugs and enhancements for the ZX5.A02 fleet. The following ECUs will be updated throughout the procedure Dash (v5.3.0), Vehicle Controller (v3.13.08), Body Controller (v2.2.2), and Prodrive 2.0 (v6.1.0).

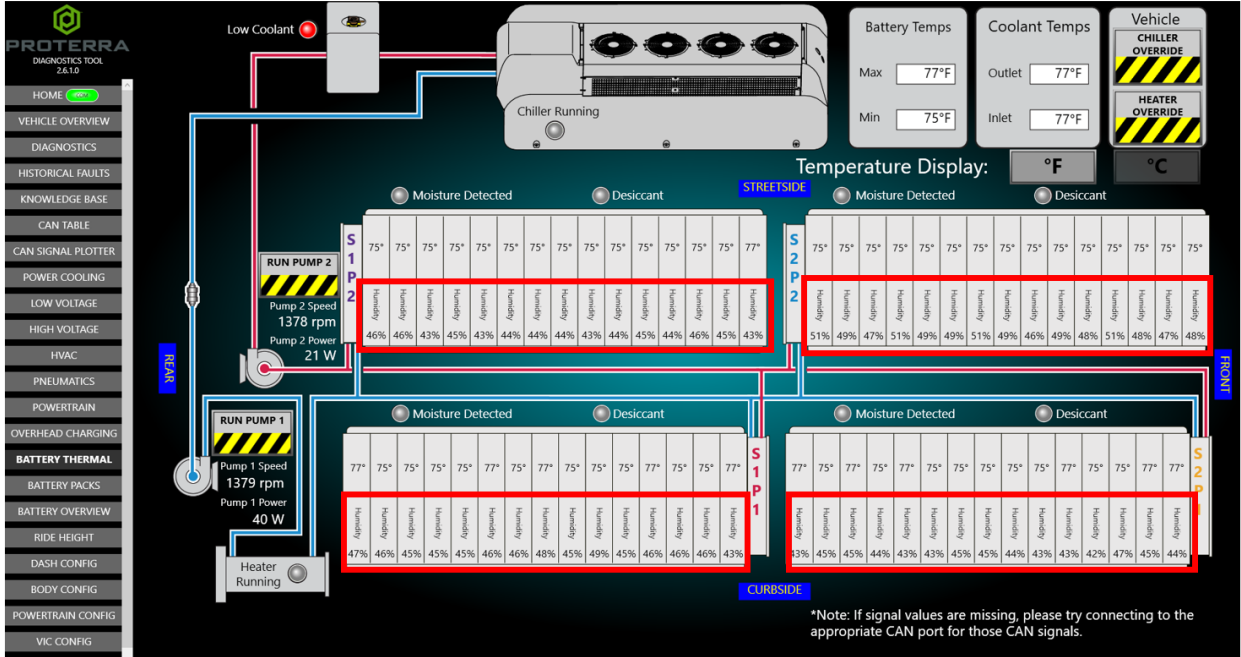
Step 3: View the humidity level of each module per battery pack; the pack ID is located on the graphic of the A-Bay. If the module humidity levels are less than 70%, the battery pack check is complete. If there is one or more module(s) that exceeds 70% humidity, you must proceed to the next step.

Example: S1P1, S1P2, S2P1 and S2P2 as shown below. NOTE: your screen and Pack ID may look different based on the vintage of vehicle.

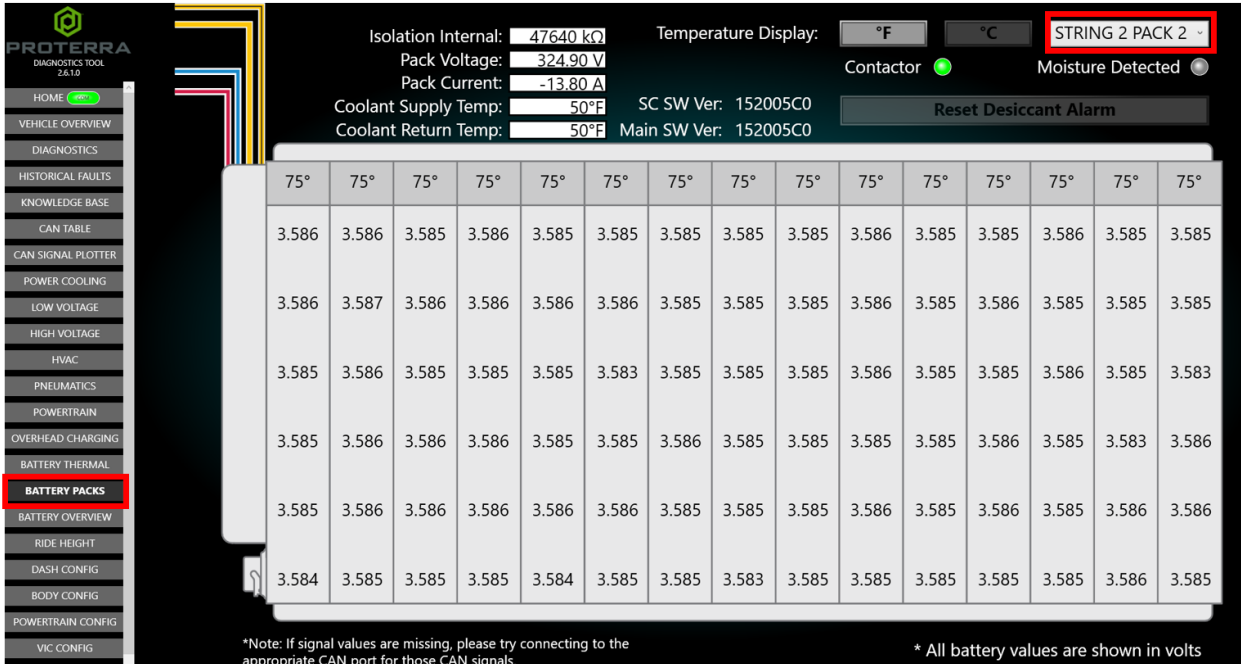
Step 4: (i) View the “Battery Packs” screen (see the “Battery Thermal” screen on the left-hand side below); and (ii) select the Pack ID of any battery pack(s) with a humidity level that exceeds 70% (see the pull-down menu in the upper right-hand corner below).

Example: If S2P2 has humidity of 70%, select “String 2 Pack 2” in the pull-down window.
