TECHNICAL SERVICE BULLETIN

ISSUE DATE:	1-22-2021
SERVICE BULLETIN SUBJECT:	Door Opening Body Crack Repair
VINs or MODELS AFFECTED:	Service Specified Buses
COMPLETE BY:	Next Service Opportunity
SERVICE BULLETIN #:	FC-21-10
Labor Operation Code:	UZ43Z

DOOR OPENING BODY CRACK REPAIR

TTC Bus Rear Door Corner Crack Repair

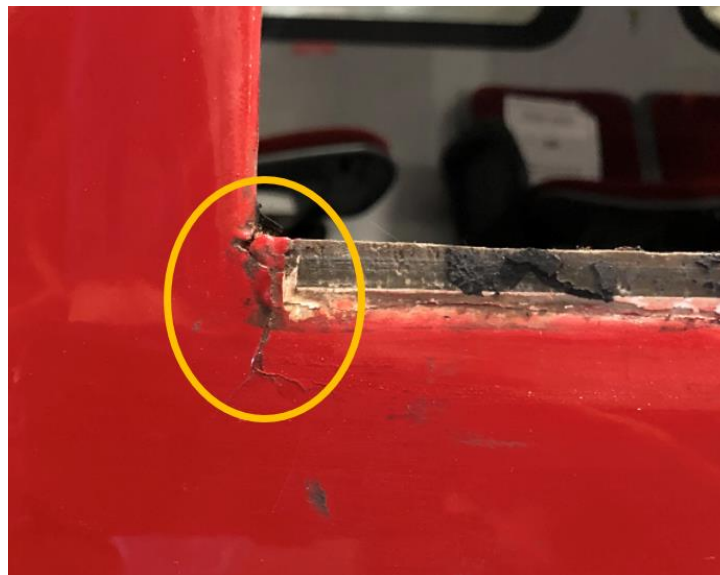
This procedure documents the steps required to repair the rear door corner cracks shown below on Toronto Transit Company Bus after corner cracks were excavated and resin-rich areas were removed. The procedure is applicable to all buses consisting of the identified damage – Bus 3728 is referred to in this document. The general approach is to fill the exposed voids from the excavation, and add layers to the external surfaces using a wet layup to reinforce the area and build the profile.

Figure 1 Example of rear door corner crack

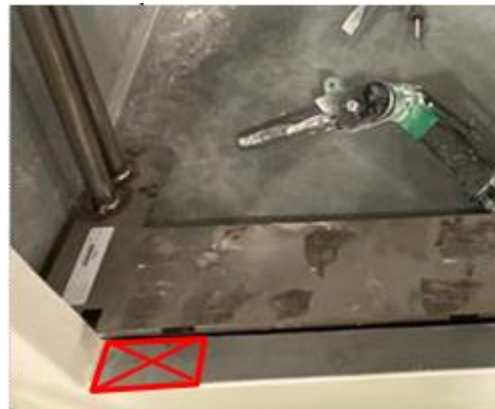
Figure 4 Drilling location for the crack repair

3.1.5 Using a small grinding wheel or diamond cutter, create an opening in the threshold/sill where shown:

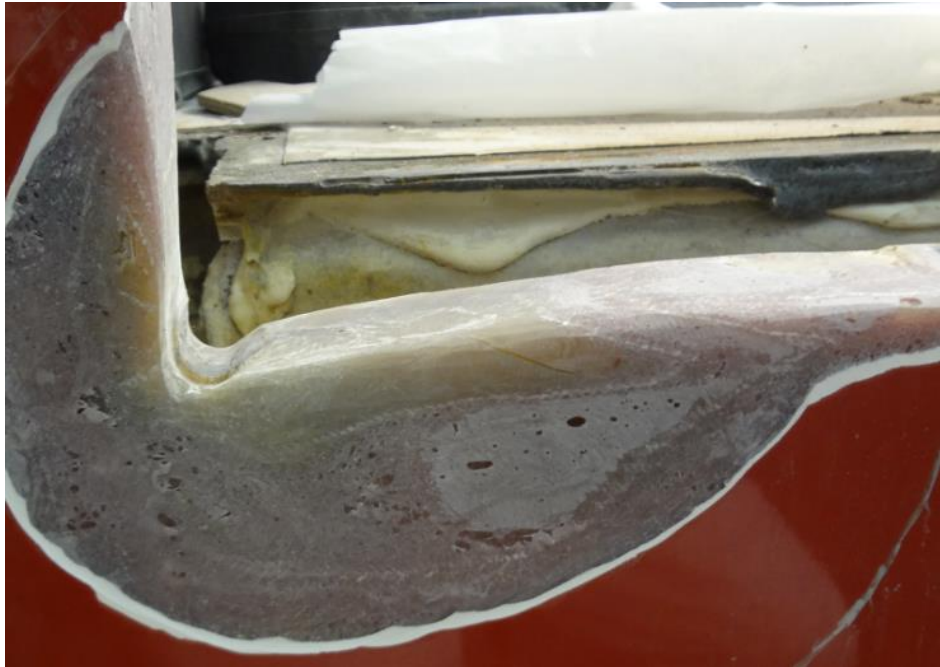
- 3.1.8** Continue sanding/grinding into laminate until existing crack has been removed and shows no further propagation. Void or cavity between bonded parts (floor & body) may be exposed when sanding through the laminate.

Figure 5 Excavated corner crack

- 3.1.9** Feather/taper the sanding outward from the exposed edges the valleys or crack center.
- 3.1.10** If any wet balsa is observed by hand in the voids, extract the wet balsa, and allow the cavity to dry overnight or accelerate the drying via a heat gun and air movement.
- 3.1.11** Vacuum or blow out any debris in the voids; vacuum all surface debris and use a clean rag with acetone to remove any remaining dust.
- 3.1.12** Repair area grinding complete. Record photos of repair area.

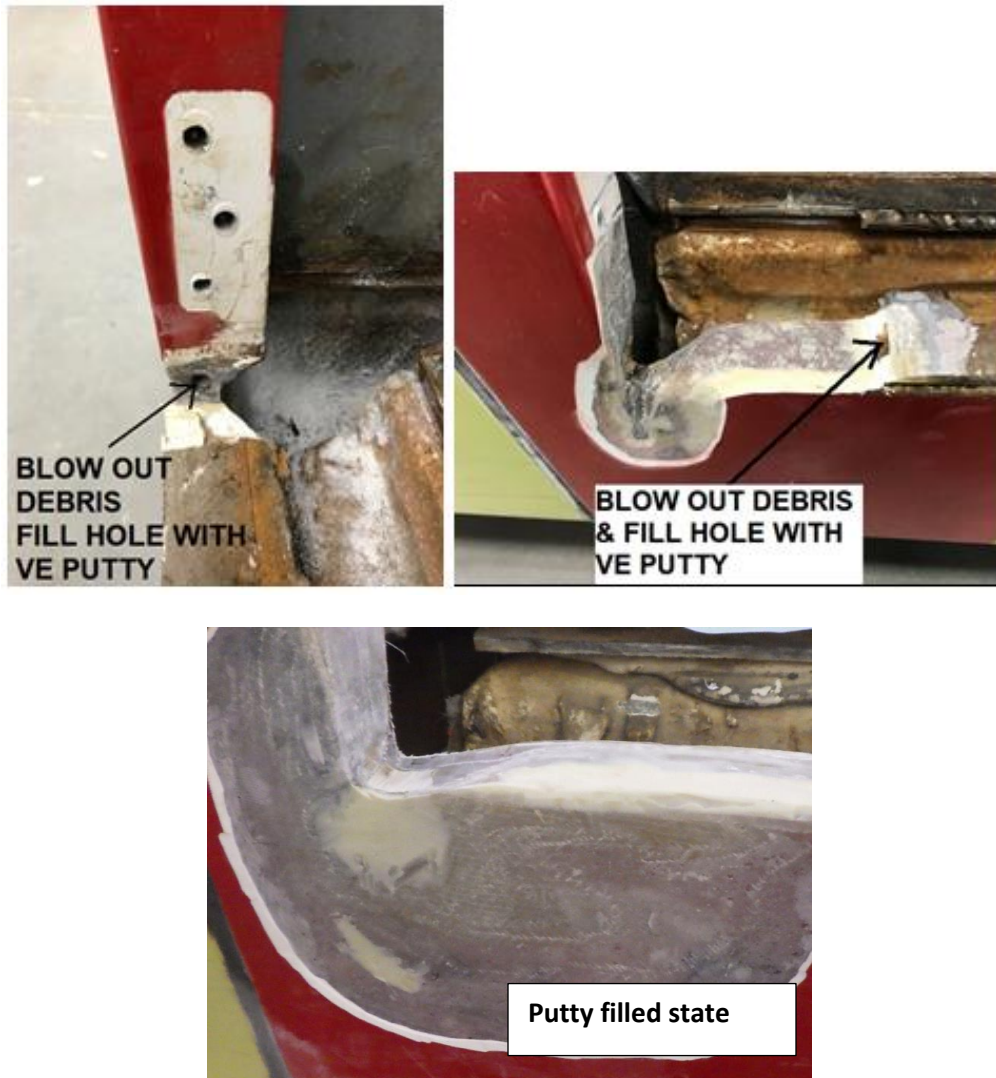
Figure 6 Filling the exposed cavity with VE chopper fiber putty (No. 876)

3.2.2 Ensure to fill any voids or cavities in the excavated area by using VE chopped fiber putty (No. 876). Required hardener quantity for the VE chopped fiber putty is 2.0% by mass.

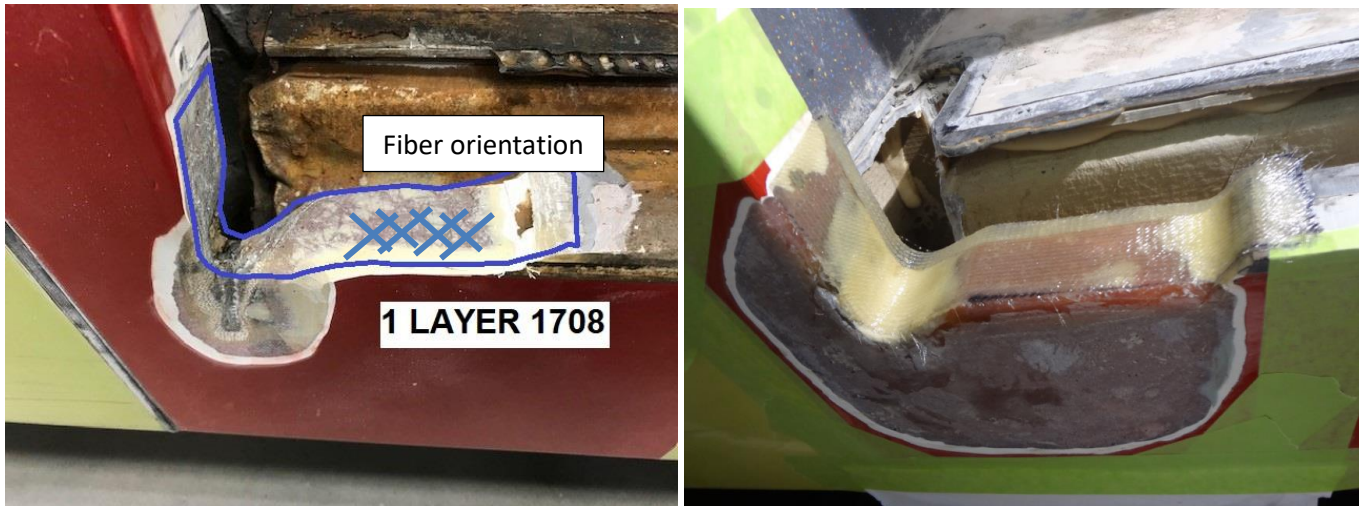
Figure 7 Application of first reinforcement ply (1708)

3.2.3 Wet out 1 layer of 1708 Biaxial glass with catalyzed VE resin (Hydropel H034-AKA-33 with MEKP 925, typical for all plies listed in this repair) and run the ply from the threshold onto the door jamb. Fiber direction of $\pm 45^\circ$ is running along the length of the strip. Catalyst mass shall be 1.0% – 2.0% of the total resin mass (e.g. 100 g resin = 1 – 2 g of catalyst). It is recommended that the total mix volume does not exceed 100 g.

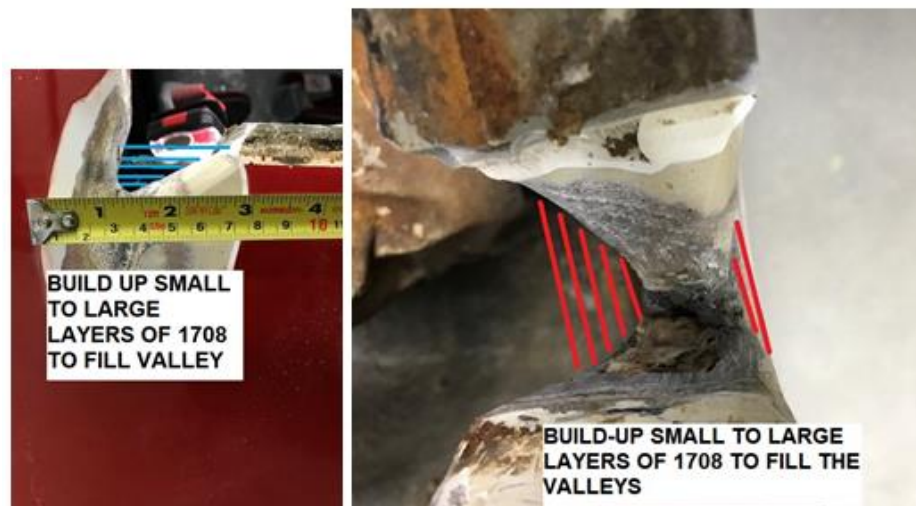
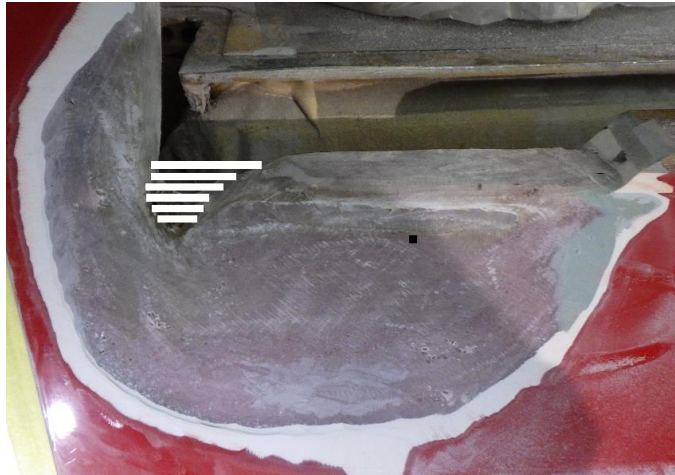
Figure 8 Schematics of filling the “valley” with reinforcement plies (1708)

3.2.4 Fill any valleys using short strips of 1708 biaxial glass as shown in the side view (left) and top view (right) in the figure below; add just enough layers of 1708 to help level the void with the surrounding intact laminate skins. Strips should gradually increase in size, as needed, but should remain in the same plane and not be directed around corners. Record photo of glass application.

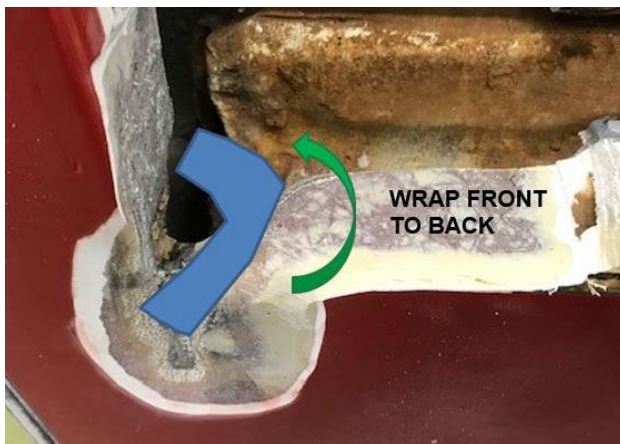
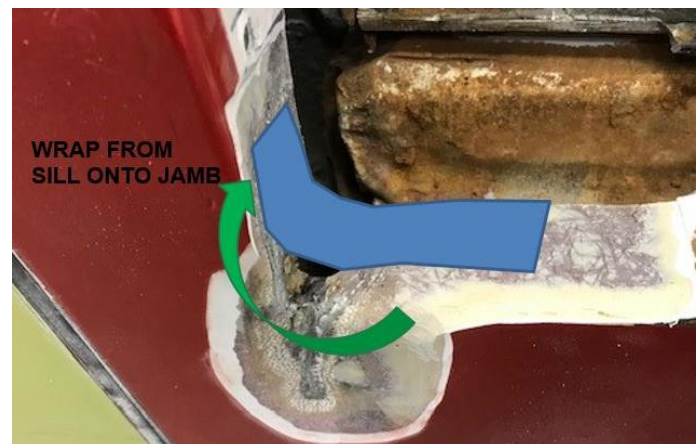
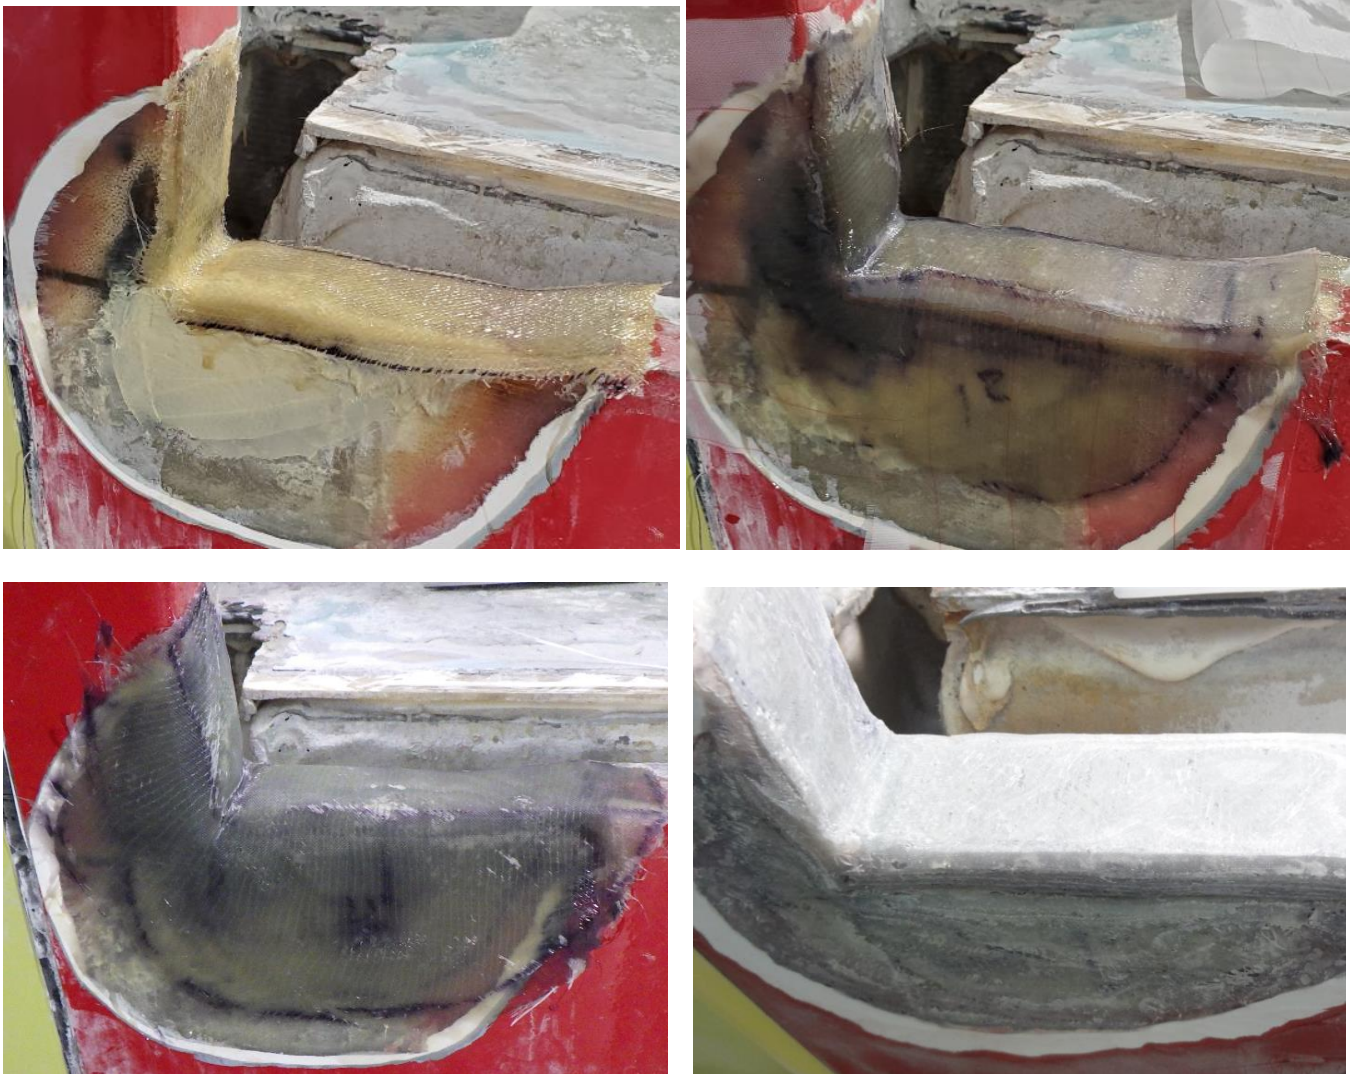
Figure 9 Application of reinforcement plies on the door corner (1708)

3.2.5 Alternate 1708 plies from front to back with those running from the sill onto the jamb. Each ply must get bigger than the previous one so that they extend beyond the previous one. All plies have $\pm 45^\circ$ fiber direction running along the long side of the strip. Record photo of glass application.

- a. 1st ply from the front side to the back side.
- b. 1st ply from sill to jamb.
- c. 2nd ply 15 to 20 mm longer than the 1st (at each end) from front to back.
- d. 2nd ply 15 to 20 mm longer than the 1st (at each end) from sill to jamb.
- e. 3rd ply 15 to 20 mm longer than the 2nd (at each end) from front to back.
- f. 3rd ply 15 to 20 mm longer than the 2nd (at each end) from sill to jamb.

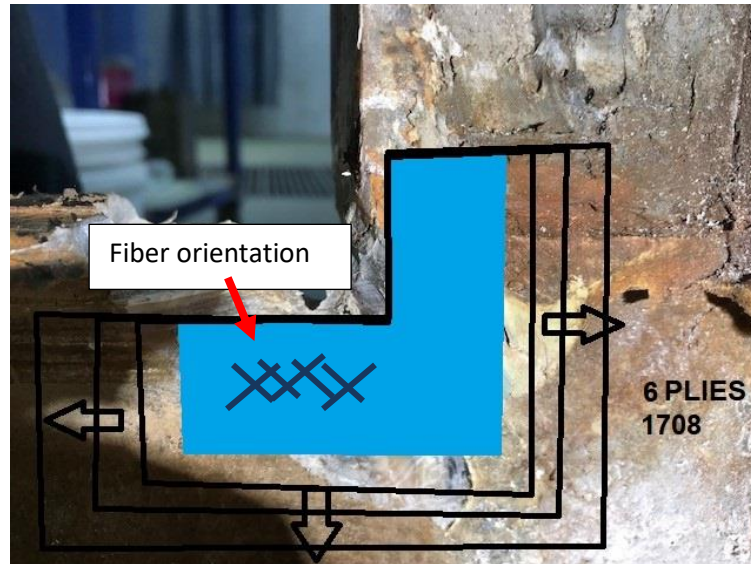
Figure 10 Application of reinforcement plies on the backside of the door

- 3.2.6** If needed, add additional plies of 1708 glass to the threshold/sill to obtain necessary height and width. Stagger the plies so that the ends extend further than the previous ply.
- 3.2.7** Add 6 plies of 1708 on the backside as shown; start at the corner and overlay the previously installed repair plies. Each additional ply should be 15 to 20mm larger than the previous ply, but only in the the directions as shown in the image below. Ensure to roll each layer with a roller to smooth out the glass and remove any air bubbles. Record photos of glass application at each stage.

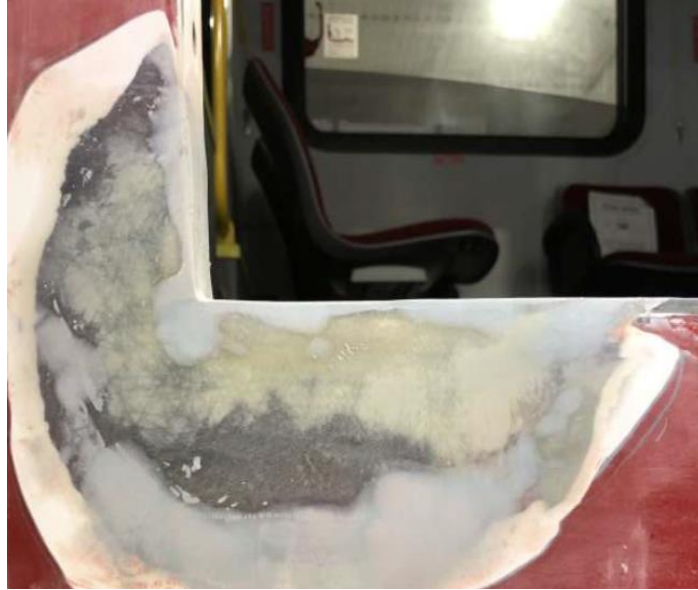
Figure 11 Filled and faired surface of the repair

3.3.2 Fill in pin holes or discontinuous surfaces using No. 01175 lightweight putty (putty No. 01175 light weight body filler), catalyzed with cream hardener 10140. Mix ratio is 100 g filler to 3 ± 0.5 g hardener.

3.3.4 Fair the patched area using a DA sander with 80 or 120-grit sanding disk.

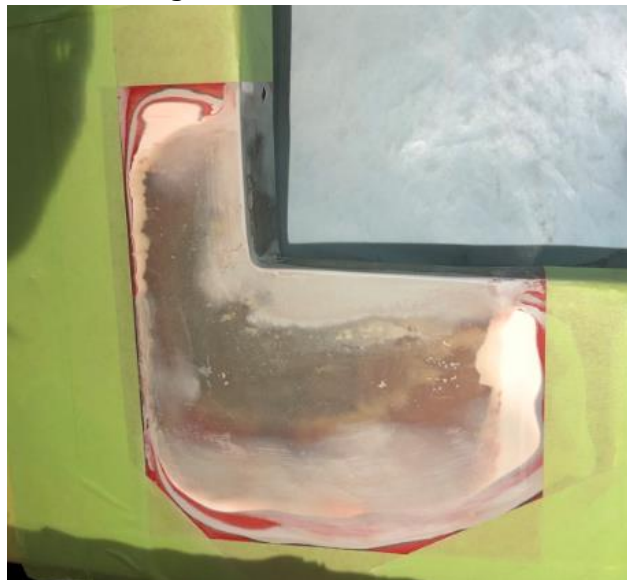
Figure 12 Masking the repair area prior to gel coating

3.3.6 Mask the area surrounding patch, using craft paper and green masking tape. The masking should start just inside the area sanded with 220 grit.

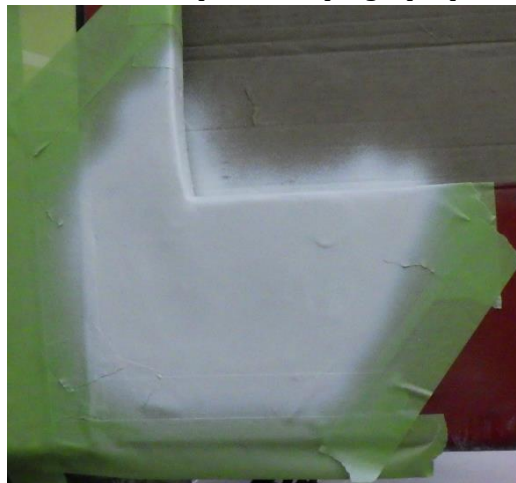
Figure 13 Application of gel coat

3.3.11 Apply the first coat of gelcoat to the area of patch, keeping a perpendicular distance of approx. 12”.

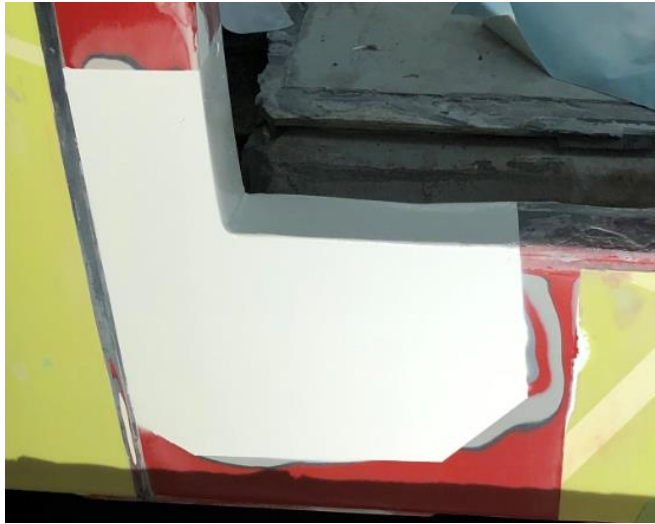
Figure 14 Completed repair

3.3.15 Fair area using DA with 320 grit & 600 grit sanding disks. Take photos of the finished repair.
