## Throttle lift-off clunking noises at drive shafts of rear axle

Topic number	LI35.30-P-058566
Version	7
Function group	35.30 - Final drive, drive shafts
Date	1/15/25
Validity	Mercedes Benz cars and SUVs as of manufacture year 1996
	On model 203, 209, 171 as of approx. week 21/04 coated as standard with Molykote paint
Reason for change	Validity adjusted

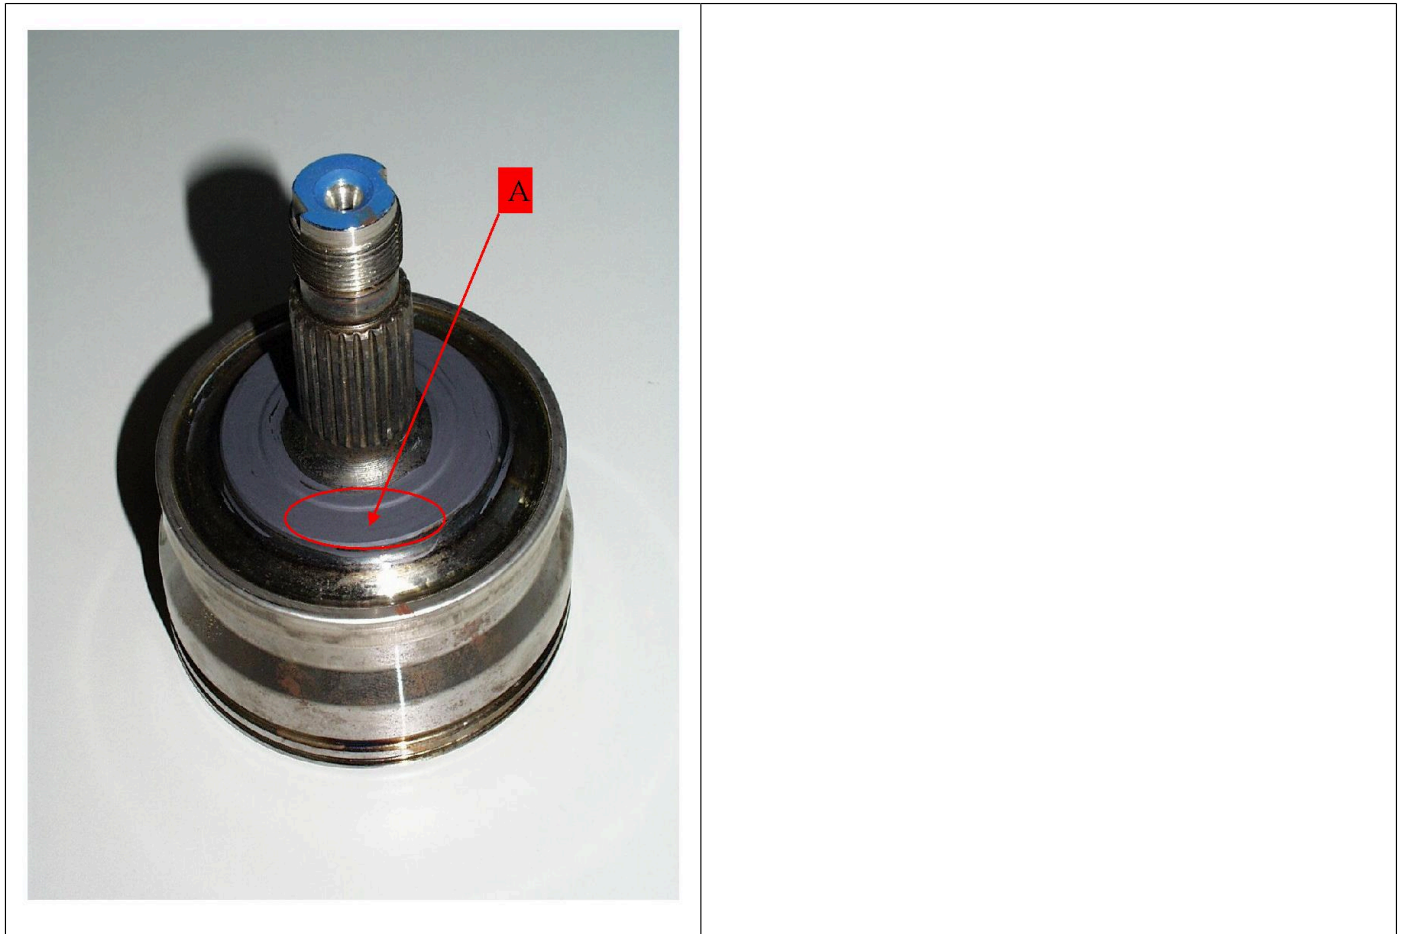
Gelenkgehäuse aussen nach.jpg

After coating with Molykote paint

1. Remove side shafts
2. Clean contact surface A (see image file in attachment "Outer joint housing before") before coating with Molykote, using "spirit" (free of dust and grease)
3. Coat contact surface A (see image file in attachment "Outer joint housing after") with Molykote and leave to dry for "one hour" in removed condition
4. Reinstall side shafts
