Service Bulletin

Bulletin No.: 25-NA-012

Subject: Front Floor Console Center Compartment Door Stuck Closed

Brand:	Model:	Model Year:		VIN:		Engine:	Transmission:
		from	to	from	to		
GMC	Hummer EV Pickup	2022	2025				
	Hummer EV SUV

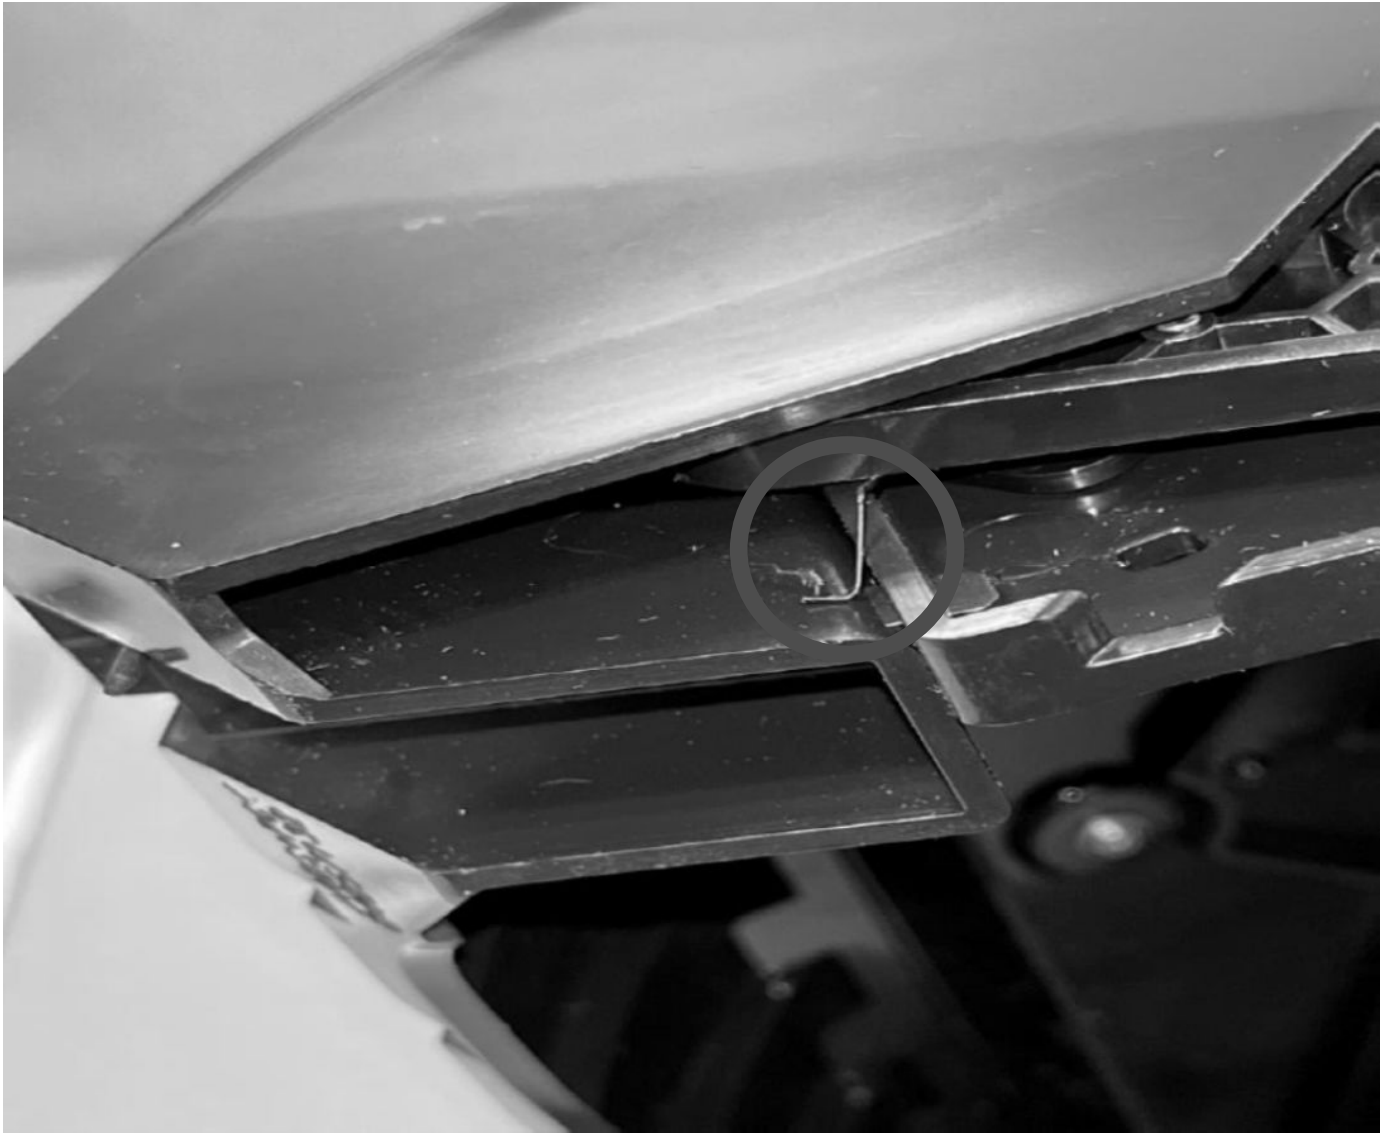
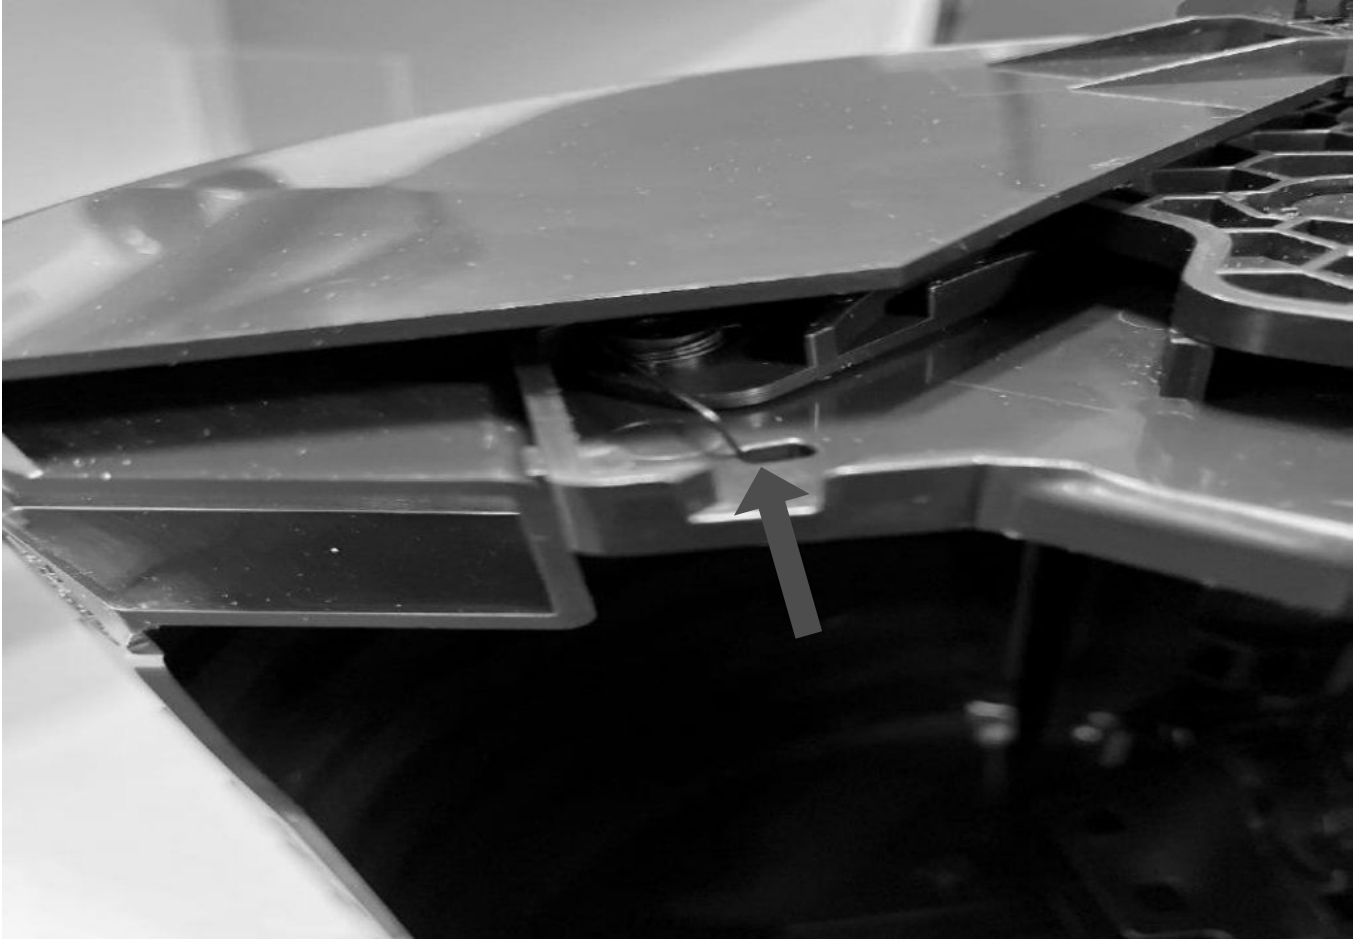
6815814

Involved Region or Country	North America, Middle East, Israel
Condition	Some customers may comment on the front floor console center compartment not opening.
Cause	The causes of the condition may be a latch spring on the floor console may be out of position.
Correction	Dealers will need to re-attach this latch spring, refer to the Service Procedure below.

2. Locate the spring using the graphics above. Using needle nose pliers, reattach the spring to the correct mounting hole.
3. Reinstall the Front Floor Console Center Compartment.
