PROTERRA

ISSUE DATE:	3-23-2022
SERVICE BULLETIN SUBJECT:	Steering Gearbox Bolt Torque Stripe and Re-torque Fleet Check
VINs or MODELS AFFECTED:	Service Specified Buses with Non-TPI Bodies
COMPLETE BY:	Next Service Opportunity
SERVICE BULLETIN #:	FC-22-46
Labor Operation Code:	N/A

STEERING GEARBOX TORQUE STRIPE AND RE-TORQUE FLEET CHECK

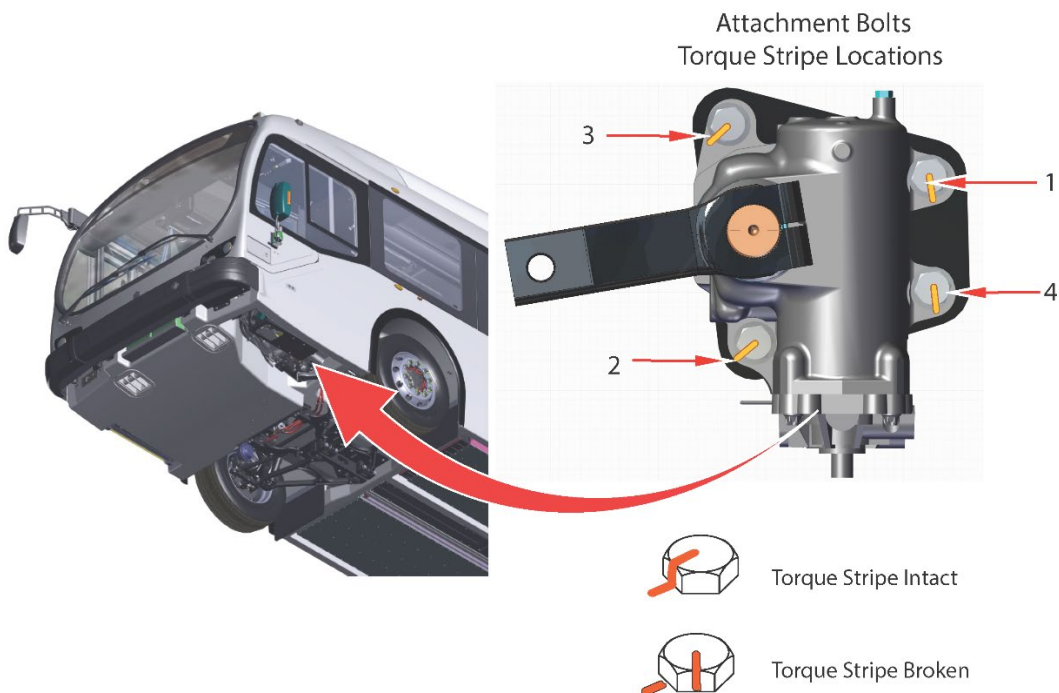
3. Access the Steering Gearbox underneath the bus.
4. Using the following illustrations and photographs as a guide, inspect the Steering Gearbox Securement Bolts. Visually confirm that each bolt has a good torque stripe and that it is not broken due to counterclockwise rotation of the bolt.

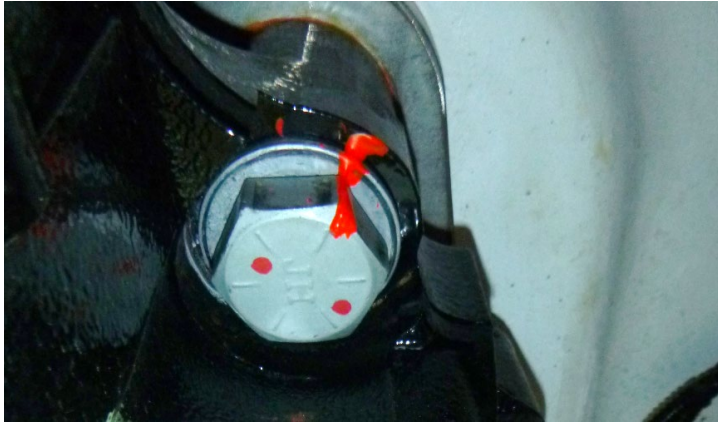
5. The following photograph shows an example of a good unbroken torque stripe.

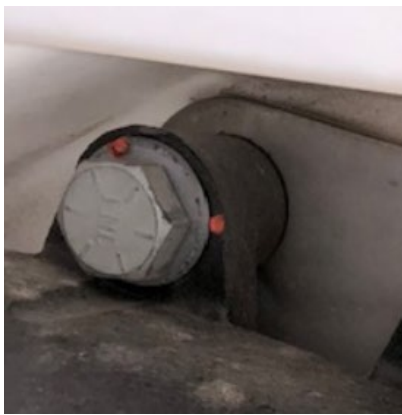
6. The following photograph shows an example of a bad torque stripe. Notice the torque stripes are broken due to rotation of the bolt.

16. If the Torque Stripes are in good condition and none of the bolts failed the re-torque test no further inspection is required and this check is complete. The bus may be lowered and returned to service.
17. If bad/broken torque stripes are identified or any of the bolts failed the re-torque test, contact Proterra Customer Service to receive additional instructions after filling out the inspection form linked above. If a Proterra team member performs the inspection the Work Order should be escalated to the Proterra back office in addition to submitting the form.
18. If bad/broken torque stripes were found or any of the bolts failed the re-torque test, the bus may be lowered and Lockout/Tagout devices removed but the bus should not be returned to service until additional inspections are performed.

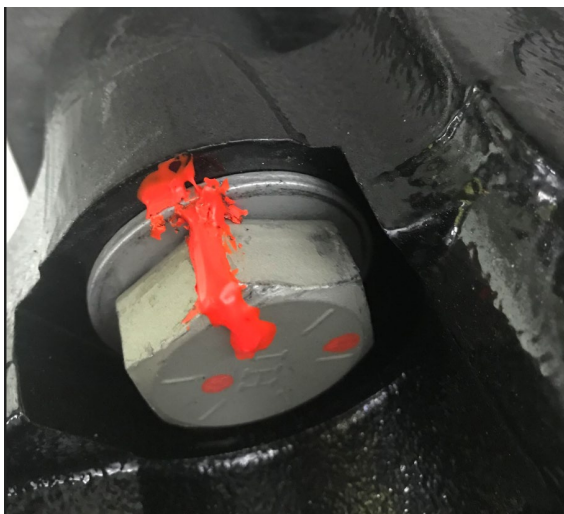
7. The following photograph shows an example of a good torque stripe. Although it is broken, the bolt has rotated clockwise for a small portion of one turn. This can occur when the bolts have been re-torqued prior to shipment during a factory inspection.
