# TECHNICAL SERVICE BULLETIN

<b>ISSUE DATE:</b>	10-6-2021
<b>SERVICE BULLETIN SUBJECT:</b>	Ancillary Bay Battery Pack Ground Screw Replacement
<b>VINs or MODELS AFFECTED:</b>	Service Specified Buses
<b>COMPLETE BY:</b>	Next Service Opportunity
<b>SERVICE BULLETIN #:</b>	SC-21-174
<b>Labor Operation Code:</b>	HB45Z

## ANCILLARY BAY GROUND SCREW RETROFIT

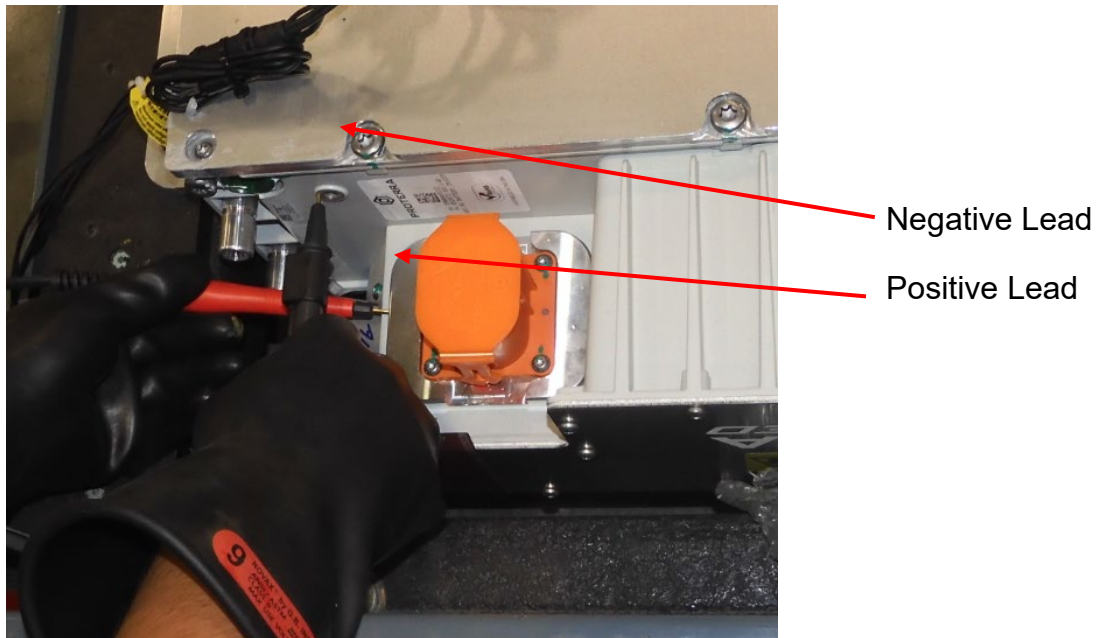
9. Using the calibrated Hioki RM3545 Resistance Meter, measure the resistance between the two points shown in the following photograph. Clean the areas with Shop Towels and Isopropyl Alcohol before beginning the measurement.

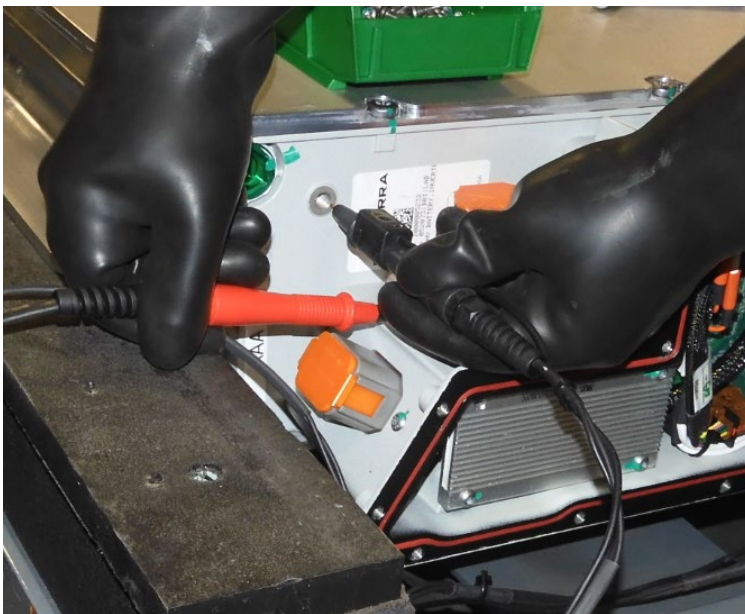
21. Using the calibrated Hioki RM3545 Resistance Meter, repeat the Resistance Measurement performed earlier.

22. Record the Resistance Measurement. The value should be 10 milliohms or less.
