Technical Information

Door Panel Leather Repair Procedure

DATE: January 28, 2025

MODELS: M157 Ghibli and QP(All MY).

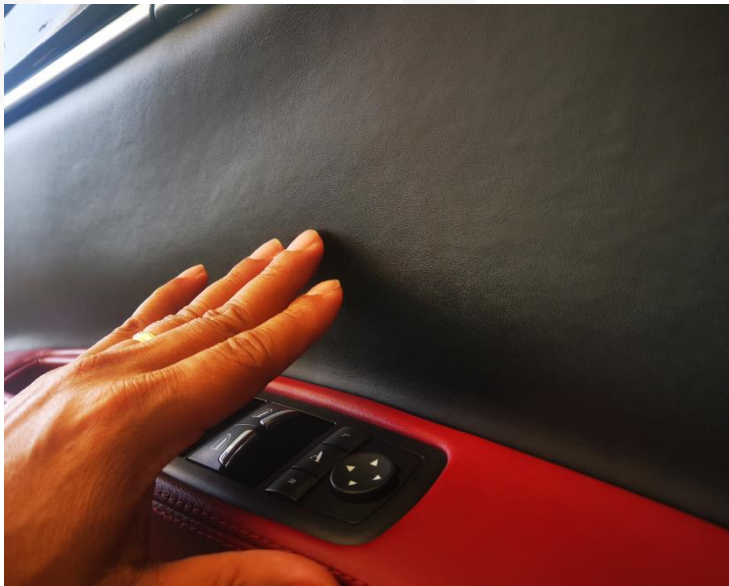
This technical bulletin serves as a guide and provides supplementary information for field management of repairs to the Ghibli door panel, specifically addressing the leather detachment issue. For field management of related cases, we ask you to check on site the availability of a leather specialist who can carry out the below indicated repair.

CUSTOMER CONCERN: Door Panel Leather Peeling/Bubbling.
