## SERVICE BULLETIN

**APPLICABILITY:** 22-23MY WRX Models

**NUMBER:** 15-301-22R

**SUBJECT:** Reprogramming File Availability for Optimization  
 of Gen 4 Denso CP1 Infotainment Systems

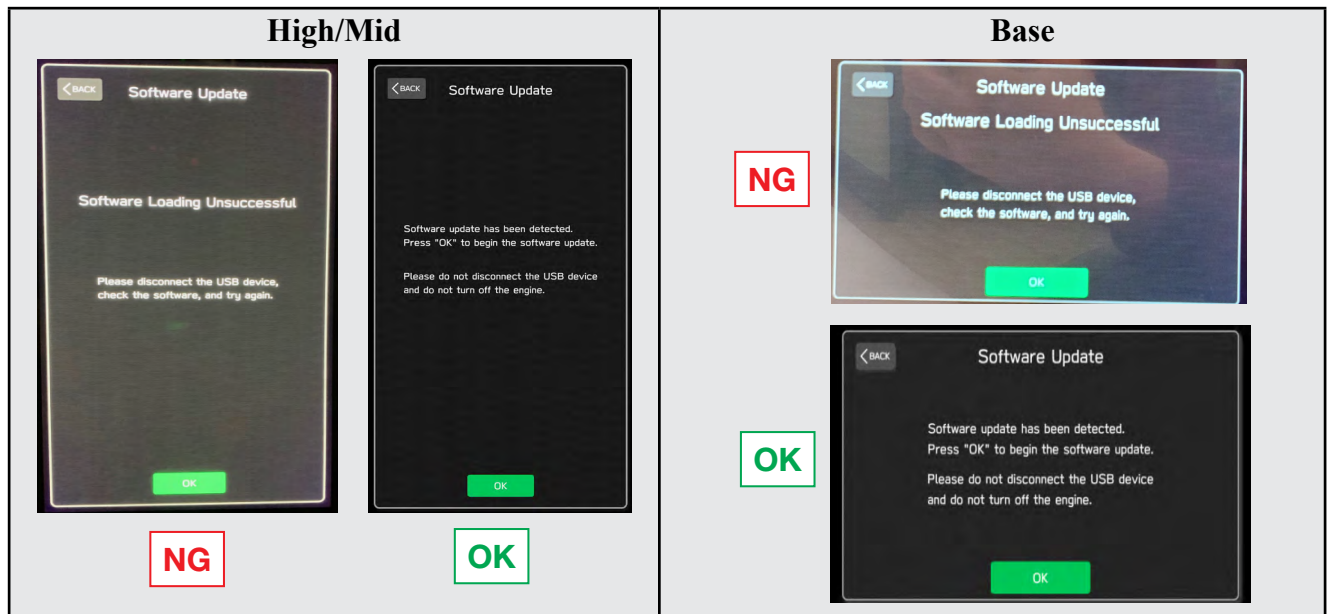
**NOTE:** If after plugging in the USB, the screen displays a **Software Loading Unsuccessful** message, confirm the USB device has been properly formatted and the the software on the device matches the system being reprogrammed (example: Base software is being used to update a Base system) and retry.

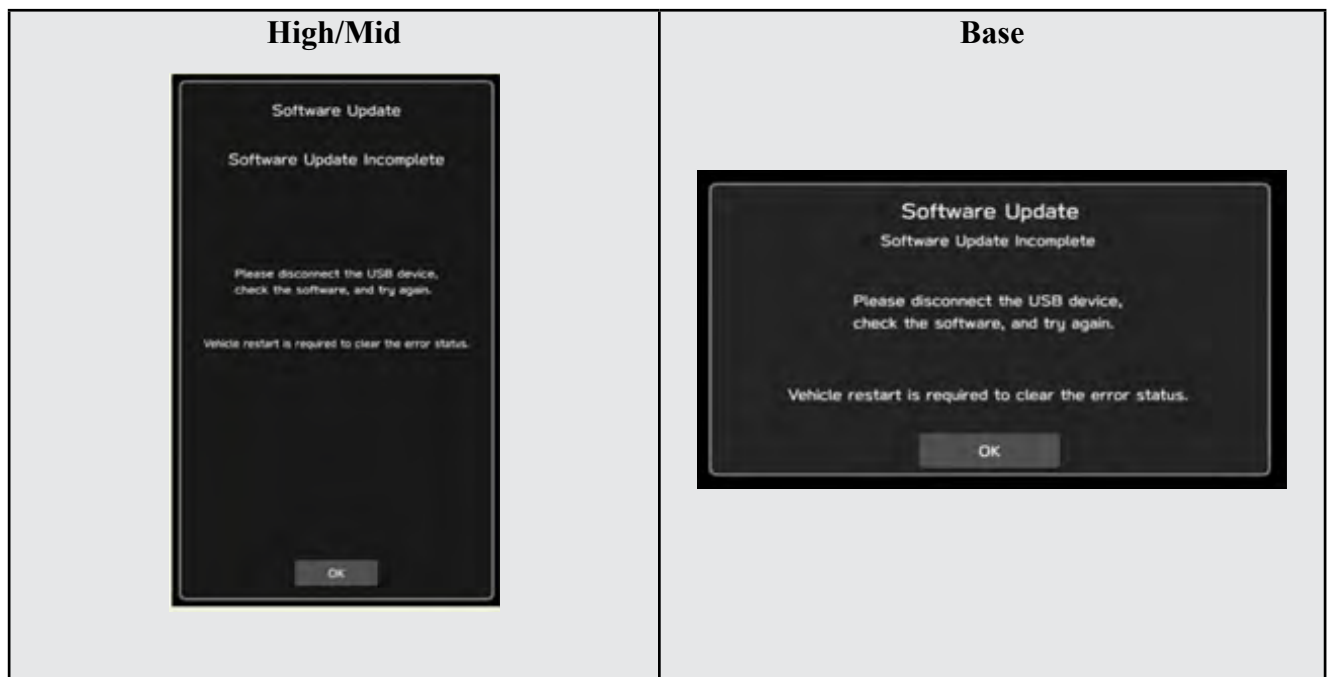
If you get the message **Software Update Incomplete** as shown below, please don't replace the hardware but retry updating the software according to the instructions in "**Appendix B**" on pg. 17.

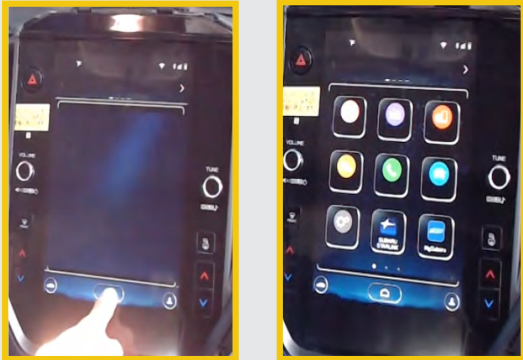
| Number | Symptoms to be Improved: |
|---|---|
| 6 | After switching the clock function to AUTO, the CID screen display becomes distorted<br> |

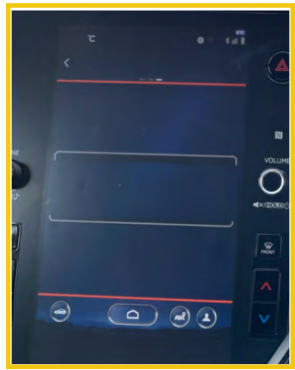
| Number | Symptoms to be Improved: |
|---|---|
| 7 | The CID screen display becomes distorted causing icons and text to be displayed incorrectly, when using USB audio in folder playback mode: the track list is scrolled at the moment when the playing folder switches<br> |

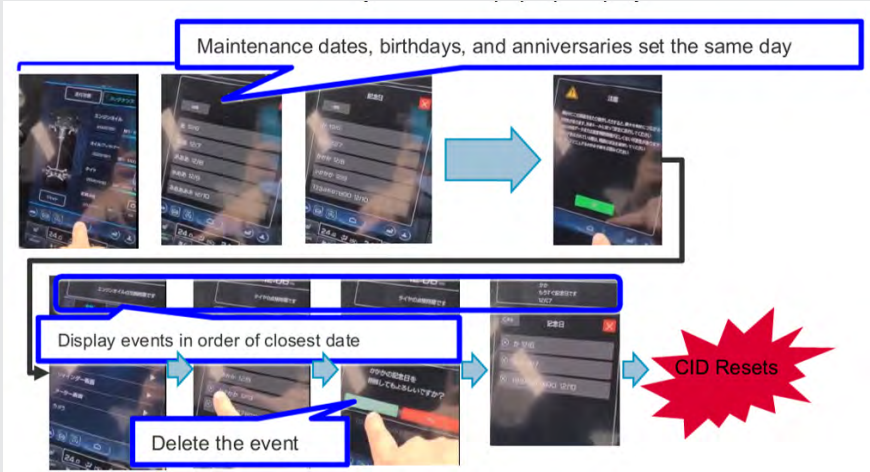
| Number | Symptoms to be Improved: |
|---|---|
| 10 | <p>If a same date is set to maintenance date, birthday, and anniversary date, pop-ups will appear in sequence on the top of the CID after engine is started when the day comes. Under this condition, if an operation is performed to delete the maintenance date, birthday or anniversary date registration within a few seconds immediately before the pop-up display, the CID screen will reset.</p> |

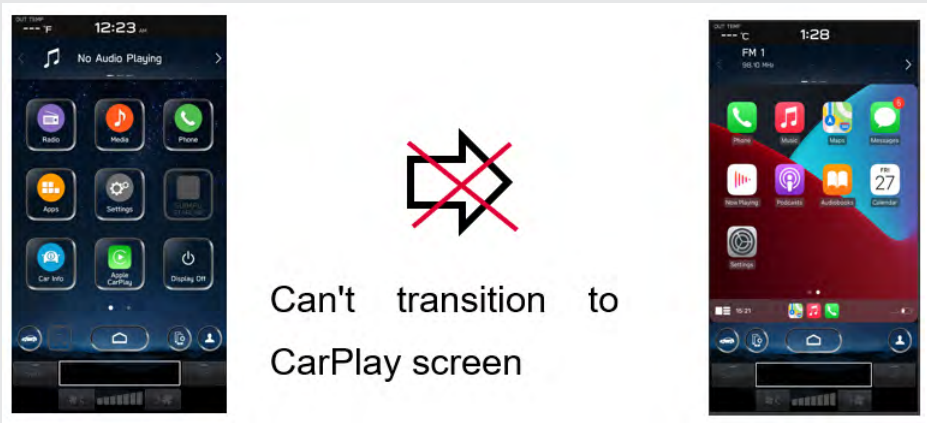
| Number | Symptoms to be Improved: |
|---|---|
| 14 | <p>When the engine is started with the iPhone connected via USB, CarPlay does not start even if the CarPlay icon on the home screen is pressed.</p> <p>&lt;Hint&gt; This can be resolved by reinserting the USB cable.</p> |

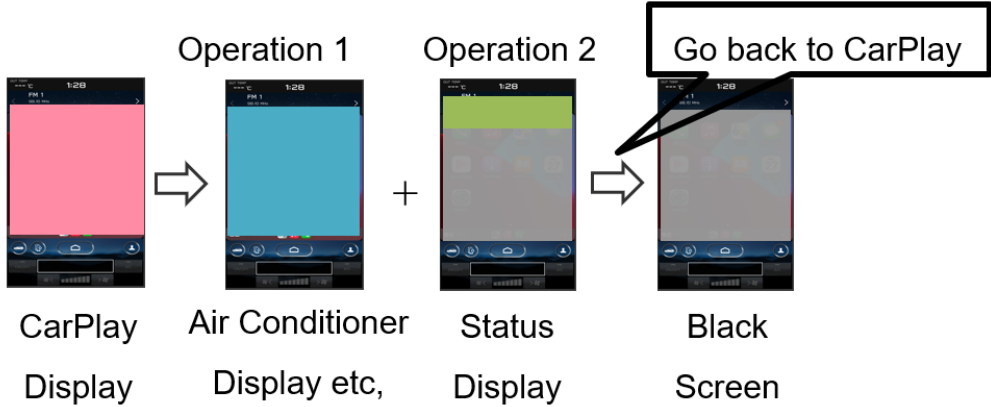
| Number | Symptoms to be Improved: |
|---|---|
| 15 | <p>After performing operations 1 and 2 below from the CarPlay screen, returning to the CarPlay screen causes the CarPlay screen to be black screen.</p> <p>Operation 1: Switching to a pop-up screen such as the air conditioner screen</p> <p>Operation 2: Interrupt pop-up screen display due to volume operation, etc.</p> <div data-bbox="412 317 1398 720"> <p>The diagram illustrates a sequence of four smartphone screens. The first screen is labeled 'CarPlay Display' and has a pink background. An arrow labeled 'Operation 1' points to the second screen, 'Air Conditioner Display etc.', which has a blue background. A plus sign follows. An arrow labeled 'Operation 2' points to the third screen, 'Status Display', which has a grey background. A final arrow points to the fourth screen, 'Black Screen'. A callout box with the text 'Go back to CarPlay' has an arrow pointing to the transition between the 'Status Display' and the 'Black Screen'.</p> </div> |

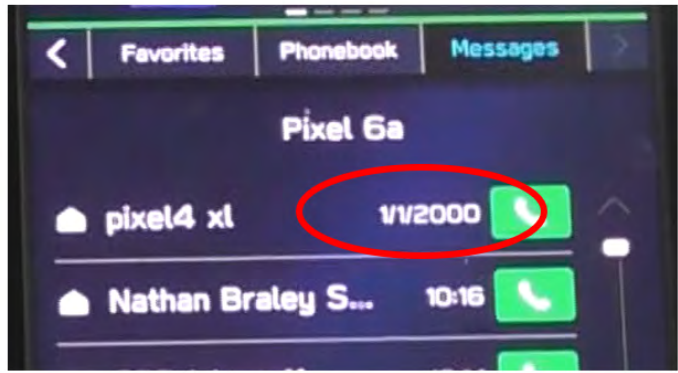
| Number | Symptoms to be Improved: |
|---|---|
| 28 | <b>The date of receipt of a received message is displayed as "2000/1/1."</b><br><b>This occurs on some models of phones with Android OS 13 or later.</b><br> |

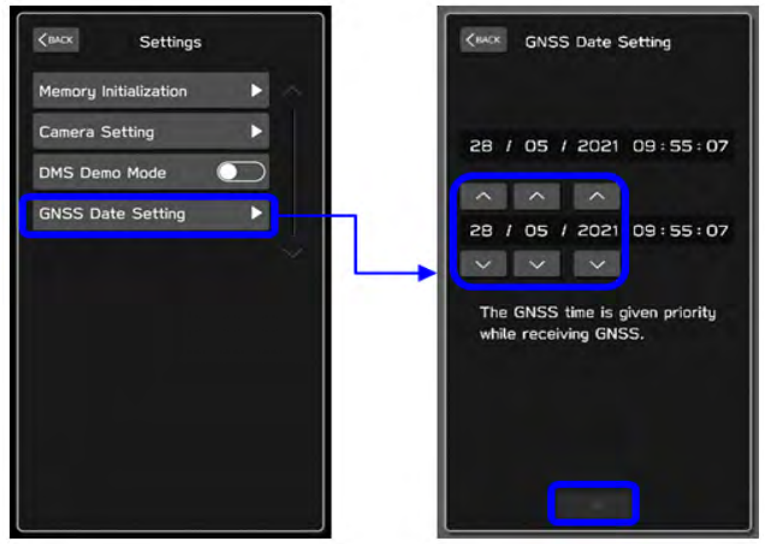
| Number | Symptoms to be Improved: |
|---|---|
| 38 | <p>When the clock was set to "AUTO," the date and time are shifted to a date approximately 20 years in the future due to anomalous values received from GPS or other reasons. If it occurs, the date and time cannot be corrected manually and have to be reset by disconnecting the battery terminal. As a countermeasure, a setting screen to manually adjust the clock display in the "AUTO" setting is to be added to the Dealership Mode (Dealership Mode-&gt;Settings-&gt;GNSS Data Setting).</p> |

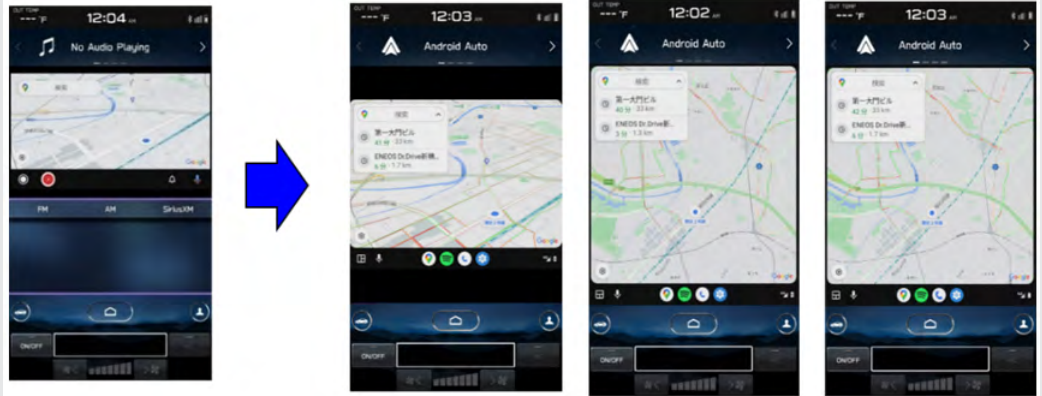
| Number | New Function or Enhancement: |
|---|---|
| 2 | <p>CCU Support vertical screen displays for Android Auto, but the actual display screen size differs depending on the Android device’s OS version.</p> |

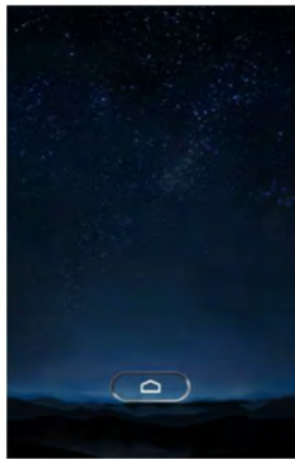
| Number | Symptoms to be Improved: |
|---|---|
| 4 | <p>Right after starting up, the CID is blank only displaying the background without icons.</p> |

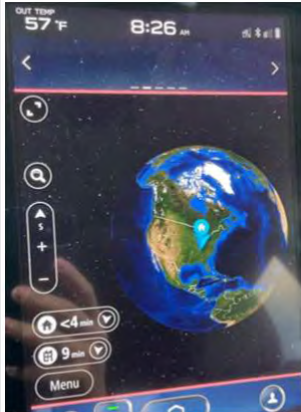
| Number | Symptoms to be Improved: |
|---|---|
| 14 | Navigation map scale is changed to the lowest setting (globe is displayed).<br> |

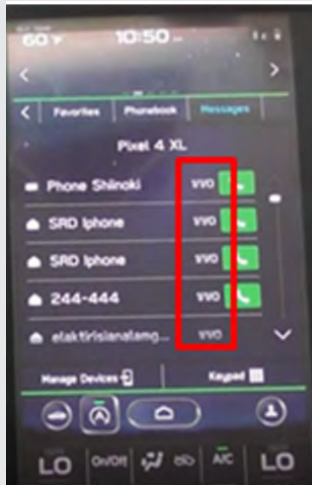
| Number | Symptoms to be Improved: |
|---|---|
| 16 | When selecting “Phone-”>”Message,” message received time is displayed incorrectly as “1/1/0.”<br>It can occur with an Android phone with a specific Android OS (Pixel 6, Pixel4a, Pixel4XL, Xperia etc. ) in which time zone data is attached to the message receiving time.<br> |

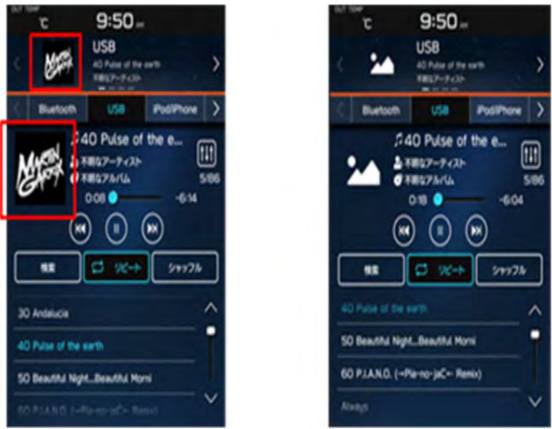
| Number | Symptoms to be Improved: |
|---|---|
| 18 | <p>Cover art of previous music is displayed when playing music without cover art in USB audio. It can occur when music with and without cover art is mixed and stored together a single USB.</p> |

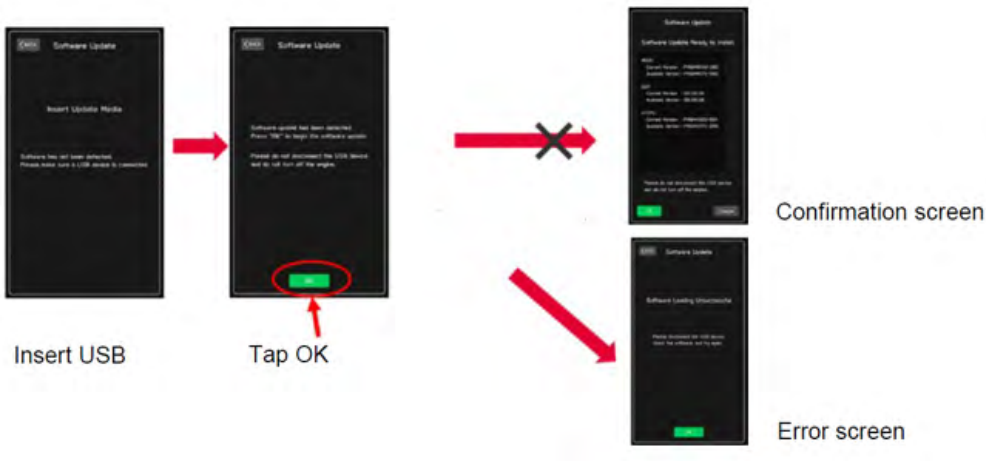
| Number | Symptoms to be Improved: |
|---|---|
| 12 | <p><b>When conducting USB reprogramming, the screen transition to error screen instead of confirmation screen.</b></p> <p>Insert USB</p> <p>Tap OK</p> <p>Confirmation screen</p> <p>Error screen</p> |

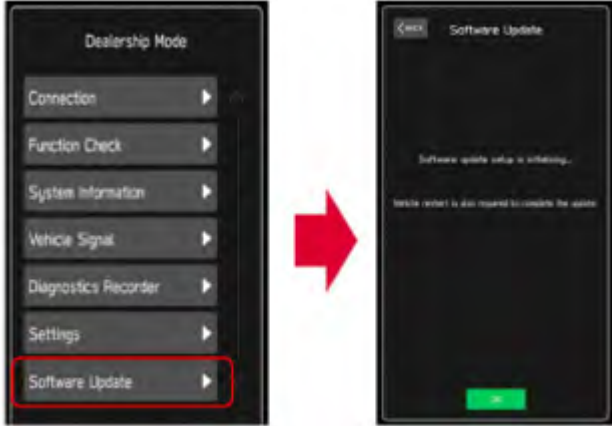
| Number | Symptoms to be Improved: |
|---|---|
| 13 | <p><b>When “Software Update” is selected in the Dealership Mode, the following initialization process does not end more than 20 minutes. *</b></p> <p>Note* In case this USB update failure occurs, retry updating according to the instructions in “Appendix A”</p> |

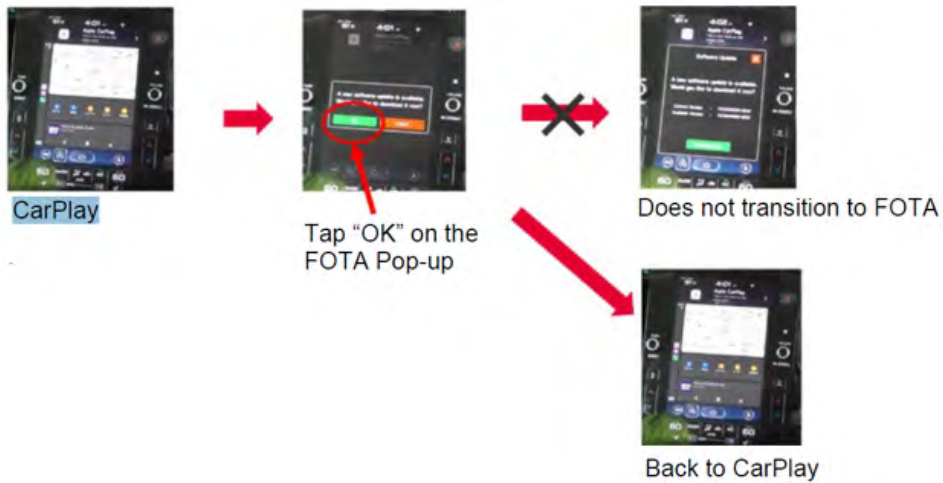
| Number | Symptoms to be Improved: |
|---|---|
| 14 | <p><b>When the FOTA pop-up (new software availability notification) is displayed while the CarPlay is being used, the display comes back to CarPlay screen even if the customer tries to get into the FOTA screen.</b></p> <p>CarPlay</p> <p>Tap “OK” on the FOTA Pop-up</p> <p>Does not transition to FOTA</p> <p>Back to CarPlay</p> |

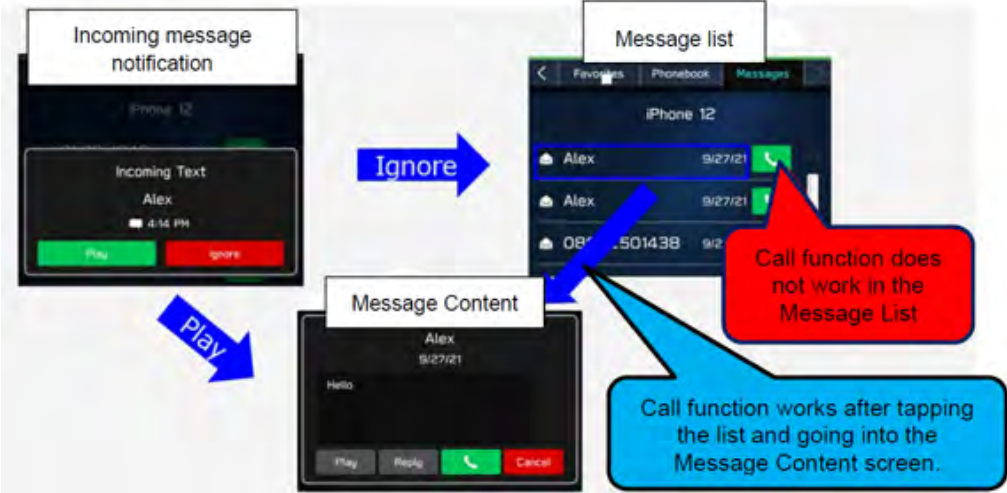
| Number | Symptoms to be Improved: |
|---|---|
| 15 | <p>Call function does not work in the Message List (after ignoring the incoming message notification.). However, the call function can still be used after getting into the Message Content screen by tapping the message list.</p> |

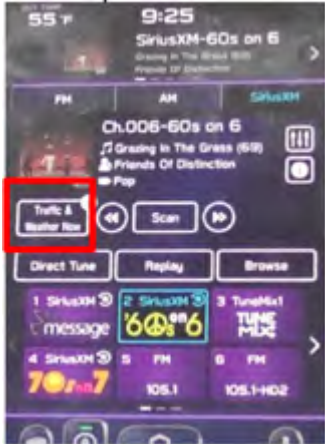
| Number | Symptoms to be Improved: |
|---|---|
| 25 | <p>No response when touching “Traffic &amp; Weather Now (TWN)” on SMX screen.</p> |

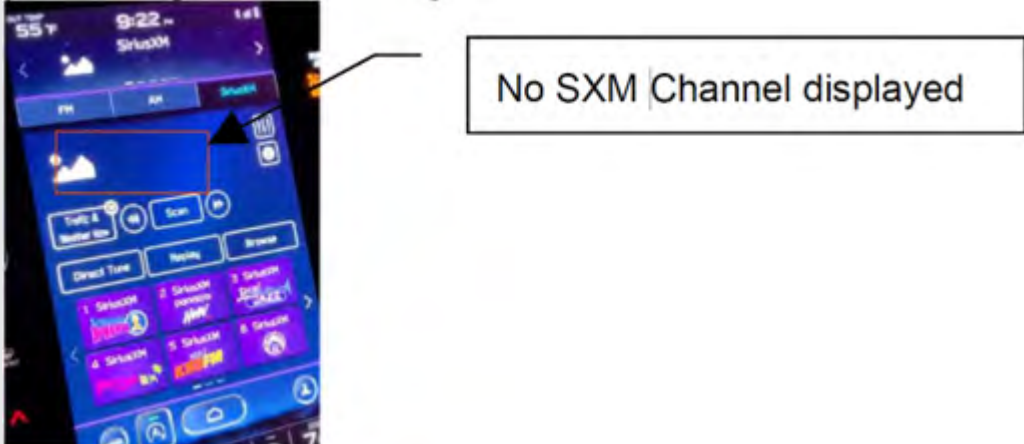
| Number | Symptoms to be Improved: |
|---|---|
| 26 | <p>SXM has blank screen and no sound when the SXM screen had been selected as audio source at the previous ignition off timing.</p> |

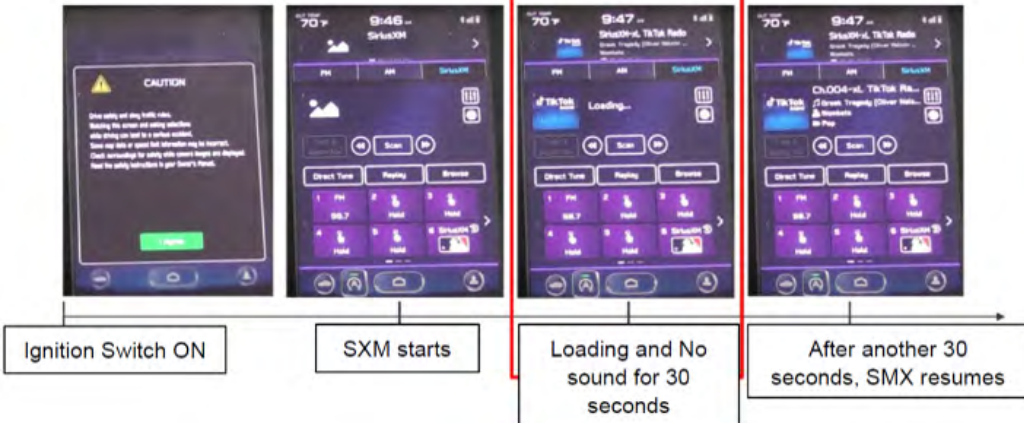
| Number | Symptoms to be Improved: |
|---|---|
| 27 | <p>About 30 seconds after starting the SXM the operation is paused with loading screen and resume after another 30 seconds. This symptom occurs when the SXM screen had been selected as audio source at the previous ignition off timing.</p> |

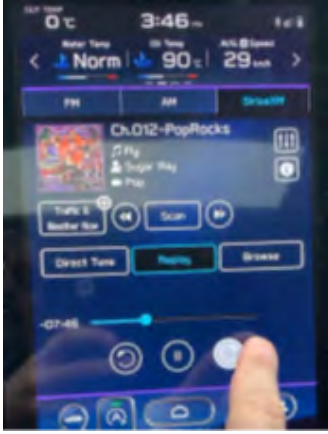
| Number | Symptoms to be Improved: |
|---|---|
| 29 | <p><b>“Fast forward” does not work in SXM replay function. (Fast Rewind works.)</b></p> |

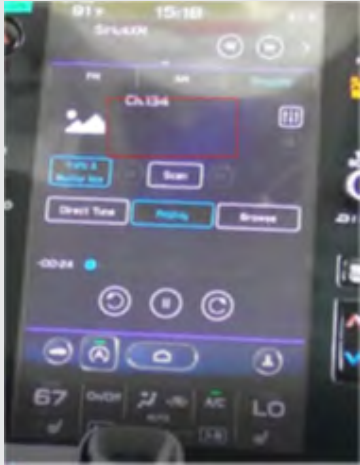
| Number | Symptoms to be Improved: |
|---|---|
| 30 | <p><b>The channel information becomes blank when the seek button (&lt;&lt; / &gt;&gt;) of the steering satellite switches is pressed continuously to control the Traffic &amp; Weather Now (TWN) in SXM.</b></p> |

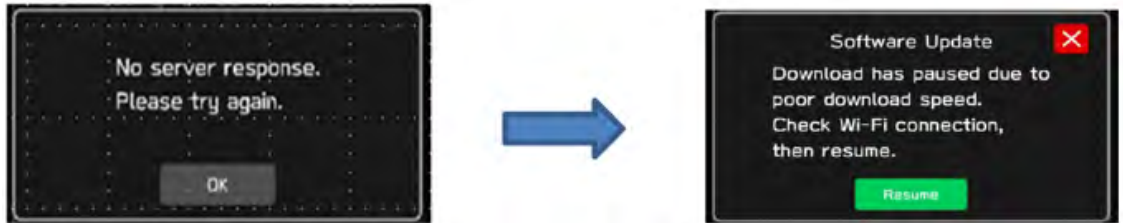
| Number | New Function or Enhancement: |
|---|---|
| 3 | <p>One of the Pop-up Error Messages displayed during the FOTA operation in case of weak Wi-Fi signal is not intuitive. Even if the customer tap “OK,” it does not transit to another screen.</p> <div style="text-align: center;"> </div> <p>As the improvement for this inconvenience, the message is changed so that the customer finds the reason why the FOTA operation has been paused. Also a “Resume” button is prepared so that the customer can do the rest of operations after necessary action (moving the vehicle to another place with better Wi-Fi connection**, or tethering the CP1 to a mobile phone, etc.)</p> <p><b>Note** The FOTA operation can be paused when the Wi-Fi indicator at the upper right corner of the CID is not in “Good” or “Excellent” as shown below.</b></p> <div style="text-align: center;"> </div> |

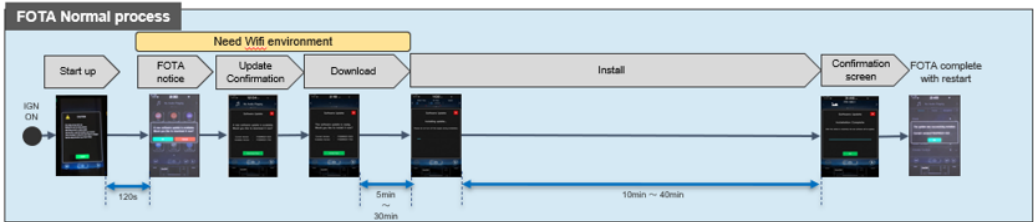
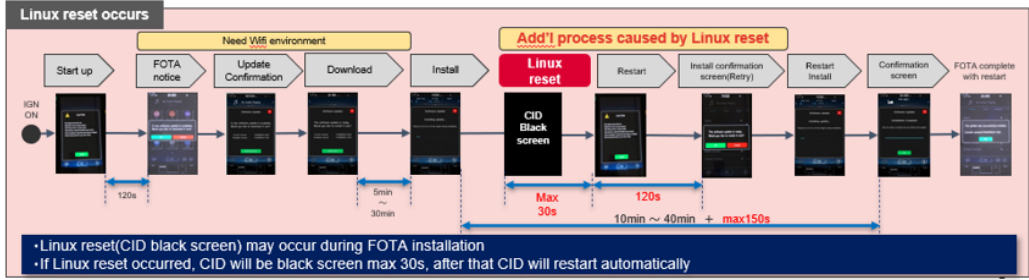
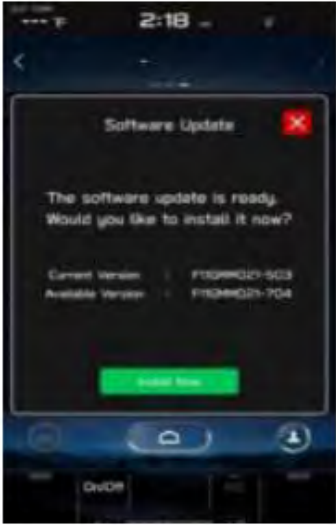
| Number | Symptoms to be Improved: |
|---|---|
| 1 | <p>System restarts itself during FOTA (Firmware Over The Air) update. FOTA operation is conducted in two processes: downloading (from the server to the Cockpit Control Unit via Wi-Fi) and installation (inside the Cockpit Control Unit). During the FOTA operation, after the new software has been downloaded to the Cockpit Control Unit (CCU) customer is to push “Install Now” on the Center Information Display (CID) to start installation of the software.</p> <p><b>FOTA Normal process</b></p> <p><b>However, in rare case, the CCU restarts itself* during installation.</b></p> <p><b>Linux reset occurs</b></p> <p><b>Note*</b> Even if this symptom occurs, after approximately 2 minutes, the system resumes, and the CID comes back to the below screen. Customer can then push the “Install Now” to proceed with the installation.</p> |
