SERVICE BULLETIN

APPLICABILITY: 2022-25MY BRZ Models **NUMBER:** 15-297-22R
SUBJECT: Reprogramming File Availability for Optimization of Gen 4 Denso CP1 Infotainment Systems **DATE:** 07/01/22
REVISED: 01/13/25

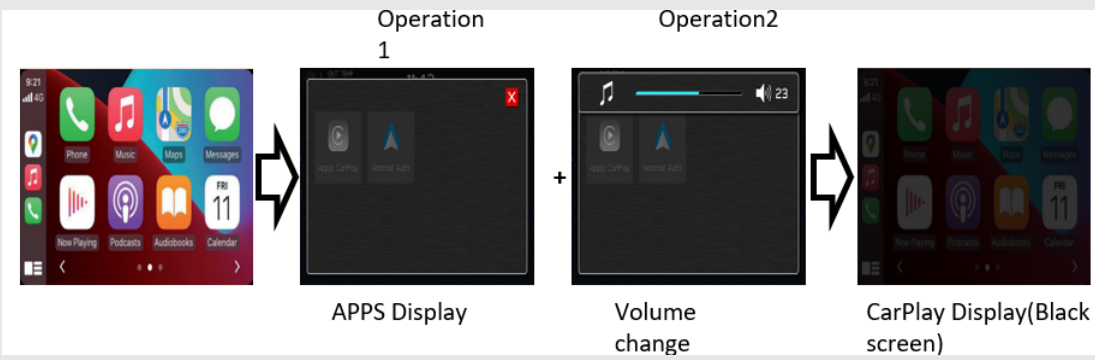
Category	Symptom
Black screen	While welcome animation on CID is displayed and the driver's door is left open, if turning ignition OFF/ON, the CID screen will be black screen.
	After starting the engine, the loading animation remains and the screen does not transition.
Display	Repeated and consecutive operation of voice recognition activation, CarPlay activation, and the HOME button operation may cause the CarPlay screen to be black screen for several seconds.
	<p>After performing operations 1 and 2 below from the CarPlay screen, returning to the CarPlay screen may cause the CarPlay screen to be black screen.</p> <p>Operation 1: Switching to a pop-up screen such as the air conditioner screen</p> <p>Operation 2: Interrupt pop-up screen display by volume operation, etc.</p> <div style="text-align: center;">

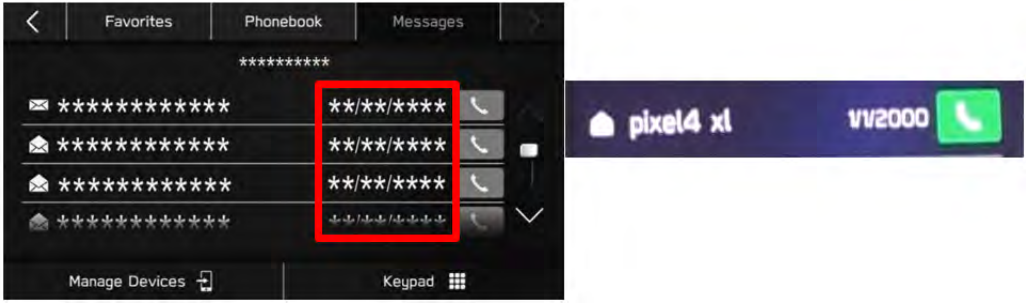
Category	Symptom
Display (cont.)	<p>The date of receipt of a received message is displayed as 2000/1/1. This occurs on some models of phones with Android OS 13 or later.</p>

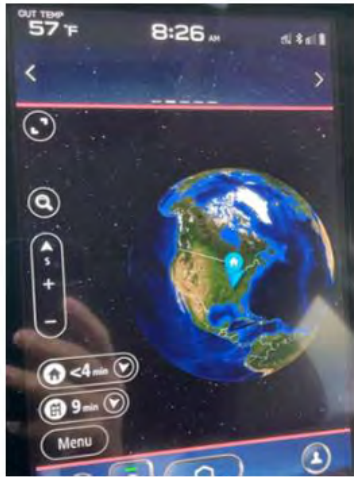
12	<p>Navigation map scale is changed to the lowest setting (globe is displayed).</p>

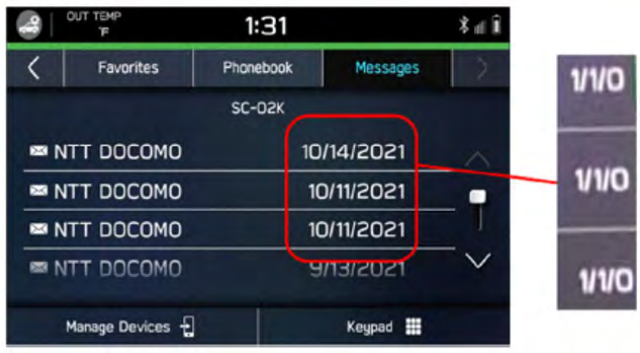
Number	Symptoms to be Improved:
<p>14</p>	<p>When selecting “Phone->”Message,” message received time is displayed incorrectly as “1/1/0.”</p> <p>It can occur with an Android phone with a specific Android OS (Pixel 6, Pixel4a, Pixel4XL, Xperia etc.) in which time zone data is attached to the message receiving time.</p>

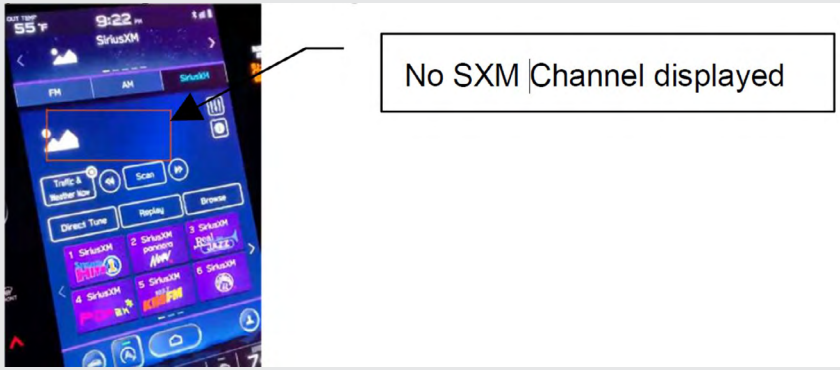
Number	Symptoms to be Improved:
26	<p>SXM has blank screen and no sound when the SXM screen had been selected as audio source at the previous ignition off timing.</p>

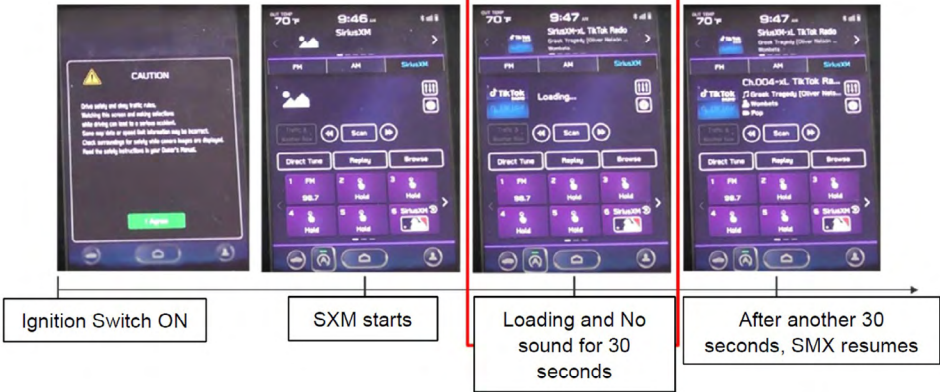
27	<p>About 30 seconds after starting the SXM the operation is paused with loading screen and resume after another 30 seconds. This symptom occurs when the SXM screen had been selected as audio source at the previous ignition off timing.</p>

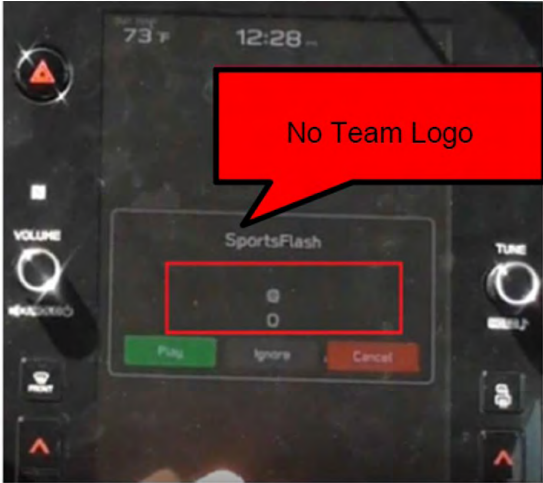
31	<p>The team logo is not displayed on Sports Flash screen when the SXM screen had been selected as audio source at the previous ignition off timing.</p>
