PROTERRA

TECHNICAL SERVICE BULLETIN

ISSUE DATE:	6-15-2021
SERVICE BULLETIN SUBJECT:	800 Volt ZX5 Horn Relay Retrofit
VINs or MODELS AFFECTED:	Service Specified Buses
COMPLETE BY:	Next Service Opportunity
SERVICE BULLETIN #:	SC-21-87
LABOR OPERATION CODE:	DE43Z

800 VOLT ZX5 HORN RELAY RETROFIT

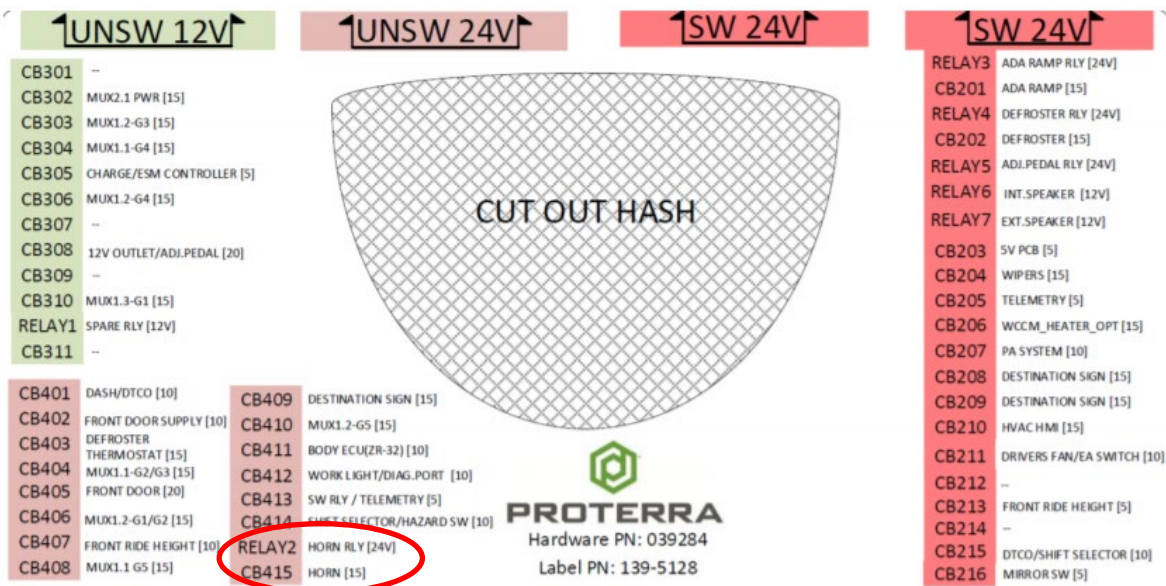
This procedure updates the horn relay and circuit breaker to more robust versions.

3. Remove the VEC cover.
4. Using the new VEC Label as a guide, locate RELAY2 and CB415. These locations are shown circled in red in the following illustration.
5. Using the Yellow Tool provided inside the VEC, replace RELAY2 (**128-2640**) and CB415 (**013529**) with the new ones from the kit.
6. Remove the installed Label from the VEC.
