SERVICE BULLETIN

NUMBER: 11-205-25

DATE: 01/16/25

SUBJECT: DTC P1449 EVAP System Clog Detected / Repair Procedure

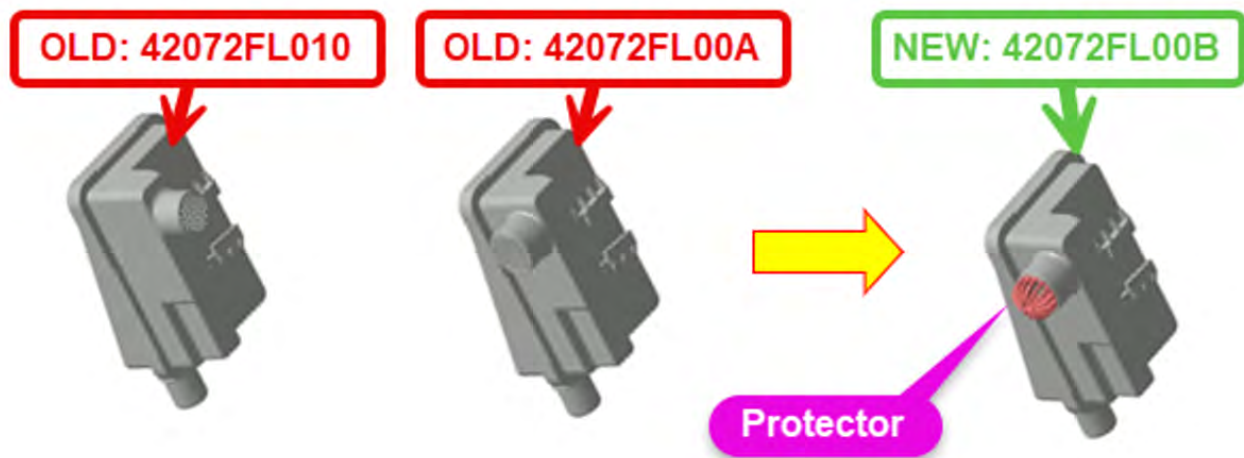
DRAIN FILTER / DESCRIPTION OF DESIGN CHANGE:

This bulletin announces the repair procedures to be followed when DTC P1449 (EVAP System Clog Detected) is detected by the Engine Control Module (ECM). New drain filter assemblies have been developed with an added protector to prevent debris build up. For some models, reprogramming and an additional mud guard will require replacement along with the drain filter. If DTC P1449 is found to be detected by the ECM, follow the service procedure outlined in this bulletin.

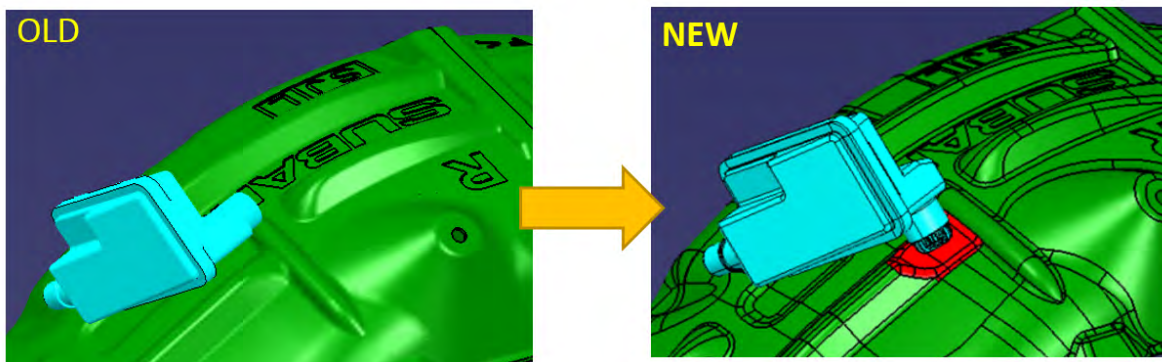
FORESTER

IMPORTANT: Mud guard replacement is **ONLY** required on Forester and WRX models.

STEP 1: Replace the drain filter and right rear mud guard as per the applicable Service Manual. Refer to STIS: Engine > EMISSIONCONTROL (AUX. EMISSION CONTRL DEVICES) > Drain Filter
