SERVICE BULLETIN

APPLICABILITY: 2020-24MY Legacy and Outback
2019-24MY Ascent

NUMBER: 07-189-21R

SUBJECT: Door Window Regulator- Erratic Operation

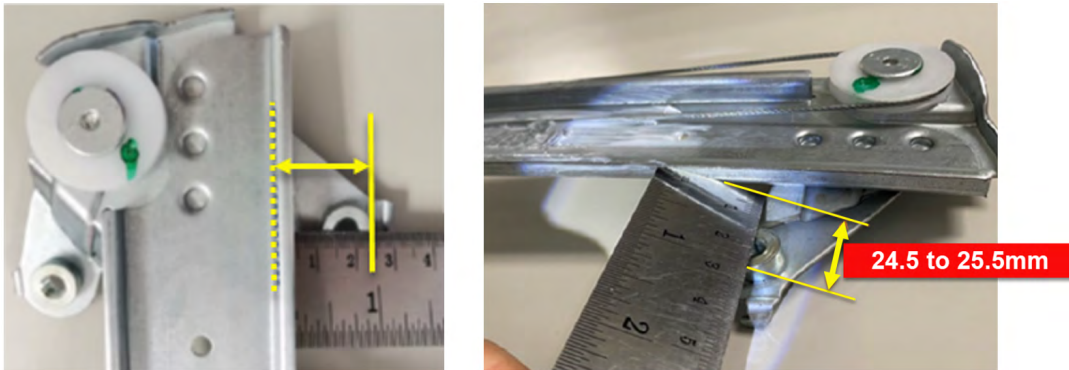
STEP 2: Measure the regulator upper roller frame to confirm the regulator was correctly assembled. If the measured distance between the outside of the rail guide (see dashed line below) and the outer side of the mounting nut is not within **24.5 to 25.5mm**, the regulator will require replacement. A 30mm wide ruler is recommended.

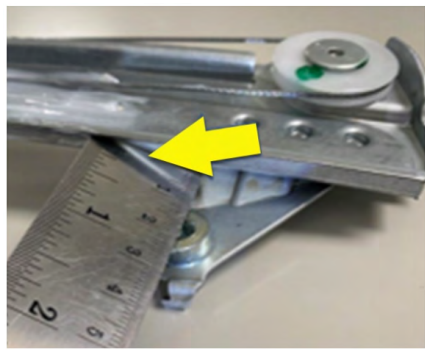
IMPORTANT NOTE: ALWAYS confirm there is no gap between ruler and the frame.

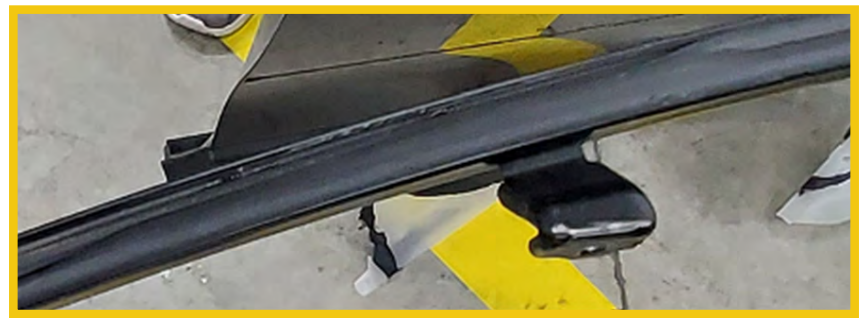
STEP 3: When inspection determines window regulator replacement is required, the door glass run channel seal will also require replacement. See the example photo below of the door glass run channel seal.

The service procedures for window regulator assembly and door glass run channel replacement remain unchanged. Always refer to STIS and review the full requirements of the repair being performed. The Service Manual procedures contain information critical to performing an effective repair the first time, every time. This includes but is not limited to important SAFETY precautions, proper inspection criteria, necessary special tools, required processes and related one-time-use parts needed for a complete and lasting repair.
