SERVICE PROGRAM BULLETIN

APPLICABILITY: 2025 MY Legacy
2025 MY Outback (Including Wilderness)

NUMBER: WRC-24

SUBJECT: Cockpit Control Unit Software Update

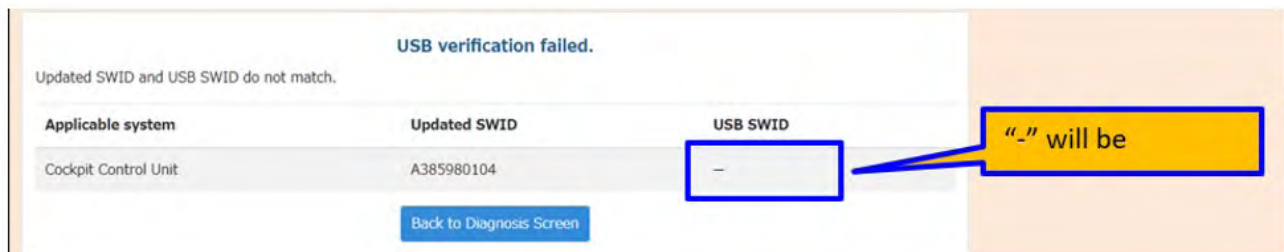
IMPORTANT NOTE: In rare cases when the CCU does not complete the USB authentication check in time resulting in the message box below.

The recovery steps are outlined below.

- Perform a soft reset of the CP1 by holding down the CID volume knob.
- Once the CP1 has restarted, retry step ii on the previous page and then press the “Start Reprogramming” button.
- If the same failure is encountered again, please proceed with the diagnostic of failure by checking the USB drive data integrity.

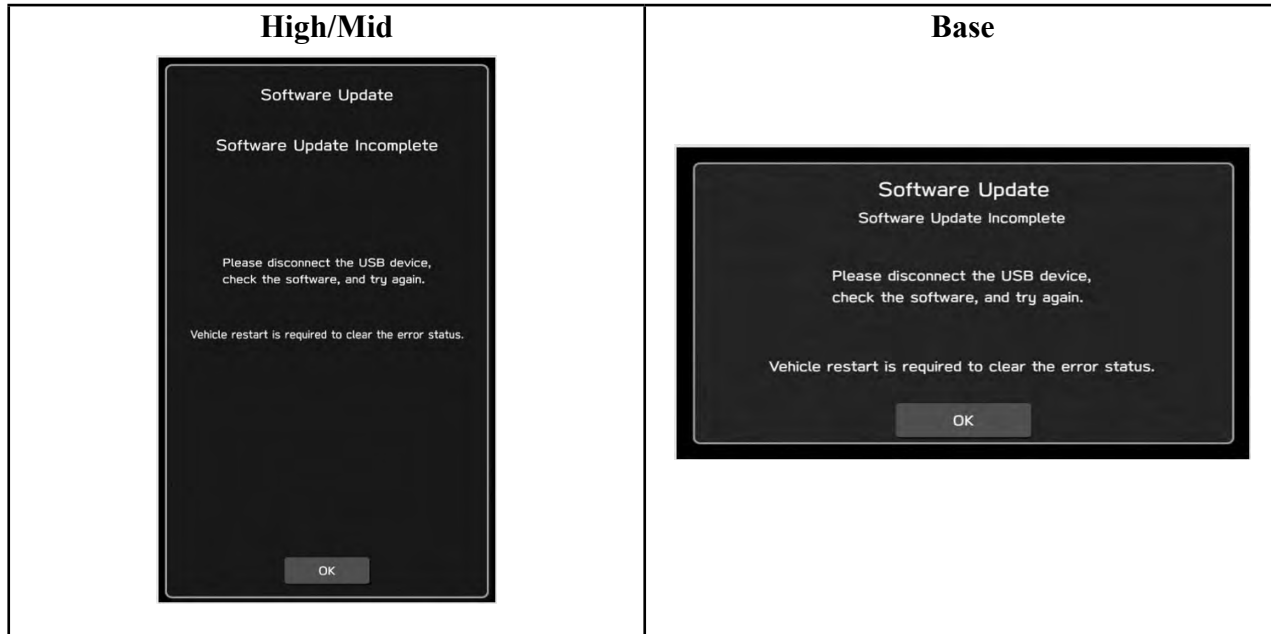
- If the first attempt of update fails with the message below, follow the steps described below 1-2 to 1-8 before retrying the software update.

1-1. Select OK in the screen below
