## SERVICE BULLETIN

**NUMBER:** 15-305-22R

**DATE:** 11/15/22

**SUBJECT:** Reprogramming File Availability for Optimization of Gen 4.5 Denso CP1.5 Infotainment Systems

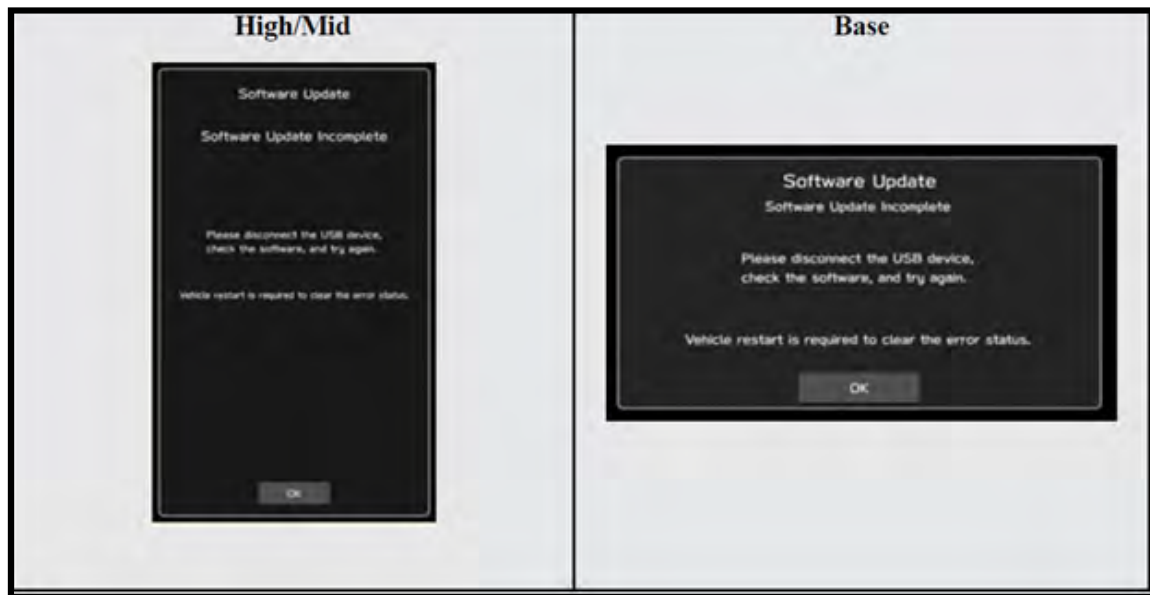
If you get the message **Software Update Incomplete** as shown below, please don't replace the hardware but retry updating the software according to the instructions in [Appendix 6 \(page 29\)](#).

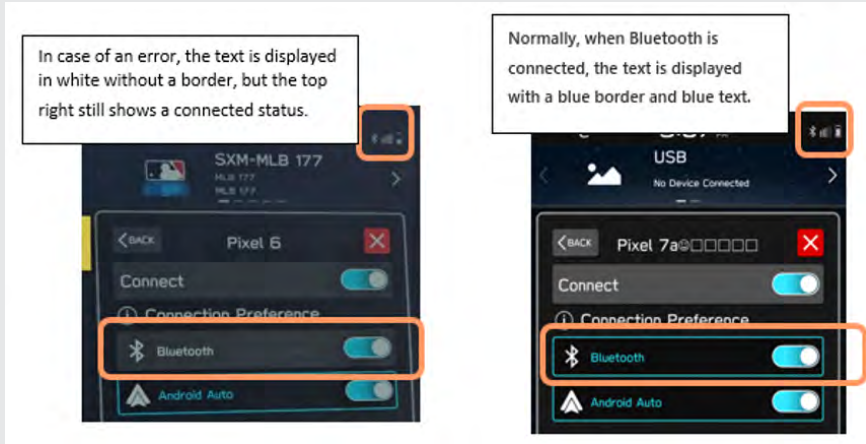
| Number | Category | Symptoms to be Improved: |
|---|---|---|
| 4 | Bluetooth | <p>1. Toggling the CarPlay ON/OFF switch multiple times on the Manage Devices screen while the iPhone is connected via USB, may result in a ""Bluetooth connection unavailable"" state. It is the same as a ""CarPlay connection unavailable"" state. Bluetooth icon in the top right corner of the CID screen may still indicate a connected state.</p> <p>2. When multiple Android Devices attempt to connect during ignition on, it may result in a "Bluetooth connection unavailable" state. It is the same as a "wireless Android Auto connection unavailable" state. Bluetooth icon in the top right corner of the CID screen may still indicate a connected state.</p> <p>Bluetooth connection may not be available and the pairing Delete may not work.<br/>(only applicable to HIGH and MID trim)</p> |

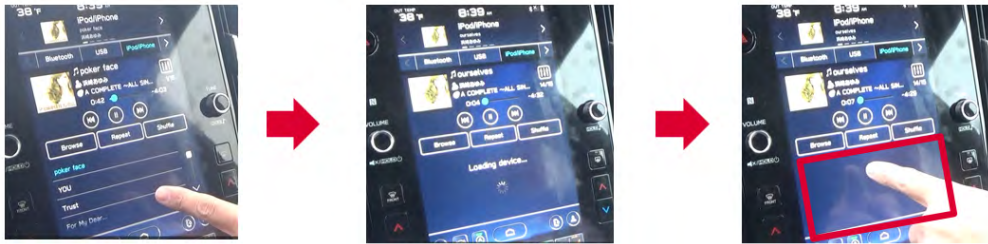
| Number | Category | Symptoms to be Improved: |
|---|---|---|
| 5 | Audio | <p>(1) After ignition on, the audio may not return to the audio that was playing at the previously played audio.</p> <p>(2) Audio sound may not sound immediately after ignition on.</p> <p>On iPhone audio with iOS 16.4 or later the song list disappears when a song in the playing playlist is selected.<br/>(only applicable to HIGH and MID trim)</p> <p>After ignition on it may take approximately 16 seconds for iPod audio audio to play.<br/>(only applicable to HIGH and MID trim)</p> |

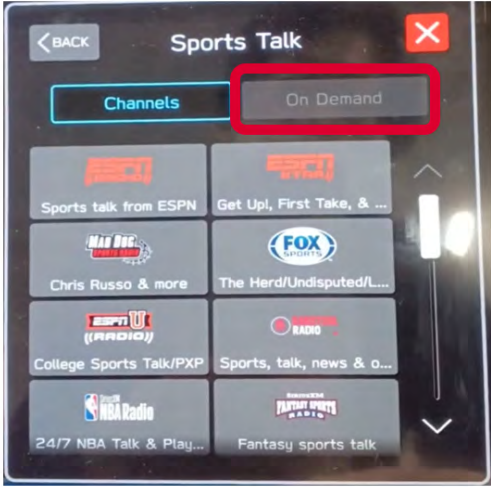
| Number | Category | Symptoms to be Improved: |
|---|---|---|
| 7 | SXM | <p>In the SXM screen, the On Demand button in the upper right corner is grayed out and cannot be operated in the Sports→ Sports Talk screen.<br/>(only applicable to HIGH and MID trim)</p> |

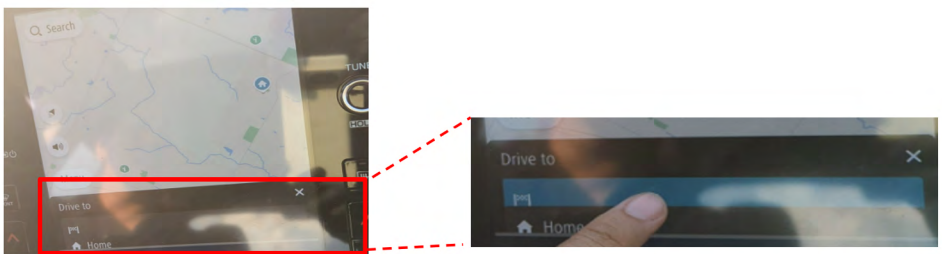
| Number | Category | Symptoms to be Improved: |
|---|---|---|
| | | <p>Three destination suggestion displays in the navigation system are sometimes displayed overlapping each other. Originally, up to three destination suggestions are displayed at the bottom of the screen when the navigation system is started.<br/>(only applicable to HIGH trim)</p> |

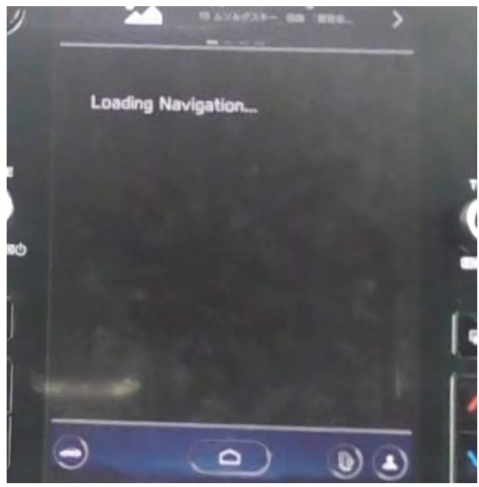
| Number | Category | Symptoms to be Improved: |
|---|---|---|
| 8 | Navi | <p>When turning ignition off and on while the Map screen is displayed, the message ""Loading Navigation..." may remain on the screen, and the Map screen may not be displayed.<br/>(only applicable to HIGH trim)</p> |

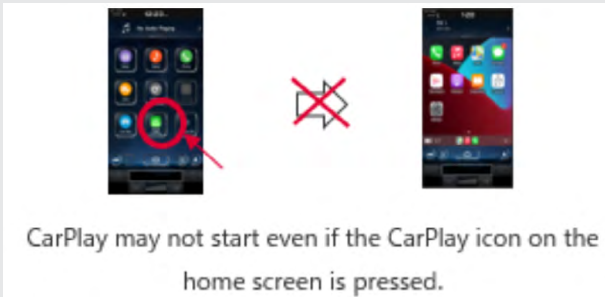
| Number | Category | Symptoms to be Improved: |
|---|---|---|
| | | <p>CarPlay may not start even if the CarPlay icon on the home screen is pressed.</p> |

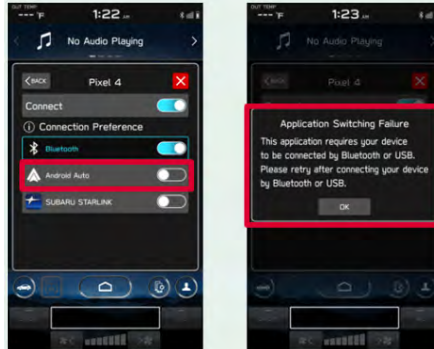
| Number | Category | Symptoms to be Improved: |
|---|---|---|
| | | <p>- When you toggle on Android Auto from the Manage Device screen in CID while the Android device is not connected via USB, there may be a failure to start Wireless Android Auto (not applicable to BASE trim)</p> |

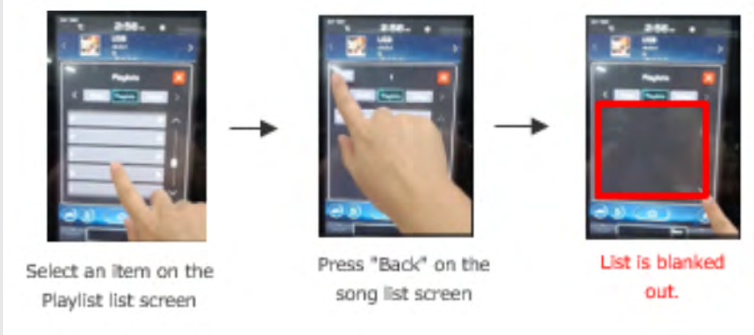
| Number | Category | Symptoms to be Improved: |
|---|---|---|
| 6 | Audio | <p>- When returning to the Playlist List screen by pressing "Back" after selecting a Playlist on page 4 or later in the Playlist List screen, the Playlist List is displayed blank.</p> <p>Select an item on the Playlist list screen → Press "Back" on the song list screen → List is blanked out.</p> |

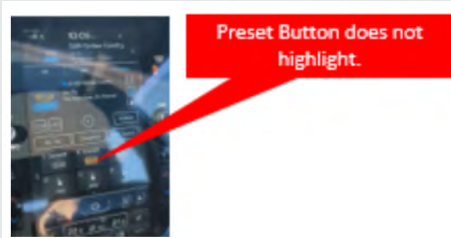
| Number | Category | Symptoms to be Improved: |
|---|---|---|
| 8 | Radio | <p>- When pressing a preset button for a registered radio channel, you can play the channel. But the button you pressed does not highlight, and you cannot operate through presets using the steering wheel controls (not applicable to WRX)</p> <p>- While listening to the radio, the audio suddenly cuts out (not applicable to WRX)</p> <p>- FM / AM radio is not available after turning ignition on</p> <p>- After pressing the radio icon from the HOME screen, FM radio may not have sound</p> <p>- The radio presets are all blank</p> |

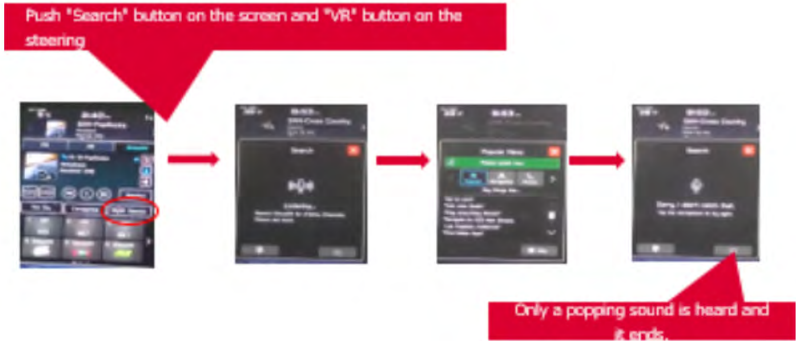
| Number | Category | Symptoms to be Improved: |
|---|---|---|
| | | <p>- The voice recognition function encounters an error and ends, when initiating the SXM Search feature simultaneously with the activation of the CCU unit's voice recognition</p> |

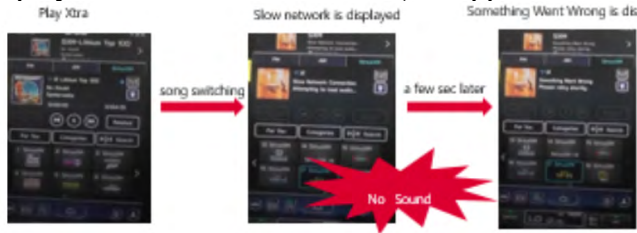
| Number | Category | Symptoms to be Improved: |
|---|---|---|
| 9 | SXM | <p>- SXM sound stops sounding after conditions listed below:</p> <ol style="list-style-type: none"> <li>1. Register FM station A, an SXM sports channel that is not in the middle of a game, and FM station B in the order in which they are listed in the radio presets.</li> <li>2. Use the steering wheel switch to switch from FM station A to FM station B, skipping the SXM sports channel that is not in the middle of a game.</li> <li>3. Just before the playback of FM station B starts, operate the steering switch seek to return to the previous channel.</li> </ol> <p>- While playing SXM's Xtra channel, "Slow Network" --&gt; "Something Went Wrong" is displayed and no sound is heard (not applicable to BASE trim)</p> <p>- When the preset channel on the SXM is pressed, a different channel is selected instead of the registered channel</p> |

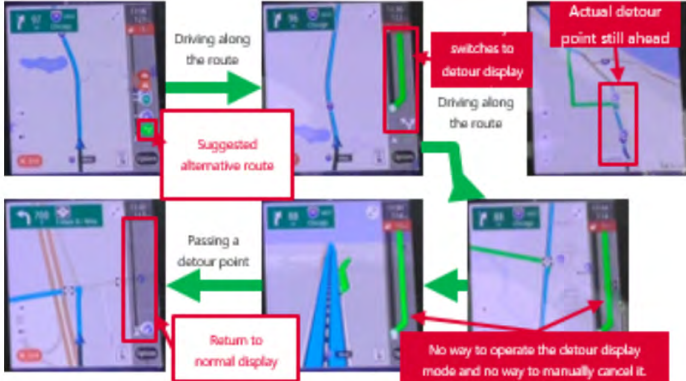
| Number | Category | Symptoms to be Improved: |
|---|---|---|
| 13 | Navi Operation | <p>- While a detour route is suggested by NAVI system if a faster detour is found before reaching the suggested alternate point, the route bar switches to the detour display mode a few miles before the actual detour point causing an error. This detour display mode continues and the route bar becomes inoperative until passing the detour point (only applicable to HIGH trim).</p> |

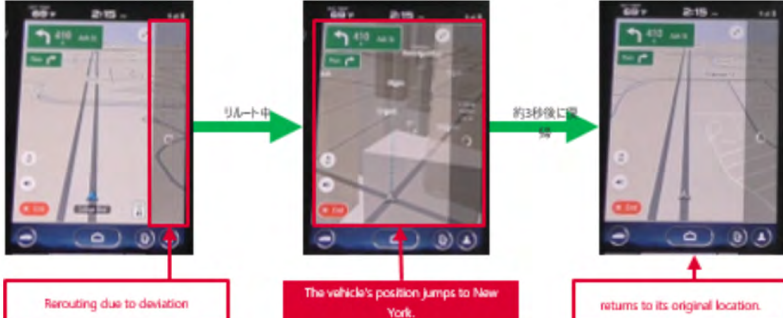
| Number | Category | Symptoms to be Improved: |
|---|---|---|
| | | <p>- During long-distance route navigation, if you deviate from the planned route and a rerouting occurs, there is a sudden jump in your vehicle's position to New York (the default location) while the rerouting is in progress. After approximately 3 seconds, your position returns to its original location (only applicable to HIGH trim)</p> |

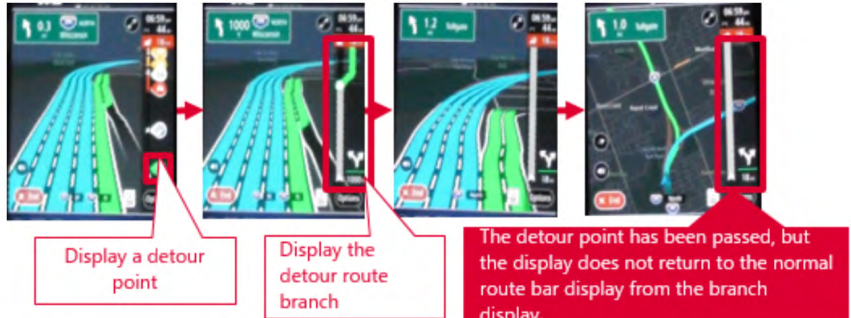
| Number | Category | Symptoms to be Improved: |
|---|---|---|
| | | <p>- After passing through a detour point, the route bar does not return to the normal route bar from the detour route branch display on the map (only applicable to HIGH trim)</p> |

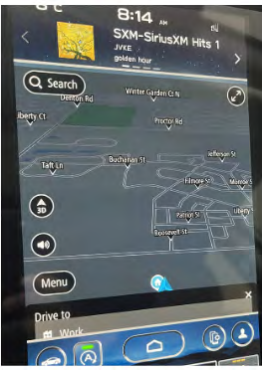
| Number | Category | Symptoms to be Improved: |
|---|---|---|
| | | <p>- In the navigation screen, the bottom of the destination suggestion list's popup screen is cut off and not fully displayed (only applicable to HIGH trim)</p> |

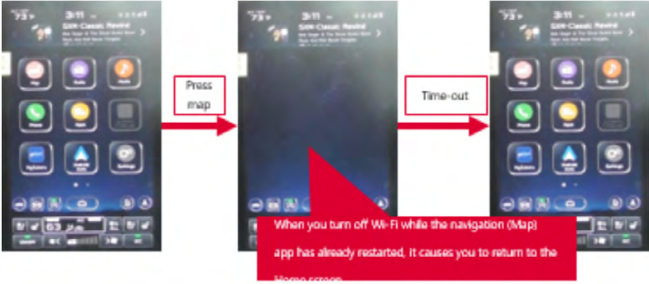
| Number | Category | Symptoms to be Improved: |
|---|---|---|
| 13 | Navi<br>Operation | <p>- During map data updates, if you switch off the Wi-Fi function from the Settings screen pressing the Map icon on the Home screen doesn't display the Map screen for a while (only applicable to HIGH trim)</p> <p>When you turn off Wi-Fi while the navigation (Map) app has already restarted, it causes you to return to the Home screen.</p> |

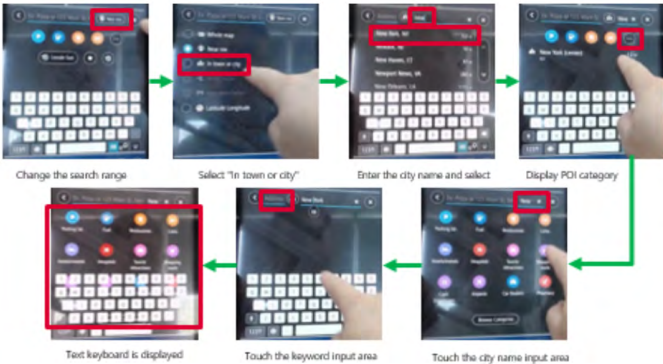
| Number | Category | Symptoms to be Improved: |
|---|---|---|
| | | <p>- The text keyboard which should not be displayed appears on top of the list of POI categories (only applicable to HIGH trim) when performing the steps below:</p> <ol style="list-style-type: none"> <li>1. Narrowing down the search range within a specific city in the navigation destination search.</li> <li>2. Move to the POI category screen.</li> <li>3. Touch the city name input area, then the keyword input area, in that order.</li> </ol> |

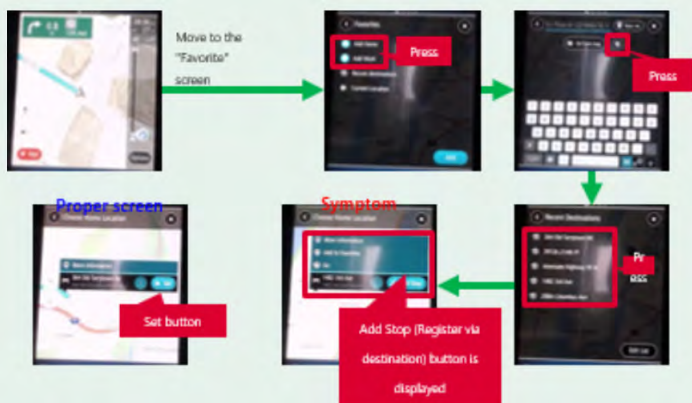
| Number | Category | Symptoms to be Improved: |
|---|---|---|
| | | <p>- Add Stop (Register via destination) button is displayed instead of Set button and Favoirte registration for Home/Work cannot be done after performig the steps below moving to the ""Favorite"" screen with the navigation destination set (only applicable to HIGH trim) :</p> <ol style="list-style-type: none"> <li>1. Press Add Home/Work</li> <li>2. Select a location from the Destination History screen</li> </ol> |

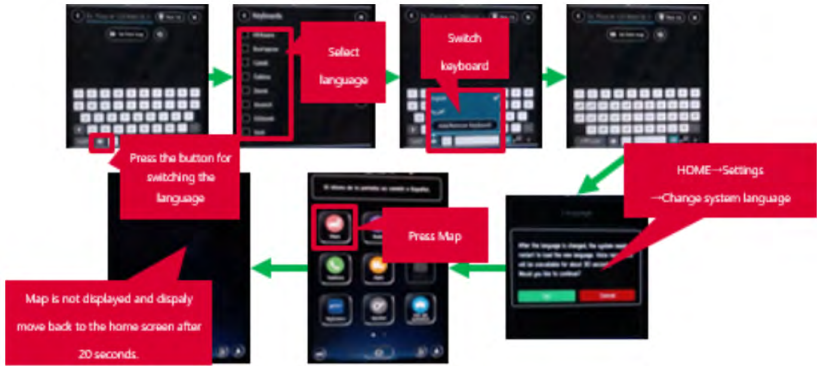
| Number | Category | Symptoms to be Improved: |
|---|---|---|
| | | <p>- Map is not displayed when Map is pressed from the home screen if switch-<br/>ing the language used for the text input keyboard on the search screen of the<br/>navigation application (only applicable to HIGH trim)</p> |

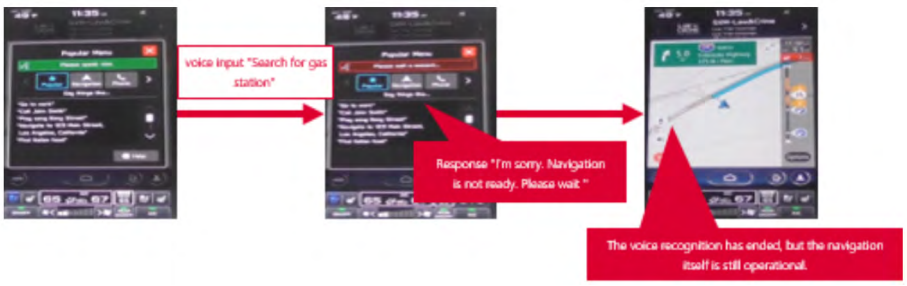
| Number | Category | Symptoms to be Improved: |
|---|---|---|
| | | <p>- When searching for navigation POIs using voice recognition, the response is "Navigation is not ready" and POI search may not start (only applicable to HIGH trim)</p> |

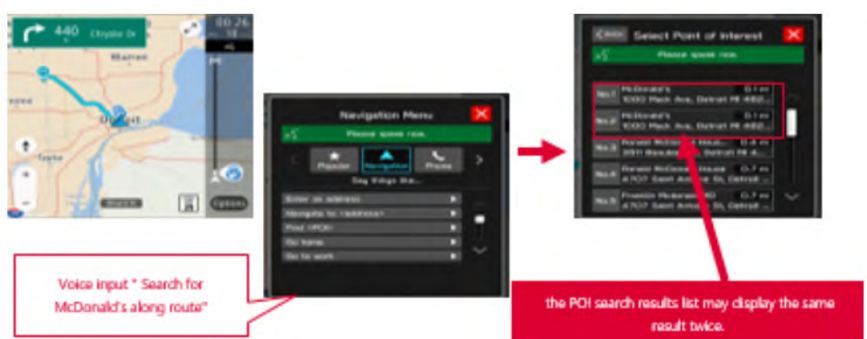
| Number | Category | Symptoms to be Improved: |
|---|---|---|
| 13 | Navi Operation | <p>- When using voice recognition during navigation to say 'Search for **** along route,' the POI search results list may display the same result twice (only applicable to HIGH trim)</p> <p>Voice input * Search for McDonald's along route</p> <p>the POI search results list may display the same result twice.</p> |

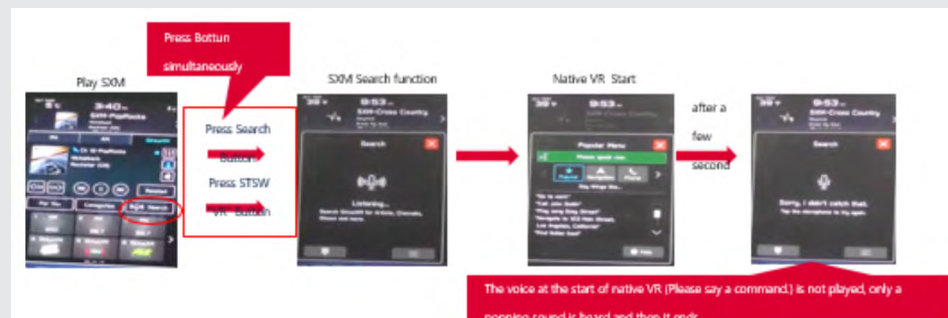
| Number | Category | Symptoms to be Improved: |
|---|---|---|
| 16 | Voice Recognition | <p>- After setting a route in the navigation system and activating voice recognition function, the route guidance is not canceled even "Cancel Route" or "Delete Destination" is completed (only applicable to HIGH trim)</p> <p>- When you say ""Call *****" using voice recognition, the meter display shows "Please wait a moment," but the call cannot be made (not applicable to WRX)<br/>(Note: ""*****" indicates an actual phone number or contact name you are trying to call)</p> <p>- Starting the CCU (Cockpit Control Unit) voice recognition while using the SXM Voice Search function results in an error and ends the voice recognition (not applicable to BASE trim)</p> <p>Press Bottom simultaneously</p> <p>Press Search</p> <p>Press STSW</p> <p>Press Bottom</p> <p>Native VR Start</p> <p>after a few seconds</p> <p>The voice at the start of native VR (Please say a command) is not played, only a popping sound is heard and then it ends.</p> <p>- When operating the navigation system via voice recognition, certain regional place names (states, cities, etc.) are not recognized (only applicable to HIGH trim)</p> |

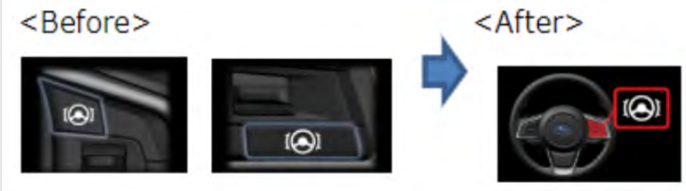
| Number | Category | Symptoms to be Improved: |
|---|---|---|
| 22 | Meter Display | <p>- Change the image of steering switch in the meter interrupt screen from individual zoomed images to an image of the entire steering wheel and the symbol (not applicable to WRX)</p> <p>Previously: different switch images were used depending on the model line and equipment grade.</p> <p>After: a common image is used regardless of the model or the grade.</p> |

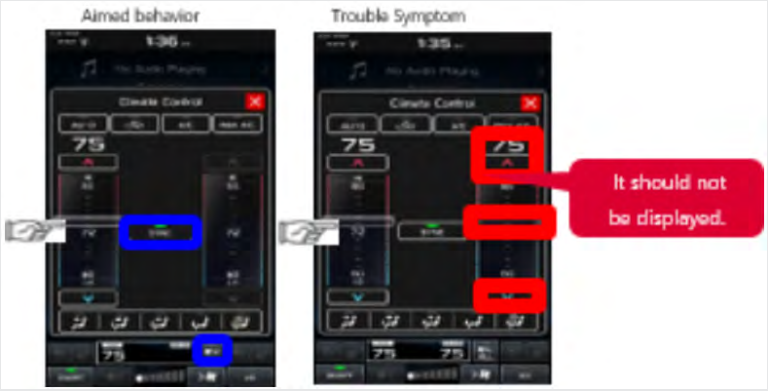
| Number | Category | Symptoms to be Improved: |
|---|---|---|
| 24 | Air Conditioner | <p>- With the air conditioning SYNC enabled and the single-seat focus set to the driver's seat tapping the temperature adjustment bar on the driver's side unexpectedly displays the temperature adjustment bar for the passenger's side, which should not be displayed (only applicable to BASE trim)</p> |

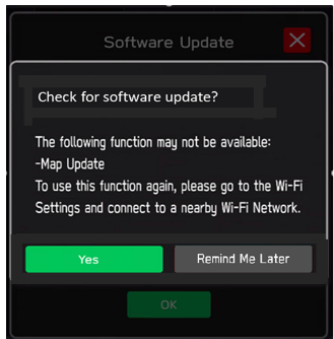
| Number | Category | Symptoms to be Improved: |
|---|---|---|
| 26 | Software Update | <p>- To use FOTA (Firmware update Over The Air) for CCU software update via DCM (Data Communication Module) it is necessary to switch from the Wi-Fi communication settings for MapUpdate to the DCM communication settings. To notify the customer about this switching, the below message screen pops up a new CCU software becomes available from the server. (not applicable to BASE trim)</p> <p>The image shows a 'Software Update' dialog box with a red close button in the top right corner. The main text asks 'Check for software update?'. Below this, it states 'The following function may not be available: -Map Update' and 'To use this function again, please go to the Wi-Fi Settings and connect to a nearby Wi-Fi Network.' At the bottom, there are two buttons: a green 'Yes' button and a grey 'Remind Me Later' button. An 'OK' button is also visible at the very bottom.</p> |

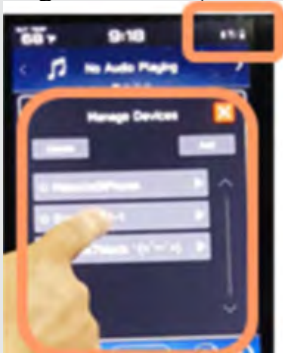
| Number | Symptoms to be Improved: |
|---|---|
| 7 | <p>Bluetooth connection is disabled with a discrepancy in the display of status bar (showing Bluetooth devices being connected) and the “Manage Devices” screen (showing no Bluetooth devices being connected.)</p> |

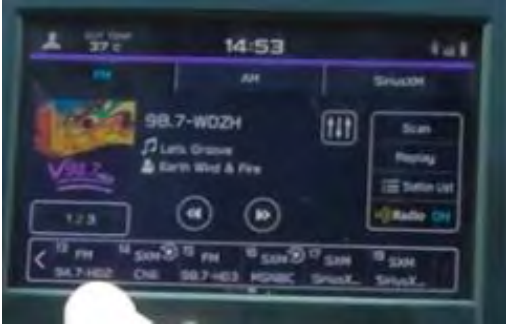
| Number | Symptoms to be Improved: |
|---|---|
| 12 | Sound is lost when changed to Subchannel 2 right after a preset HD radio channel has been selected.<br> |

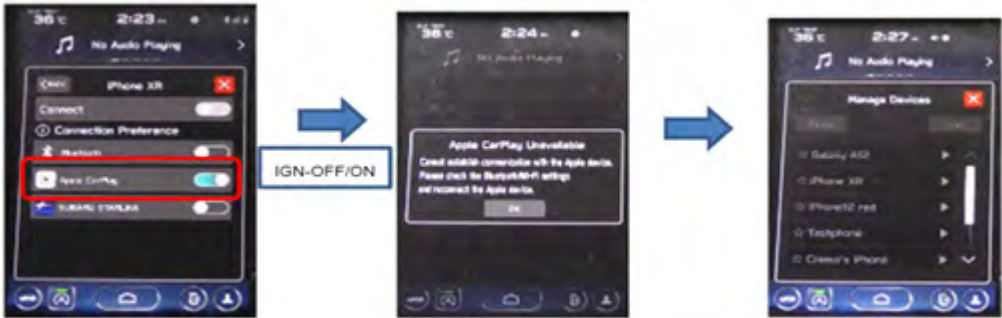
| Number | Symptoms to be Improved: |
|---|---|
| 7 | <p>Manage Device Screen becomes dark and inoperative when Ignition Switch is turned Off and On while starting CarPlay by CID operation.</p> |

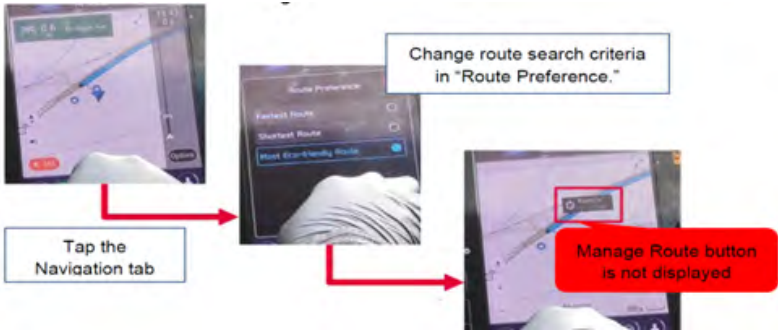
| Number | Symptoms to be Improved: |
|---|---|
| 11 | <p>“Manage Route” button is not displayed when touching the route line on Navigation system, when the route search criteria got changed in the Route Preference Screen after a route had been searched.</p> <p>Tap the Navigation tab</p> <p>Change route search criteria in "Route Preference."</p> <p>Manage Route button is not displayed</p> |

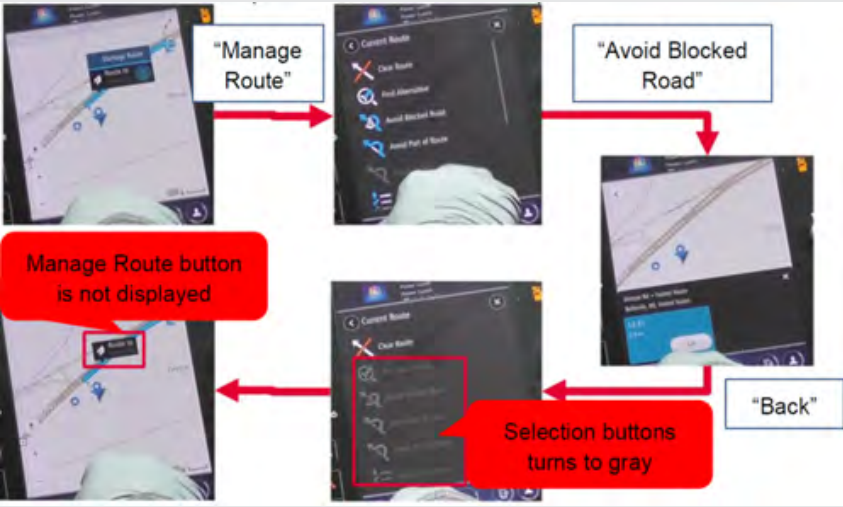
| Number | Symptoms to be Improved: |
|---|---|
| 12 | <p>“Manage Route” button is not displayed and buttons on the Current Route Screen become unselectable (turns to grayish fill) when the Navigation system is operated in the sequence of “Manage Route” &gt; “Avoid Blocked Road” (in the Current Route Screen) &gt; “Back.”</p> <p>"Manage Route"</p> <p>Manage Route button is not displayed</p> <p>"Avoid Blocked Road"</p> <p>"Back"</p> <p>Selection buttons turns to gray</p> |
