## PRODUCT CAMPAIGN BULLETIN

**APPLICABILITY:** 2017-19MY Impreza / Halogen Head Lamps

**NUMBER:** WRG-22R

**SUBJECT:** Halogen Headlamp Low Beam  
& Side Reflector

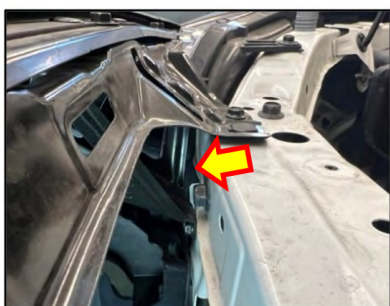
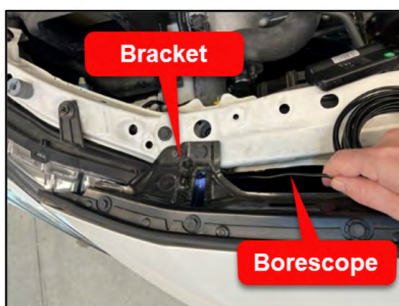
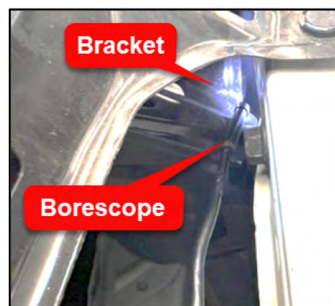
**STEP 3:** Insert a borescope in between the upper bumper bracket and the inner front portion of both left and right headlamps.

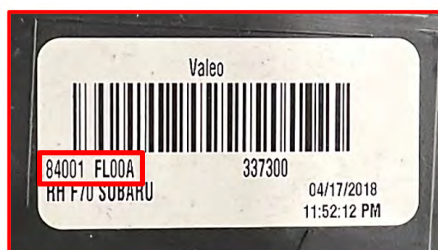
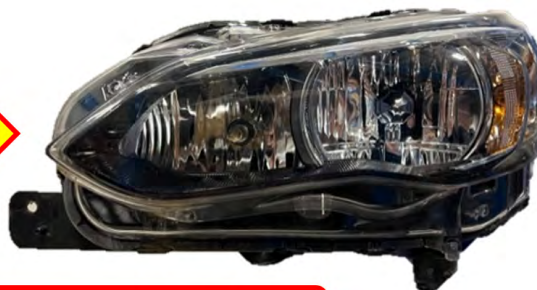
Locate the part numbers labeled on the both the left and right headlamp assemblies. The part identification label is located on the inner front portion of the headlamp. See the images below.

The example part identification label pictured above shows part number **84001FL00A**

Headlamps with part number **84001FL00B** or **84001FL01B** will not require replacement. If **84001FL00B** or **84001FL01B** are found, no replacement is required. Reinstall all removed parts in the reverse order of disassembly.

**ALL** other part numbers will require replacement and adjustment (see below).
