SERVICE PROGRAM BULLETIN

APPLICABILITY: 2025 MY Legacy
2025 MY Outback (Including Wilderness)

NUMBER: WRC-24R
DATE: 01/17/25
REVISED: 01/30/25

SUBJECT: Cockpit Control Unit Software Update

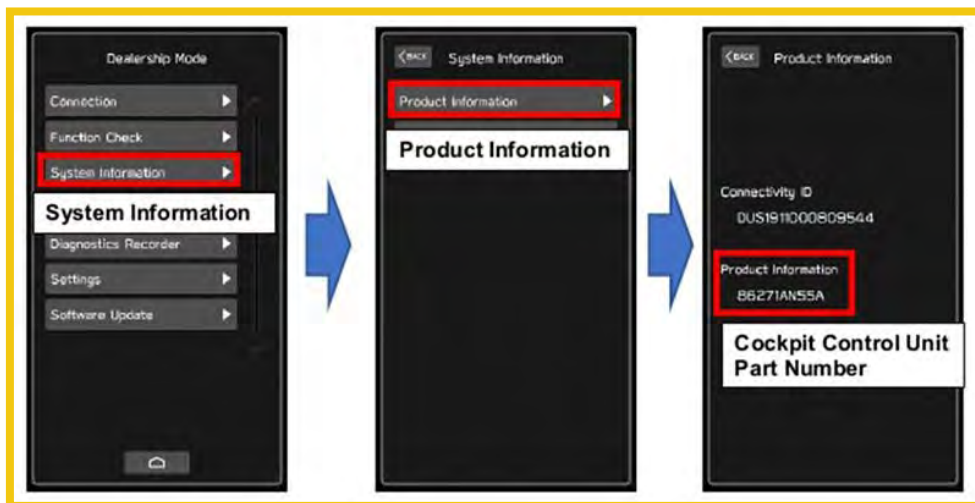
After access the Dealership Mode, go to Product Information and check the part number of the CCU.

Applicable part numbers are **86201AN55A** and **86271AN55A**. If the last letter is “B” or “C”, the CCU is not eligible for WRC-24 service program and the software shouldn’t be updated per this document.

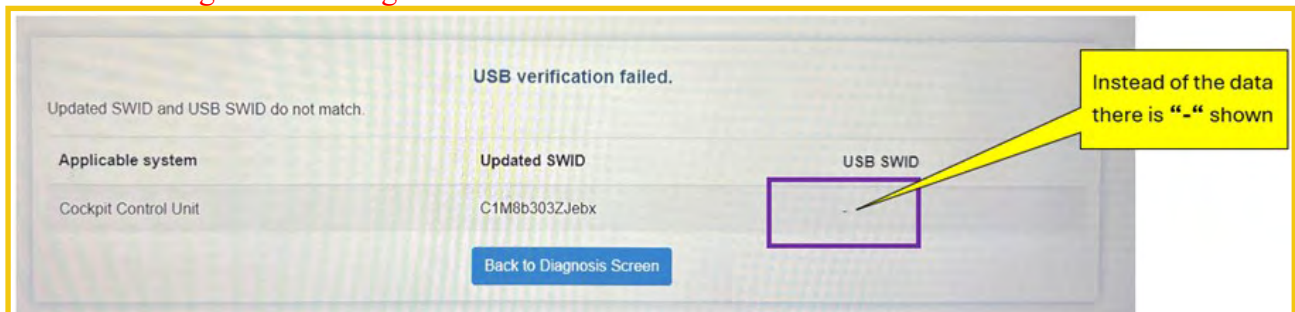
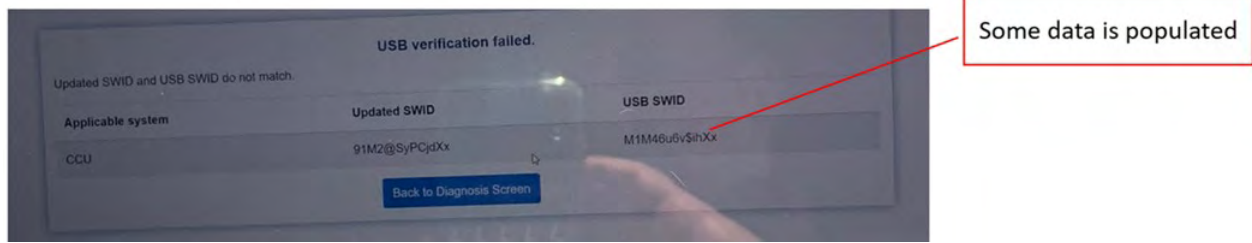
IMPORTANT NOTE: In rare cases when the CCU does not complete the USB authentication check in time resulting in the message box below.

This is not to be confused with a typical USB verification failure due to data mismatch.

Please verify the CCU has been confirmed to be eligible for this update based on the VIN and the CCU part number, then proceed with recovery steps as applicable.

- Perform a soft reset of the CP1 by holding down the CID volume knob. Please leave USB Drive connected.
- Once the CP1 has restarted, retry step ii on the previous page and then press the “Start Reprogramming” button. Please wait for 2 minutes after CP1 has restarted, before press the “Start Reprogramming” button.
- If the same failure is encountered again, please proceed with the diagnostic of failure by checking the USB drive data integrity.

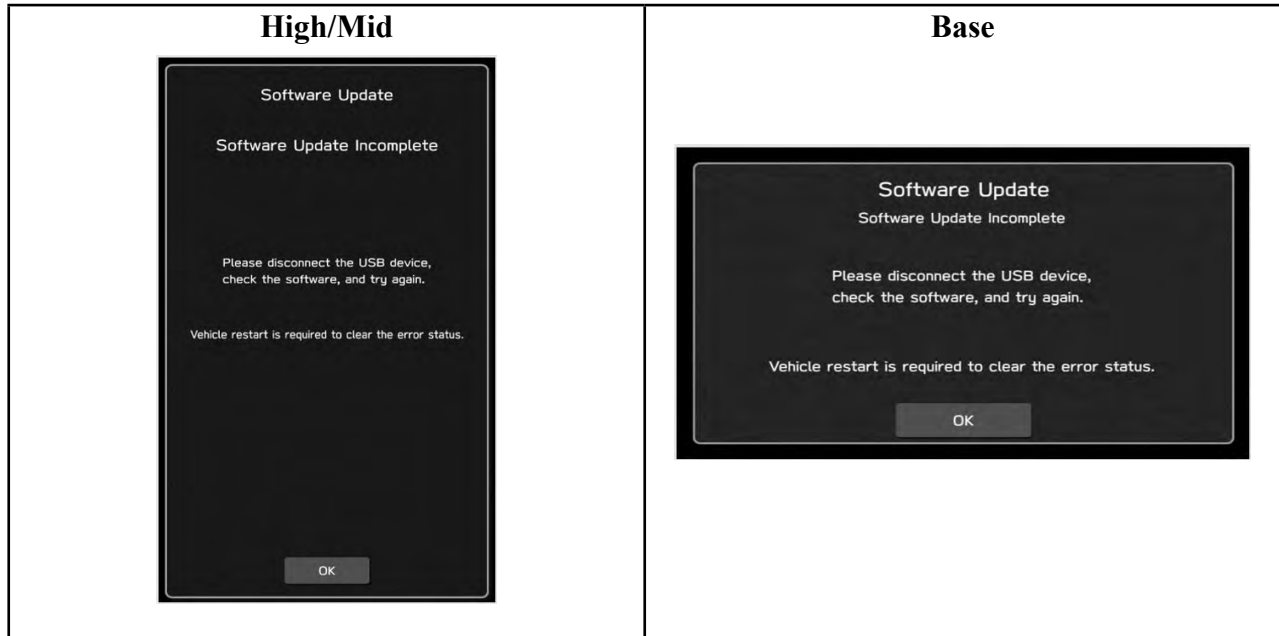
- If the first attempt of update fails with the message below, follow the steps described below 1-2 to 1-8 before retrying the software update.

1-1. Select OK in the screen below

1-2. Turn the ignition switch or the engine OFF, and turn it ON again. **Caution: Do not remove battery terminal and keep battery power supply.**
