## SERVICE BULLETIN

**APPLICABILITY:** 2020-24MY Legacy & Outback  
 2022-24MY WRX (A/T Only)  
 2019-24MY Ascent

**NUMBER:** 16-151-24R

**SUBJECT:** TR690 Chain Slip, Judder, Shudder, & Hesitation Concerns

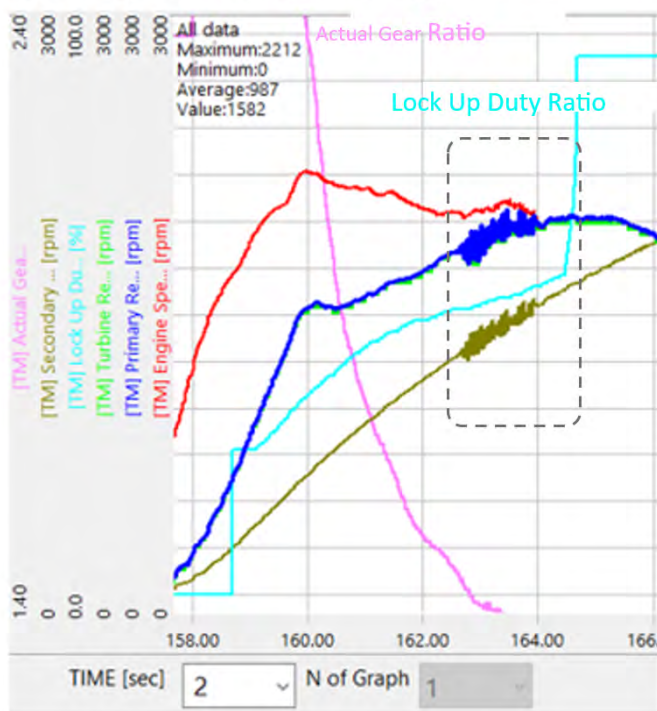
Example Graph for Lockup Judder Type A:

### Lockup Judder Type A Diagnosis Procedure.

**STEP 5:** In case a when a judder sensation is felt, the vehicle is presenting <Lockup Judder Type A>.

**Lockup Judder Type A & B:** Torque Converter (p.n. 31100AB460) replacement, CVT Fluid (p.n. 31333AA160) replacement, and TCM software reprogramming (newest software available).

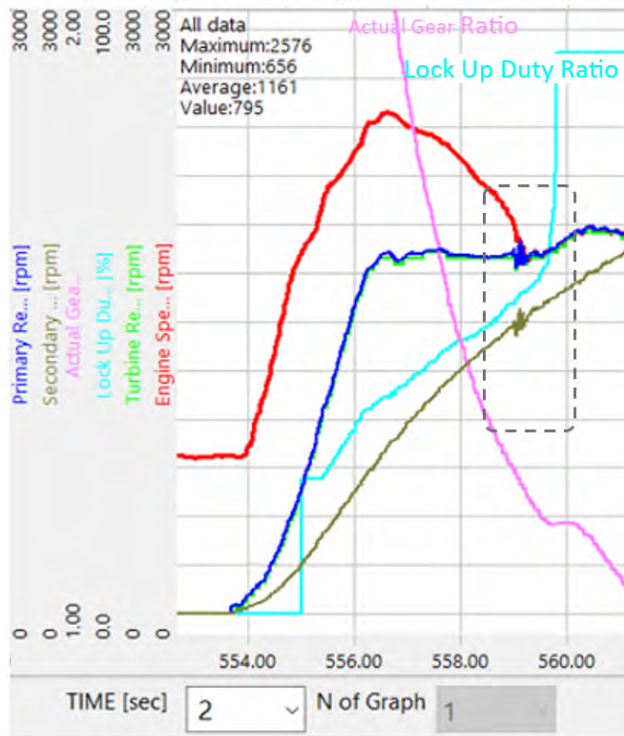
Example Graph for Lockup Judder Type B:

#### Judgement Criteria

- There are fluctuations in Turbine Revolution and Primary Rev Speed:

Peak to Peak > 50 rpm

Duration < 1 second

**STEP 4:** In a case when a judder sensation is felt, the vehicle is presenting <Lockup Judder Type B>.

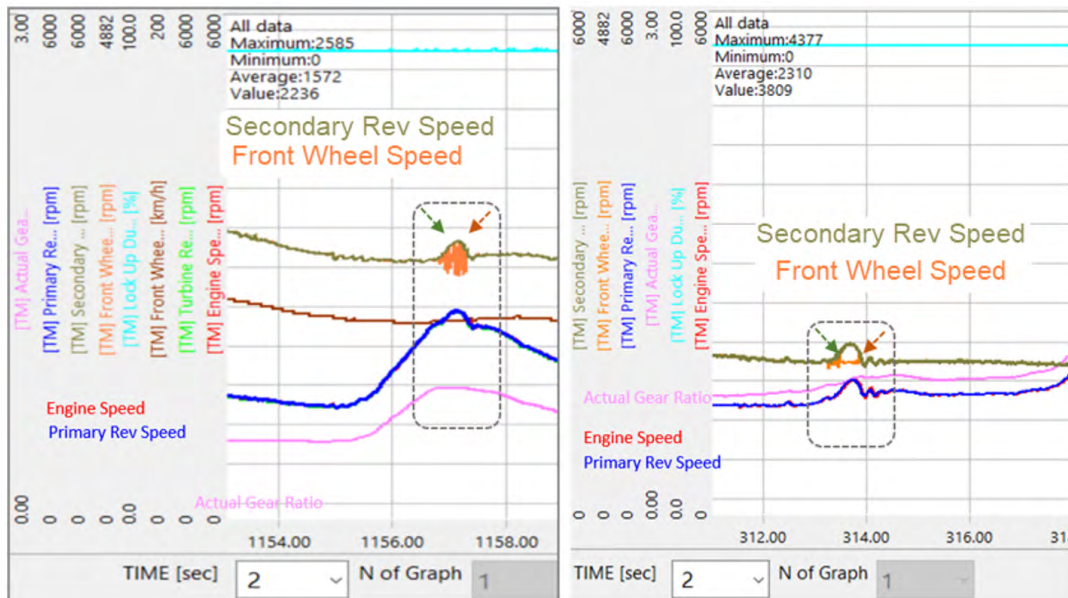
Examples Graph for Forward Clutch Judder:

#### Judgement Criteria

The rotational speeds of the upstream and downstream sides of the forward clutch do not synchronize during driving.

**Upstream side of the forward clutch: Secondary Rev Speed**

**Downstream side of the forward clutch: Front Wheel Speed**

**STEP 6:** In a case when a judder sensation is felt, the vehicle is presenting < Forward Clutch Judder >.

**Forward Clutch Judder:** CVT Fluid (p.n. 31333AA160) replacement and TCM software reprogramming (newest software available).

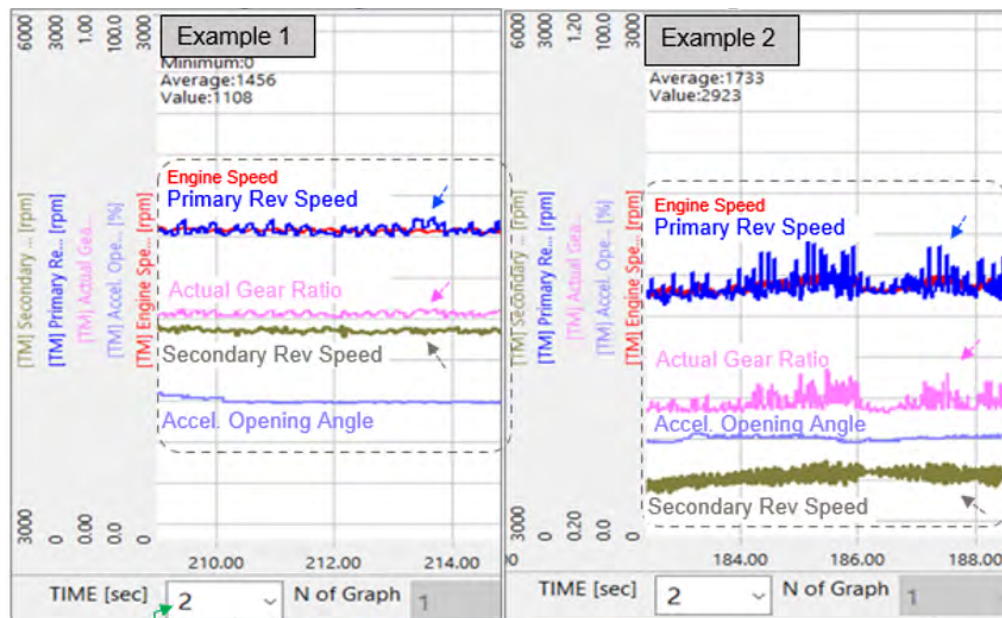
Examples of the data monitoring during Continuous Micro-Slip:

##### Judgement Criteria

During a continuous micro-slip, while the Accelerator Opening Angle monitor displays a stable value for more than one second, there are fluctuations in the Actual Gear Ratio monitor:

**Peak to Peak > 0.02**

**Frequency > 3 cycles per 1 second**

There are fluctuations in the Primary Rev Speed and/or Secondary Rev Speed monitor:

**Peak to Peak > 50 rpm**

Using Subaru Select Monitor (SSM), check and record data monitors and compare to the three examples listed below. If the recorded data from the vehicle matches the examples below, the CVT will require replacement. The SSM data will be required for claim submission. A QMR containing the same information will also be required.

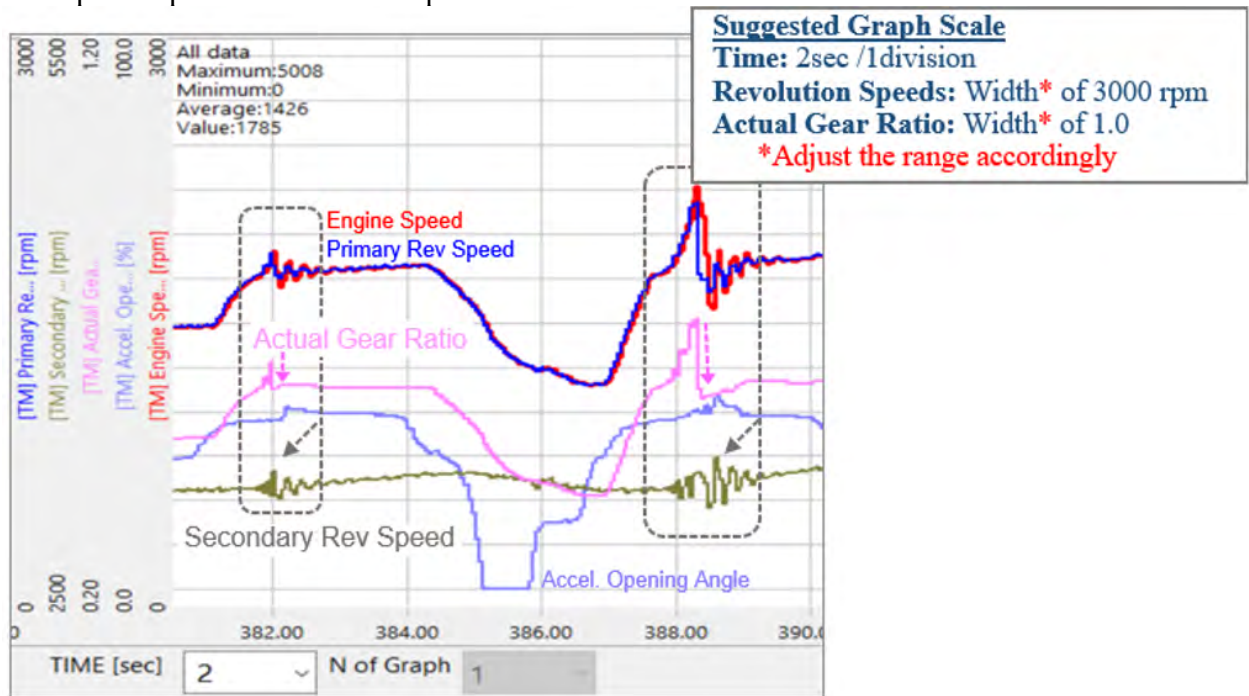
Example Graph of Short Time Slip:

When a short-time slip occurs, the changes in the Actual Gear Ratio monitor will be larger than 0.1 per 0.1 second. After the Actual Gear Ratio monitor resumes to stable conditions, distinct fluctuations in revolution speed continues.

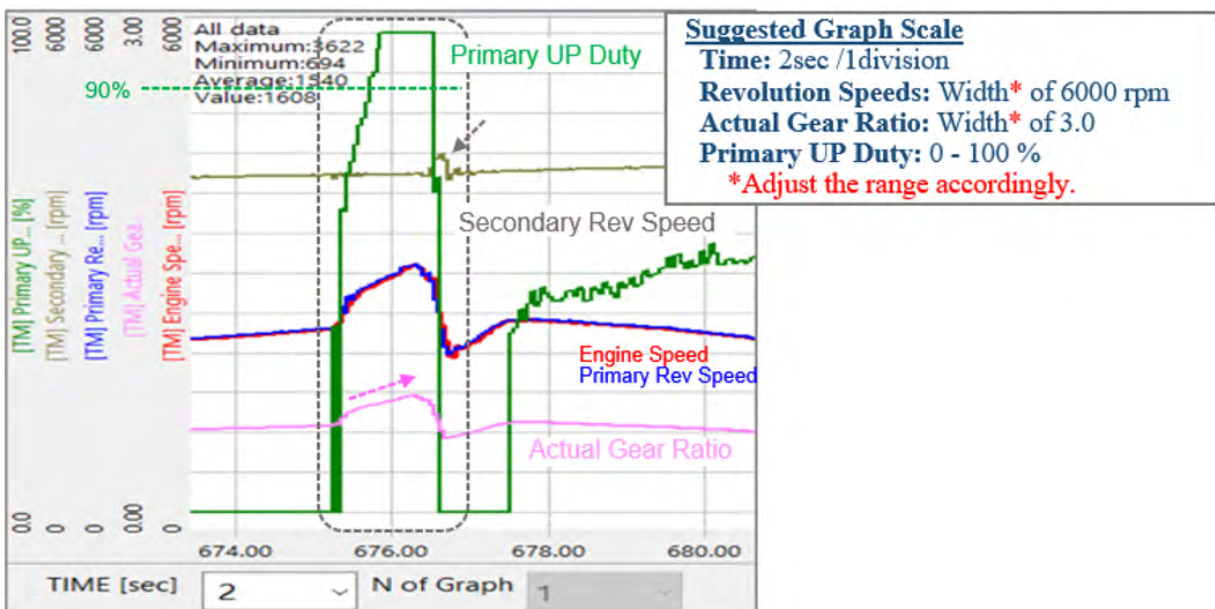
When a long-time slip occurs, the Primary UP Duty monitor will be larger than 90% and the Actual Pulley Ratio monitor lowers for a duration of 0.5 seconds or more. Even after the Actual Gear Ratio monitor resumes to stable conditions, distinct fluctuations in revolution speed continues.

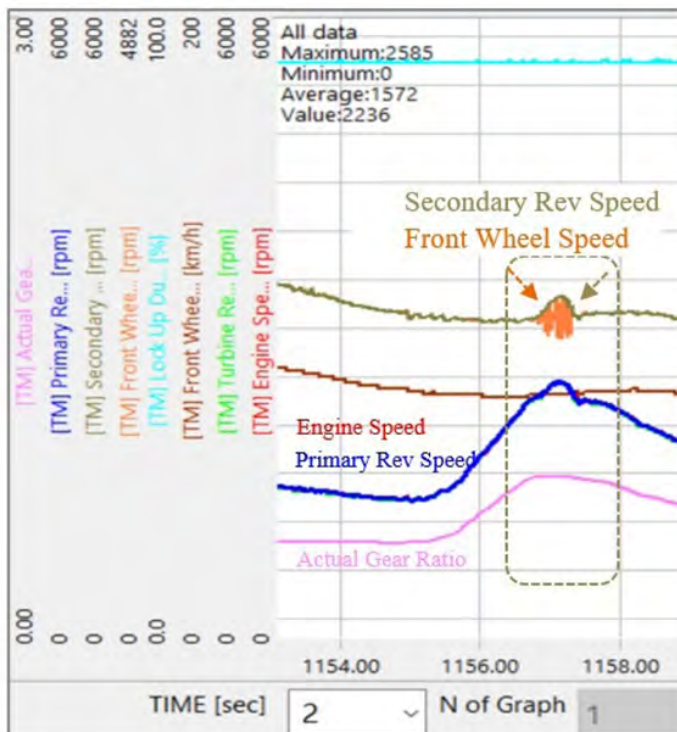
#### 1. Forward Clutch Slip Shock

The rotation speeds for the upstream and downstream sides of the forward clutch do not synchronize when driving.

Upstream side of the forward clutch-  
Secondary Rev Speed

Downstream side of the forward clutch-  
Front Wheel Speed

This shock can occur when the forward clutch slips. If this situation is reported, reprogram the TCM with the newest software available.

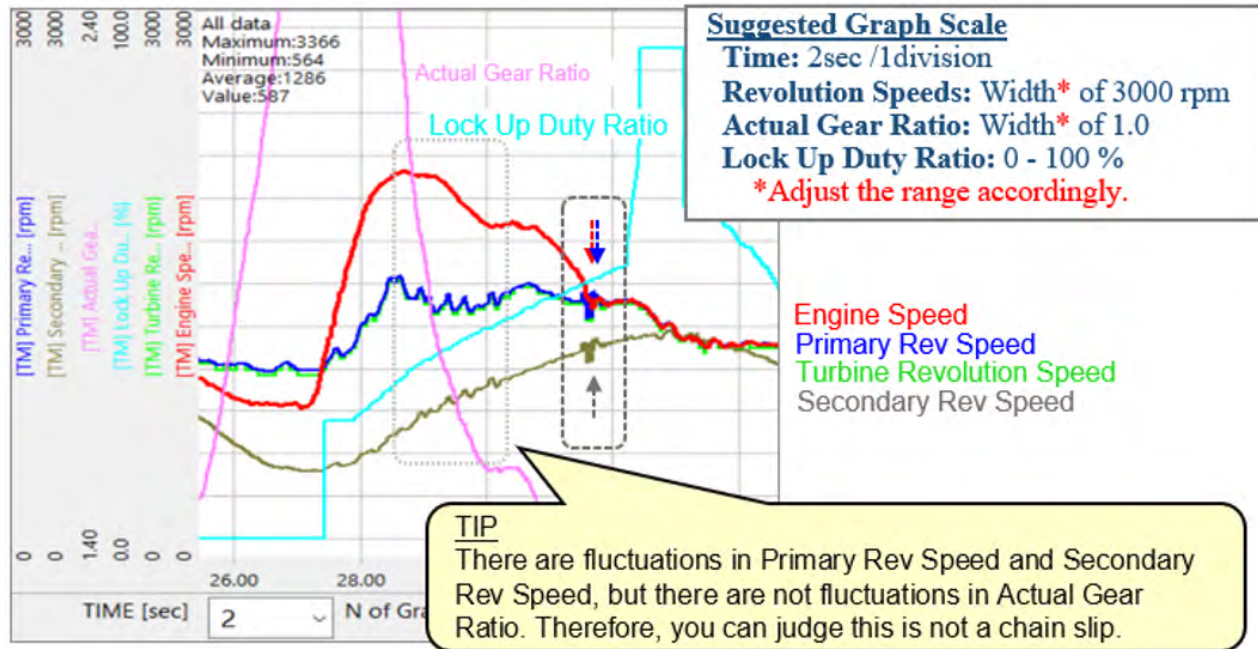
## 2. Lock Up Clutch Engagement Shock:

This shock can occur when the lock up engages rapidly. If this situation is reported, reprogram the TCM with the newest software available.

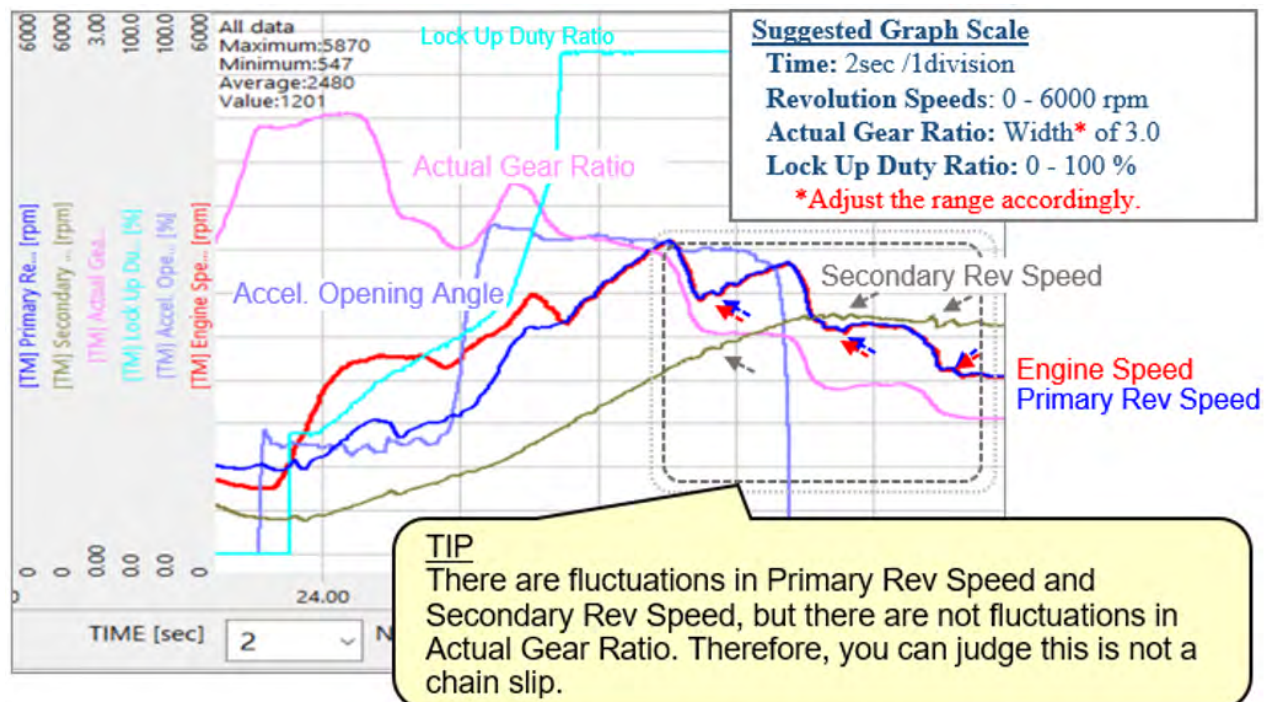
## 3. Shift Up Shock:

This shock can occur when the CVT upshifts. If this situation is reported, reprogram the TCM with new software if it is available. If there is no new software available or the reprogramming does not remedy the issue, report the situation to Techline.

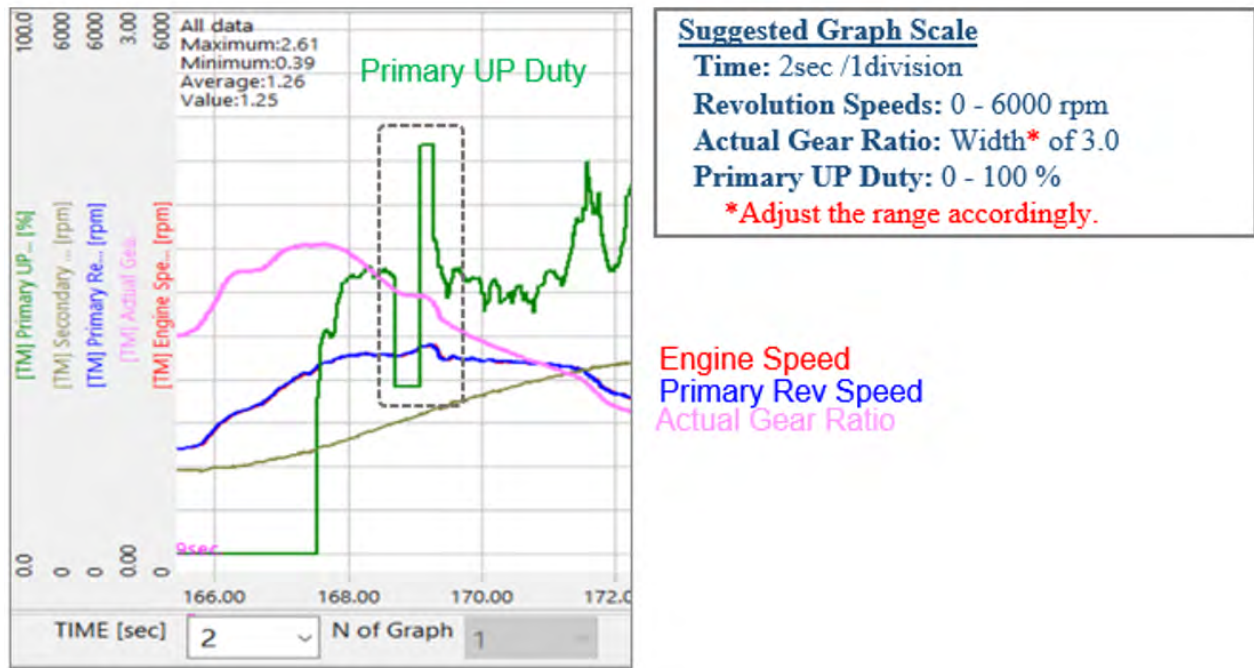
#### 4. Primary Up Duty Square Control (Ascent Models up to 2021MY):

A harsh shift can be felt while driving. If this situation is reported, reprogram the TCM with new software if it is available. If there is no new software available or the reprogramming does not remedy the issue, report the situation to Techline.
