REFERENCE:	TSB: 14-003-25 GROUP: 14 - Fuel	Date:	January 28, 2025	REVISION:	—
VEHICLES AFFECTED:	2020 - 2024 (WD) Dodge Durango This bulletin applies to vehicles built on or before July 25, 2024 (MDH 0725XX) equipped with a 3.6L V6 24V VVT Engine Upg I w/ESS (Sales Code ERC).			MARKET APPLICABILITY:	
				<input checked="" type="checkbox"/> NA	<input type="checkbox"/> MEA
				<input type="checkbox"/> SA	<input type="checkbox"/> IAP
				<input type="checkbox"/> EE	<input type="checkbox"/> CH
CUSTOMER SYMPTOM:	Customers must experience a Malfunction Indicator Lamp (MIL) illumination and the vehicle must exhibit/set the following Diagnostic Trouble Code (DTC): <ul style="list-style-type: none"> • P0452 - EVAP Pressure Switch Stuck Closed. Customers may also comment on the following: <ul style="list-style-type: none"> • The check engine light illuminates after long idle times and/or short trip driving.

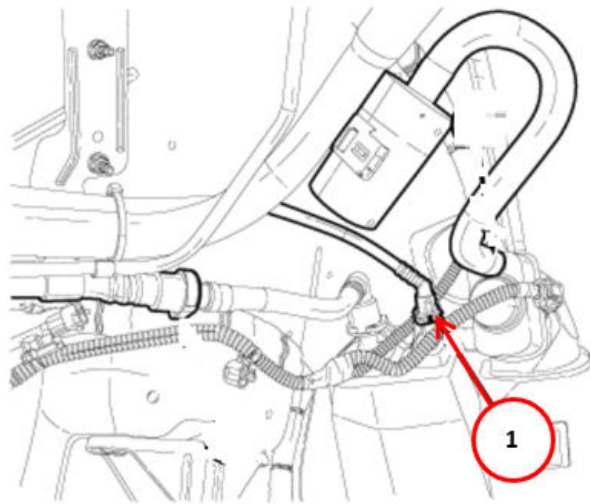
Fig. 1
Disconnect EVAP Canister Purge Line Quick Connect

1. Perform P0452 - EVAP Pressure Switch Stuck Closed DTC diagnostics to identify a faulty component or circuit. Refer to the detailed service procedures listed in DealerCONNECT> Service Library under: 28 - DTC-Based Diagnostics / Module, Powertrain Control (PCM), 3.6L / Diagnosis and Testing.
2. Did normal diagnostic identify a faulty component or circuit?
 - YES>>> Perform the suggested repair procedure based on the normal diagnostic test result.
 - NO>>> If the normal diagnostics does not identify a faulty component or circuit and it is suspected that excessive fuel condensation has accumulated in the purge line, proceed to [Step 3](#).
3. Disconnect the vapor purge line quick-connect fitting at the Evaporative Emissions (EVAP) control system canister [Fig. 1](#).

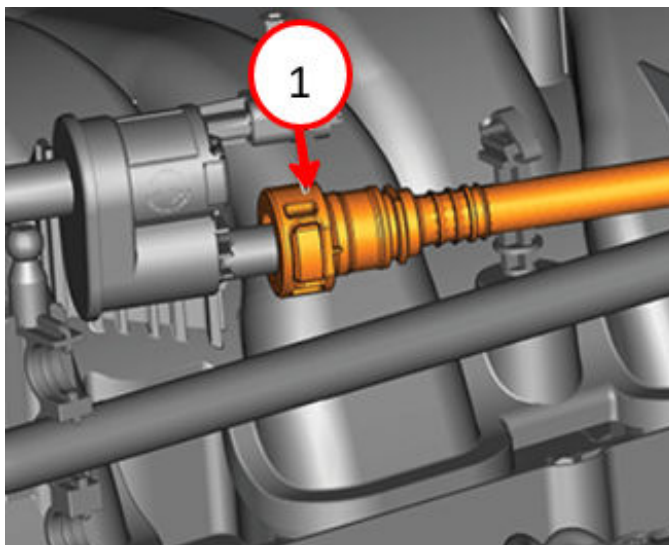
Fig. 2
Disconnect Purge Valve Solenoid Purge Line

1 - Purge Valve Solenoid Purge Line

4. Disconnect the vapor purge line at the canister purge solenoid [Fig. 2](#).

5. Blow out the purge line using short bursts of compressed air then clean out the line of any residual fuel condensate.
6. Connect the vapor purge line at the canister purge solenoid [Fig. 2](#).
7. Connect the vapor purge line quick-connect fitting at the Evaporative Emissions (EVAP) control system canister [Fig. 1](#).
8. Remove the fuel tank. Refer to the detailed Service procedures available in DealerCONNECT/ Service Library under: Service Info> 14 - Fuel System / Fuel Delivery, Gas / TANK, Fuel / Removal.
9. Position the upper heat shield on fuel tank [Fig. 3](#).

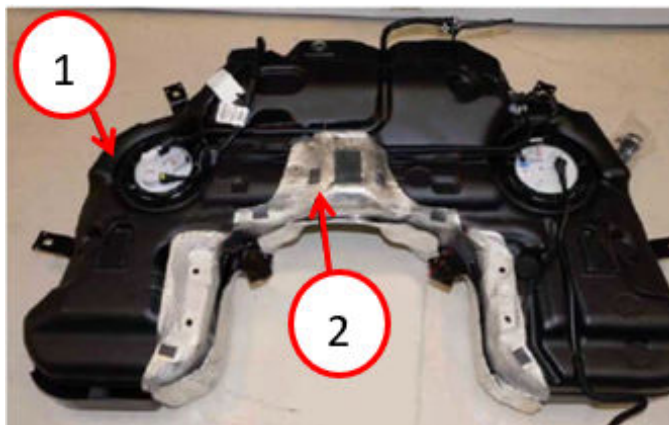
Fig. 3
Fuel Tank With Heat Shield Installation

1 - Fuel Tank Assembly
2 - Fuel Tank Heat Shield

10. Install the fuel tank. Refer to the detailed Service procedures available in DealerCONNECT/ Service Library under: Service Info> 14 - Fuel System / Fuel Delivery, Gas / TANK, Fuel / Installation.
11. Clear any DTCs that may have been set.
