Technical Service Bulletin

Subject: SECOND-ROW SEAT DOES NOT SLIDE WITH WALK-IN LEVER OPERATION	Bulletin No.: 09-001/25
	Last Issued : 01/10/2025

2024-2025 CX-90 with VINS lower than JM3KK*****218038 (produced before November 19, 2024)

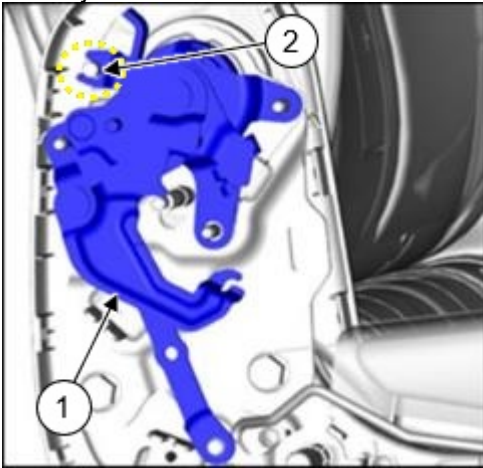
Some vehicles may experience the second-row seat (configured as captain chairs or 60/40 bench) not sliding with the walk-in lever operation, although it slides with the sliding lever. The link bracket (2) may interfere with the kick plate (1) while operating the recline function, causing the deformation of the link bracket and preventing it from pulling the cable properly to unlock the seat for sliding.

To eliminate this concern, the thickness of the link bracket has been modified to prevent deformation and the shape of the kick plate has been modified to prevent the interference.

j. Install the modified rear seat back link assembly (1) after installing the C-shape link to the shaft (2).
