# Technical Service Bulletin

<b>Subject:</b>  "BLIND SPOT MONITORING SENSOR(S) BLOCKED" DISPLAYED IN INSTRUMENT CLUSTER WHILE DRIVING	<b>Bulletin No.:</b> 09-004/25
	<b>Last Issued :</b> 01/21/2025

2022-2025 CX-5 vehicles with VINs lower than JM3 KF\*\*\*\* \*\* 608867 (Produced before Dec. 2024)

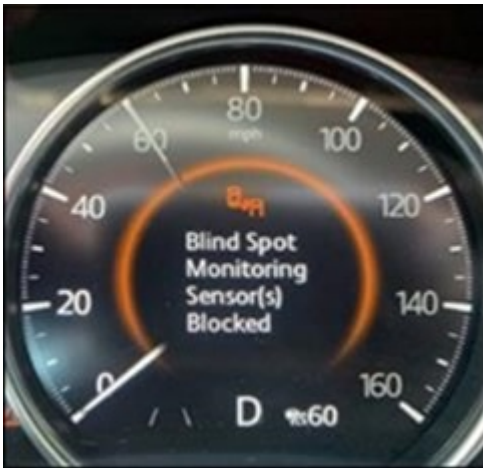
Some vehicles may experience "Blind Spot Monitoring Sensor(s) Blocked" displayed in the instrument cluster while driving over 37 mph {60 km/hr.} in areas without structures or buildings around the vehicle.

This may be caused by a partial defect in the blind spot monitoring (BSM) control module. To eliminate this concern, the blind spot monitoring (BSM) control module has been modified.

1. Verify the customer concern.
2. Replace both sides of the blind spot monitoring (BSM) control module with modified parts according to the instructions

on MGSS BLIND SPOT MONITORING (BSM) CONTROL MODULE REMOVAL/INSTALLATION.
