<b>REFERENCE:</b>	<b>TSB:</b> 14-002-25 REV. A <b>GROUP:</b> 14 - Fuel	<b>Date:</b>	February 1, 2025	<b>REVISION:</b>	14-002-25
<b>VEHICLES AFFECTED:</b>	<b>2024 - 2025 (B1) Jeep Renegade</b> <b>2024 - 2025 (H1) Jeep Commander</b> <b>2024 - 2025 (M1) Jeep Compass</b> <b>2024 - 2025 (N4) RAM Rampage</b> This bulletin applies to the vehicle built on or after <b>**January 08, 2024 (MDH 0108XX)**</b> and on or before <b>December 13, 2024 (MDH 1213XX)</b> .			<b>MARKET APPLICABILITY:</b>	
				<input checked="" type="checkbox"/> NA	<input type="checkbox"/> MEA
				<input checked="" type="checkbox"/> SA	<input type="checkbox"/> IAP
				<input type="checkbox"/> EE	<input type="checkbox"/> CH
<b>CUSTOMER SYMPTOM:</b>	<b>Customers may comment on the following:</b> <ul style="list-style-type: none"> <li>• Difficult to refuel the vehicle.</li> </ul>				
<b>CAUSE:</b>	Loose quick connect fittings

This bulletin involves inspecting, and if necessary, properly connecting the fuel hose quick connects.

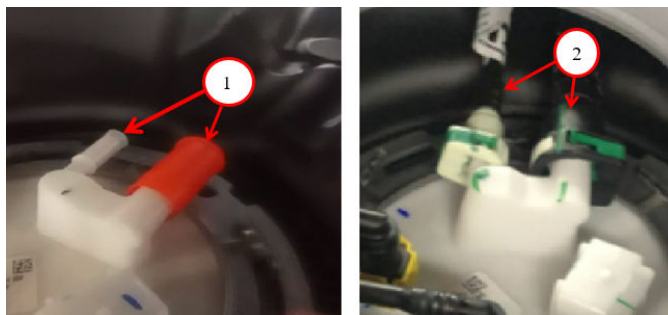
**Fig. 3**  
Fuel Pump Breather Tubes

3. Inspect the fuel breather tube connections to the fuel pump [Fig. 3](#).

1 - Fuel Breather Tubes Disconnected  
2 - Fuel Breather Tubes Connected

4. Are the fuel breather tubes connected to the fuel pump [Fig. 3](#)?

5. Remove the red tamper proof cover and connect the fuel breather tubes to the fuel pump [Fig. 3](#).
