## Check engine light or Adblue warning with fault codes P206B31, P203B31, or P300494 when outside temperatures are below 32 degrees Fahrenheit

Topic number	LI49.20-N-078838
Version	1
Function group	49.20 - Exhaust gas aftertreatment
Date	1/29/25
Validity	Model 907
Reason for change

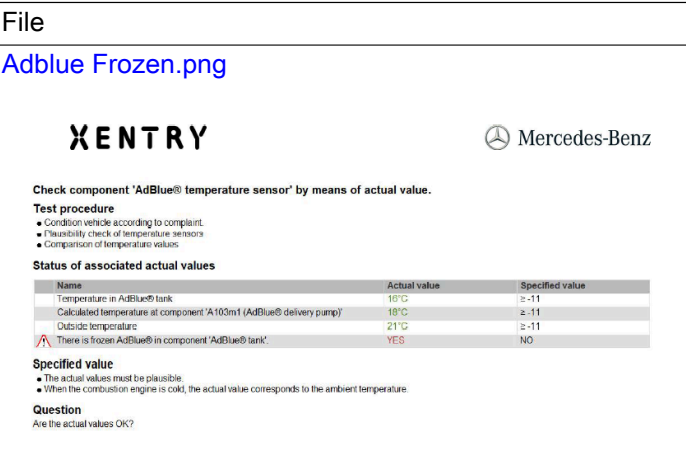
Attachments																																									
File	Description																																								
<p><a href="#">Adblue Frozen.png</a></p>

--NOTE-- If the XENTRY still shows that there is frozen Adblue or the concentration is still inaccurate after draining and filling, please refer to the attachments 'Adblue Frozen' and 'Adblue Concentration' and proceed to step C.

## C. Damaged Adblue Level Sensor/Concentration Sensor

### 1. Replace the Adblue Tank
