BULLETIN NUMBER:  
**IB16-F-001E**

## LIMITED SLIP DIFFERENTIAL CHATTERING NOISE

- 2011-2022MY Isuzu N-Series Vehicles  
Equipped with 5.2L (4HK1) Diesel Engine **and** Limited Slip Differential (LSD)  
Option Code IV0
- 2020- 2026MY Isuzu N-Series Vehicles  
Equipped with 6.6L (L8T) Gasoline Engine **and** Limited Slip Differential (LSD)  
Option Code IV0
- 2022MY Isuzu N-Series Vehicles  
Equipped with 6.0L (PSI) Gasoline Engine **and** Limited Slip Differential (LSD)  
option code IV0

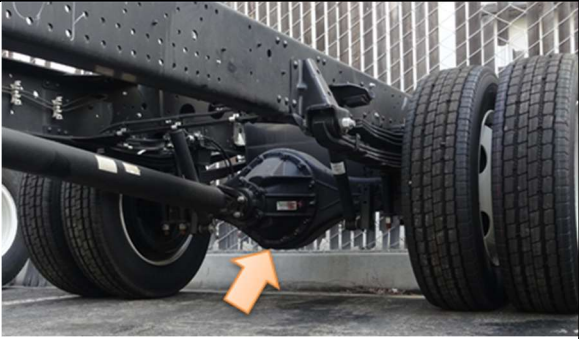
| <b>Figure 1 – Code Location</b> | <b>Figure 2 – Example of Stamping</b> | |

See Figures 1 and 2 below in this bulletin to identify a limited slip differential or check the vehicle build in IVIS (Isuzu Vehicle Information System) for Option Code IV0.

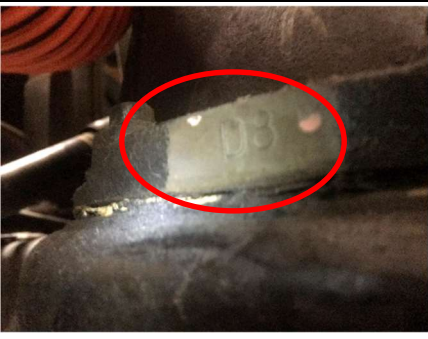
| | | <b><u>Codes</u></b><br>B7<br>D0<br>D8<br>D9<br>H0<br>H1<br>H9 |
