Title: Advantage Roof Hatch Leak due to Harness Routing

Applies To: Buses with Advantage Roof Hatches built Between 3/18/24 and 5/1/24

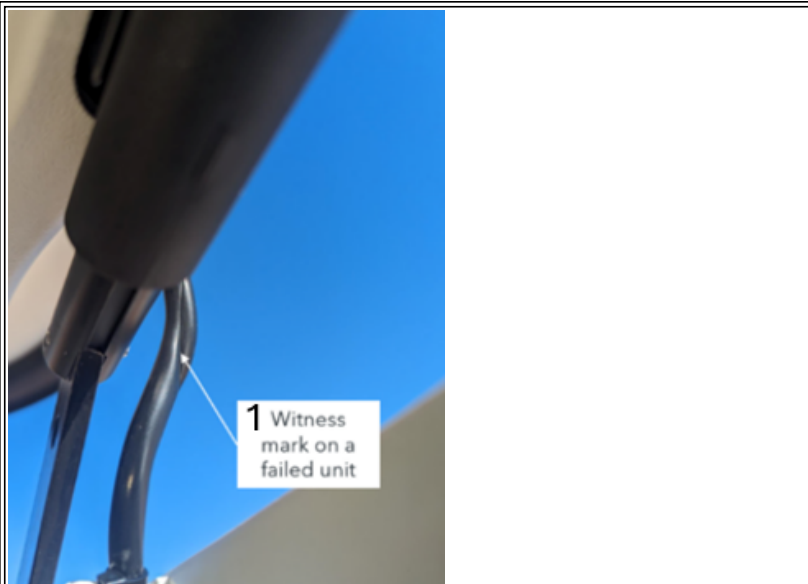
Figure #1: Hatch Harness

Water leaking at the roof hatch to the inside of the bus. The leak will be seen between the roof hatch lid and the hatch body at the rubber seal.

| Step | Action | Decision |
|---|--|---|
| 1 | <p>DIAGNOSTIC:</p> <p>Does the roof hatch leak at the lid seal and does the harness have witness marks as shown below in Figure #1?</p> | <p>Yes. See the repair section below.</p> <p>No. This article does not apply.</p> |

Item 1: Witness mark on the harness of a hatch that leaked.

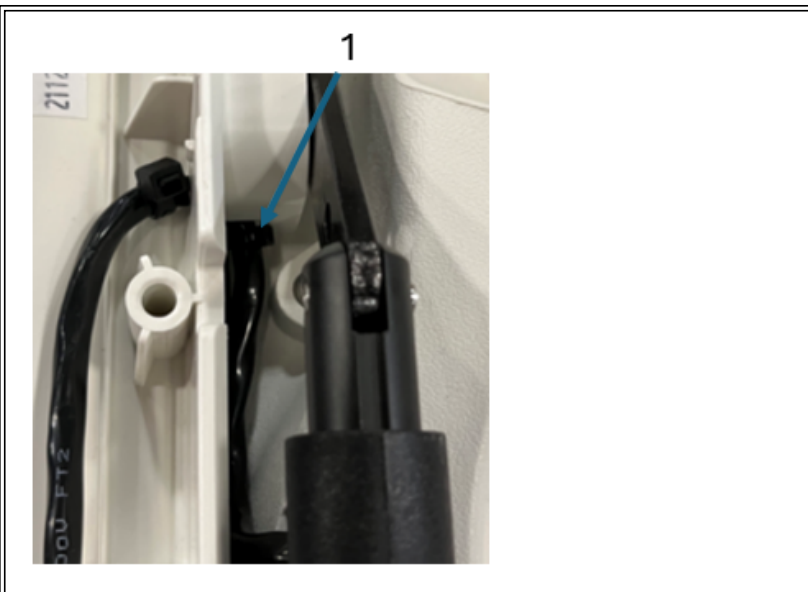
Figure #2: Hatch Harness Repaired

Item 1: Added Zip-tie.

1. Push excess harness into hatch cavity
2. Add Zip-tie as shown in Figure #2
3. Open and close the hatch lid to verify the harness is no longer able to get caught in the lid.
4. Repair complete.
