## RYKER 2025 Unit Inspection Required - 143625

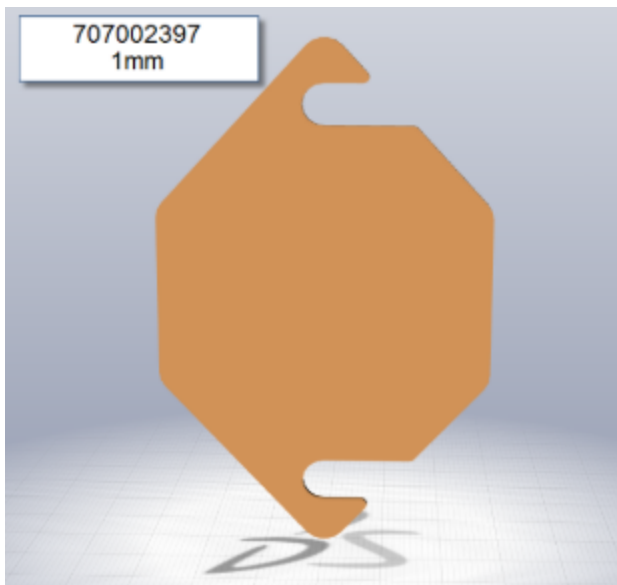
The fuel tank upper rubber pad might not have been installed properly. Also, the steering column might be in contact with the airbox.

For the steering column, add 2 shims (707002397) under RH ENGINE supports. \*Note that don't install more than 2 shims under RH support because of possible contacts on other parts above the engine.
