# Service Bulletin

Bulletin No.: 22-NA-172

Date: January, 2025

**Subject: Trailer Tire Pressure Only Reading Up To 100 PSI (689 kPa), New Parts To Increase To 147 PSI (1013 kPa)**

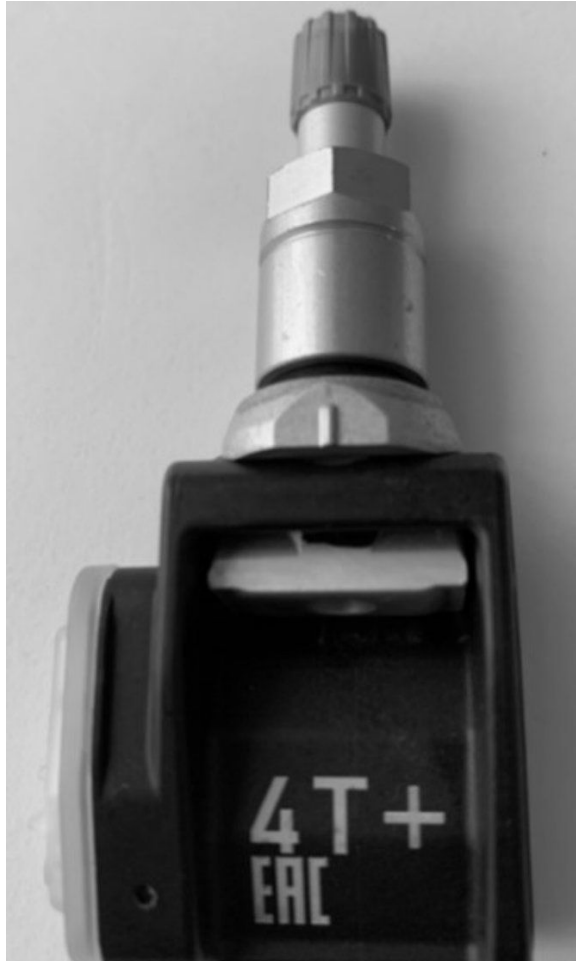
6309767

Example of the High Pressure TTPMs

- Vehicles built in Flint prior to October 1, 2021, replace both the TTPM and sensors then update the Radio software to V164 or higher.
- Vehicles built in Oshawa **DO NOT** need to replace the TTPM or sensors. Ensure the Radio software is V164 or higher.
