91-004 Repairing Seat Occupancy Sensor for ISRI, SEARS and National Truck Seats

TSB-91-004-WST

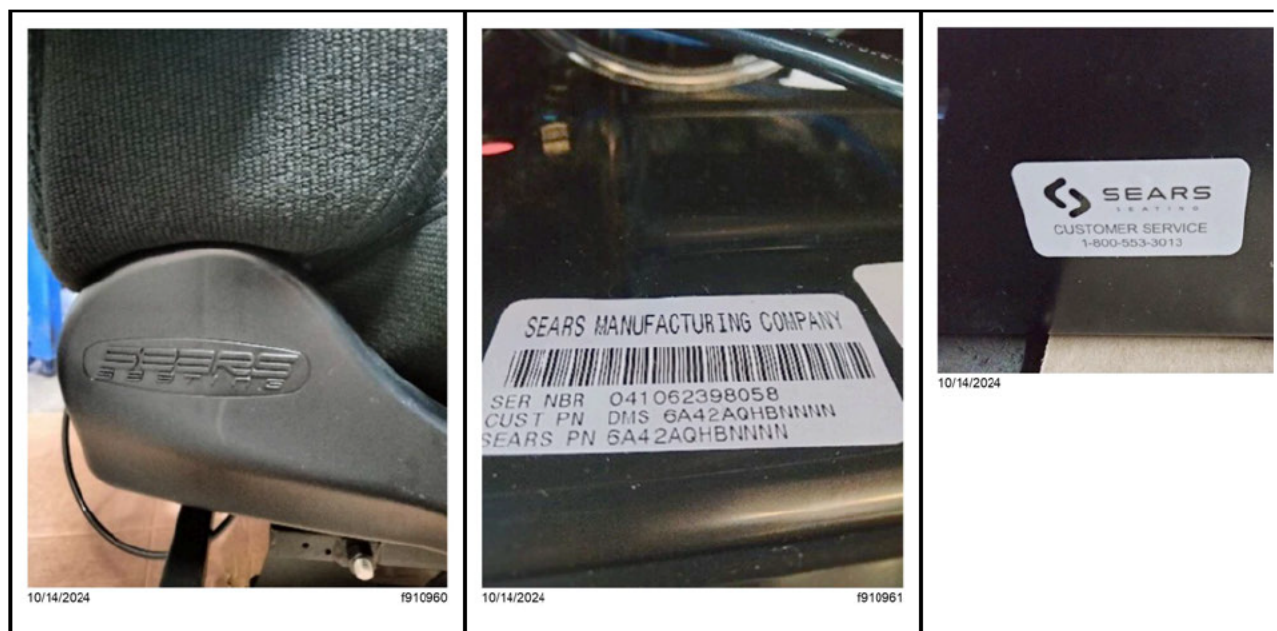
Table 1, SEARS Seat Information

2. Use the BOM to identify what seat is installed;
 - For visual ID of a SEARS seat, see the figures in [Table 1](#).

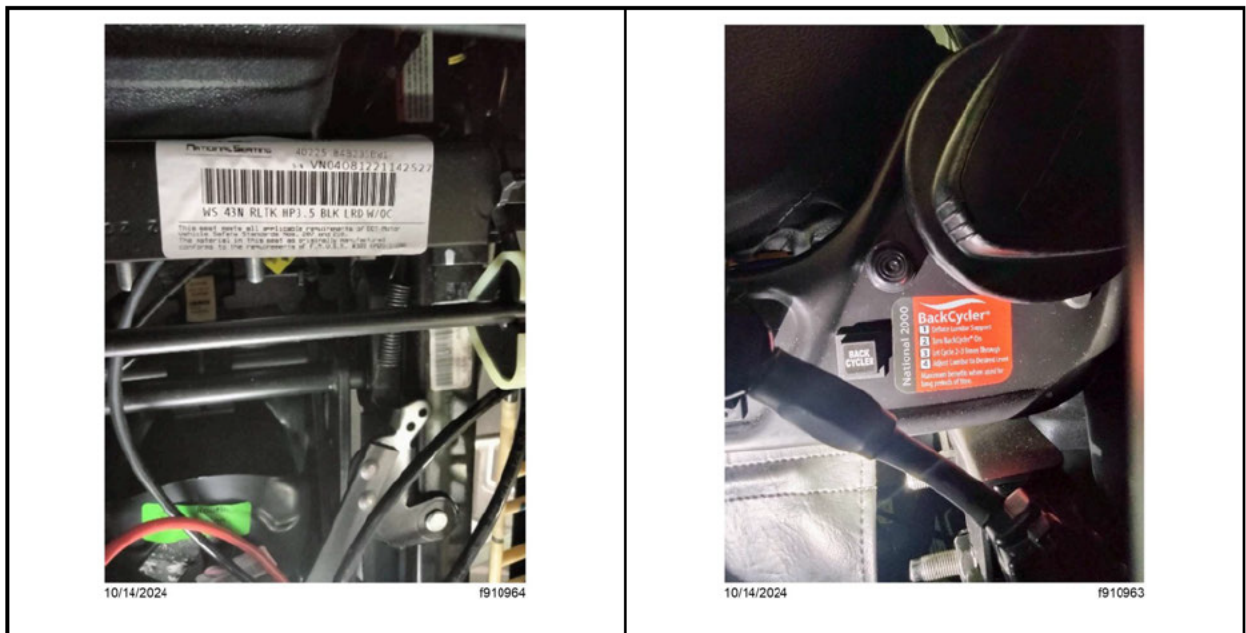
Table 2, National Truck Seat Information

- For visual ID of National Truck Seat, see the figures in Table 2.
